Partnership for Wissahickon Floodplain Reconnection

French Creek West - Case Study Abstract

Aquatic Resource Mitigation at Bensalem Township High School – PennDOT District 6-0

Watershed-wide Flooding and Wet Weather Assessment and Mitigation Study in Fishing Creek Watershed, Columbia County, PA

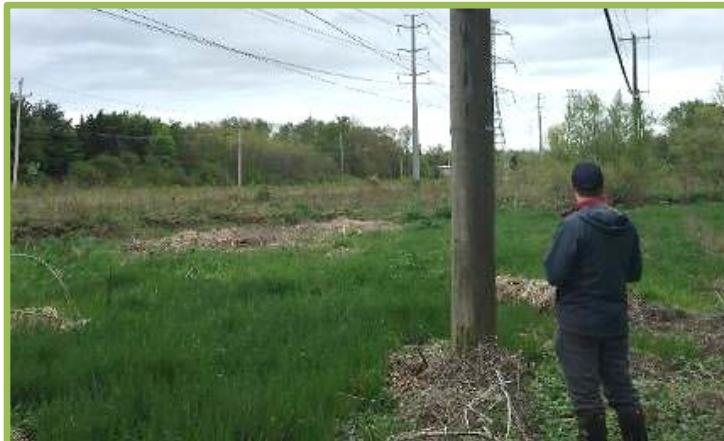
Figure 1. The project is in a high voltage electric transmission corridor, which influenced project design and requirements.

The project area has overhead power lines and utility poles throughout, which impacted project design (Figure 1). Grading in proximity to PECO poles was limited to the maximum extent practicable, while still fulfilling the project goals. Vegetation planting zones are proposed based on location of PECO transmission or distribution lines.

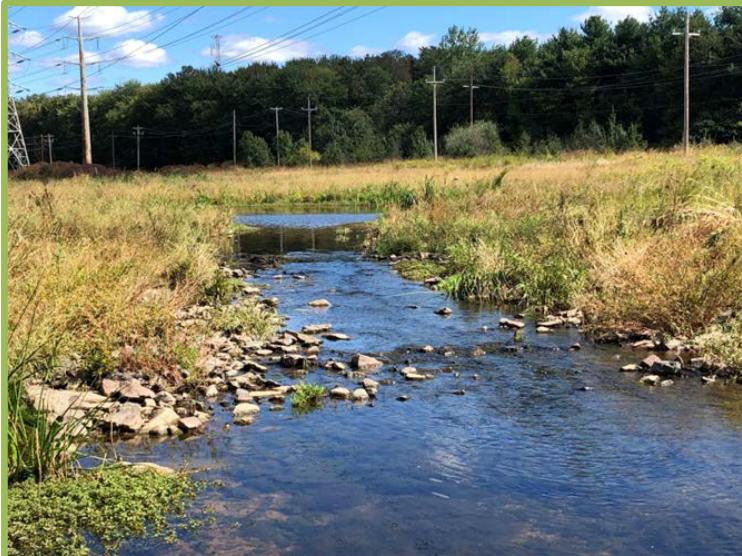
Figure 2. View of the project site post-restoration including a view of the stream restoration and floodplain reconnection.

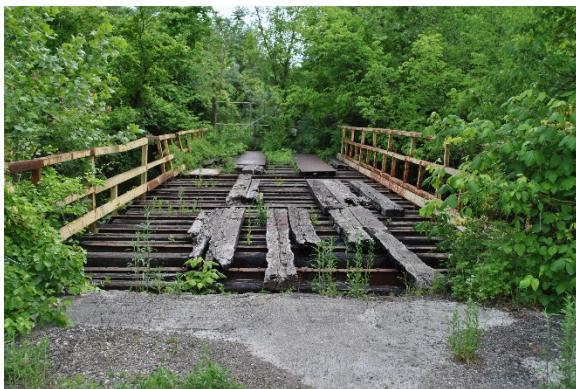
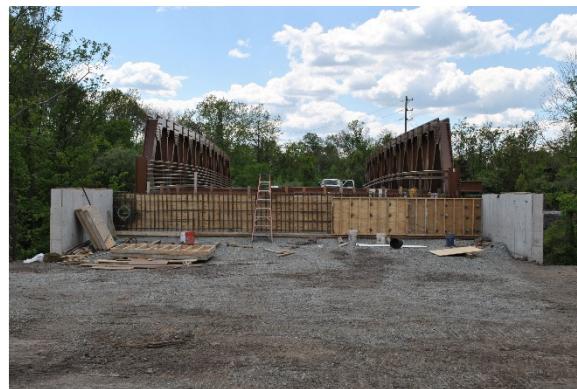
Figure 1. Existing and Reconstructed Paradise Street Vehicular Access – New Deck Raised 6 Feet Above Existing

The HEC-RAS model was investigated with a straightforward filling of the site to raise a developable area above the flood elevation. This caused a rise in the floodplain elevation, smaller than expected, but with any rise being unacceptable. Two existing bridges were built for the former steel operation. One being a rail bridge with the deck set at top of bank elevation. Given the stream geometry at this location such a bridge configuration represented a major flow obstruction. This rail bridge was partly collapsed and hazardous, its removal for any project would be required. The model was revised to remove the bridge, and the developable area of a large portion of the site improved. Another area at the upstream portion of the site still flooded, but this was a result of the second derelict bridge (Paradise Street) also constructed with the deck at top of bank elevation. Removal of this bridge further improved the developable area. A last iteration proposed fill on the site with the bridges removed with a resulting flood elevation that was lower than the updated existing model, and the FEMA effective model. The amount of fill would also comply with Act 2 Remediation requirements of a minimum 2-foot cap. This proof-of-concept was presented to and favorably received by the Borough to initiate the Land Development Process.

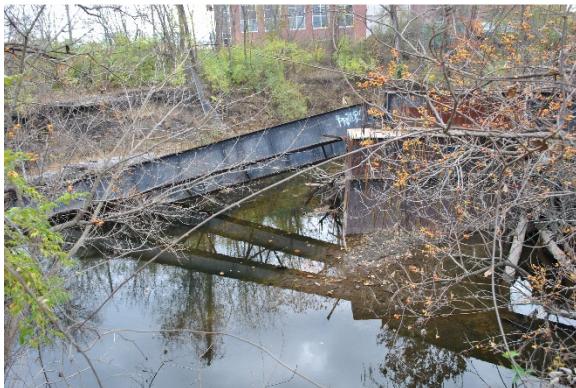
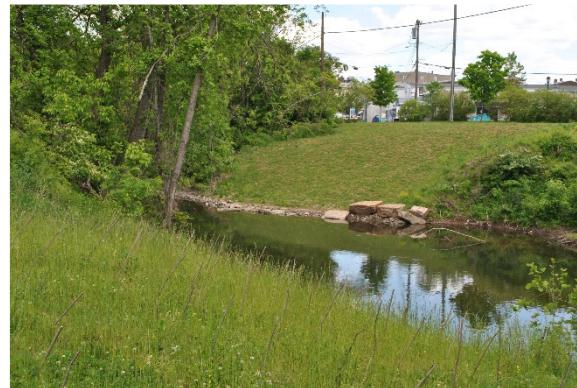
Figure 2. Existing Collapsed Rail Bridge and Restored Streambank Condition

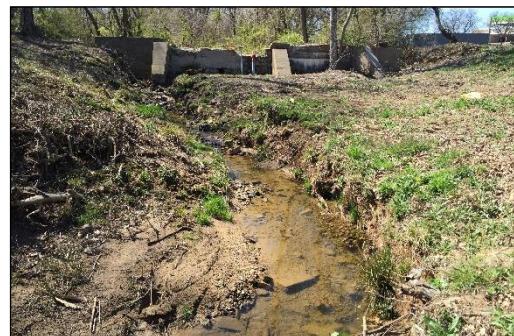
Figure 1. Existing concrete dam structure impairing aquatic organism passage and river continuity.

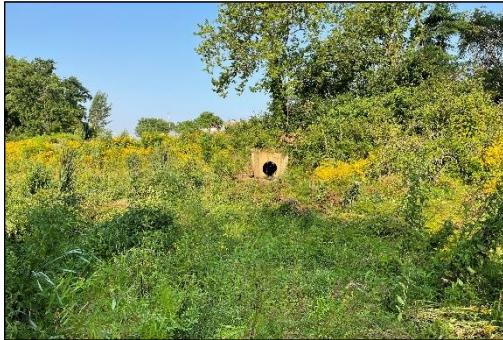
Figure 2. 54" stormwater outfall from high school parking lot discharging into preformed scour hole with level spreader to floodplain design.

stability as well as a carbon source for bio-geochemical nutrient processing and a surrogate streambed underlayment due to the inability of tying into the valley bottom basal gravels. The stream and floodplain restoration design also had to incorporate four stormwater outfalls into the stream and floodplain design in order to safely convey stormwater discharges from the nearby high school grounds to the proposed floodplain in a low energy, sheet flow condition. See **Figure 2** for one of the proposed stormwater outfalls one year after construction that was part of the overall stream and floodplain mitigation design.

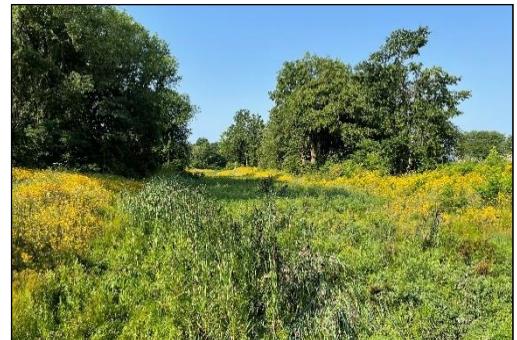
Figure 3. Stream corridor condition after 100-year storm event. This is the same location as shown in Figure 1.
