Permeability Restoration of Permeable Interlocking Concrete Pavements

Permeable Pavement Case Study at Ursinus College

Comparison of Winter Deicing Operations for Permeable Interlocking Concrete Pavements (PICP) Compared to Asphalt

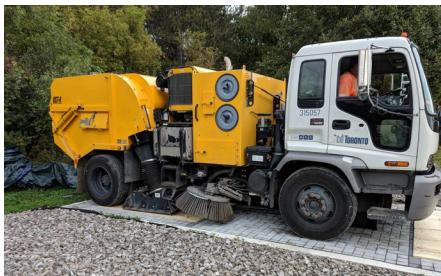
Regenerative Air Machine

Key Findings

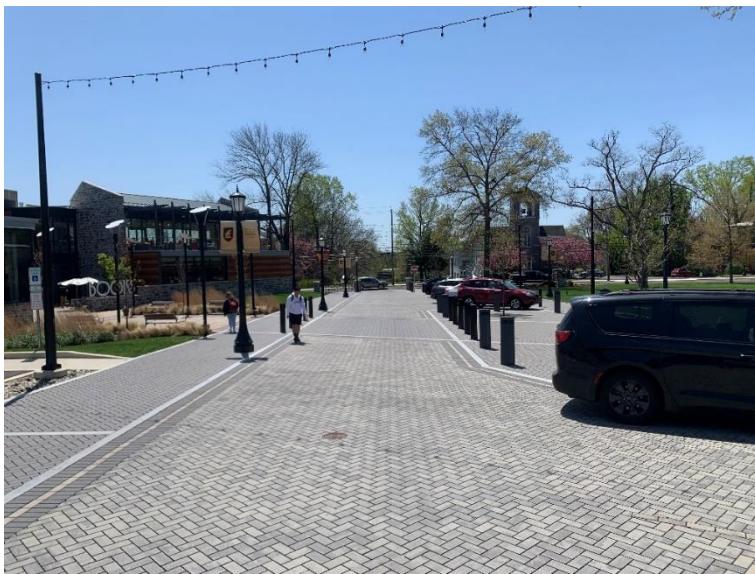
The multi-purpose pavement is an example of a successful green infrastructure project that is operating as designed. The use of permeable interlocking concrete pavement has provided multiple benefits including: a stormwater control measure that is reducing surface runoff; infiltrating rainwater into the subgrade, providing volume retention; and functioning as a highly aesthetic structural pavement surface, all in one system (Figure 2).

Figure 2. Permeable Pavers at Ursinus College
