**EVALUATING RAIN GARDENS OF DIFFERENT  
CONFIGURATIONS AND SCM INFILTRATION TESTING  
METHODS TO DETERMINE RAIN GARDEN DESIGN AND  
SITE INVESTIGATION RECOMMENDATIONS**

Thesis

Civil Engineering

April, 2016

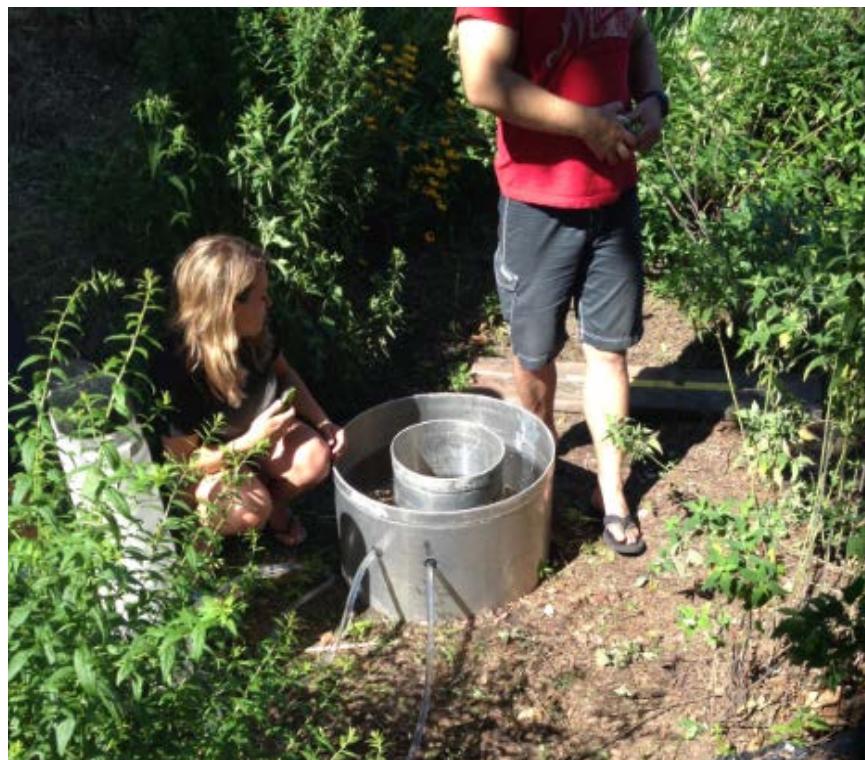
Figure 1.4 A double-ring infiltration test

While other infiltration test methods can be used, the PADEP (2006) strongly makes the case for the double-ring infiltrometer. The guidelines set forth by the PADEP do outline the procedure for the percolation testing method as well; however, for infiltration SCMs such as rain gardens the double-ring infiltrometer is considered to be more accurate in the guidelines. It is necessary to note that this procedure was outlined almost 10 years ago. The American Society for Testing and Materials (ASTM) has since updated the double-ring infiltration testing procedure as well. The double-ring infiltrometer is depicted in Figure 1.4. The double-ring infiltrometer can be difficult to install, use a large amount of time and effort to install and conduct, and requires a large amount of water. Additional test methods which are easier to install, faster to conduct, and use less water have been developed and used since the PADEP guidelines were set forth in 2006.

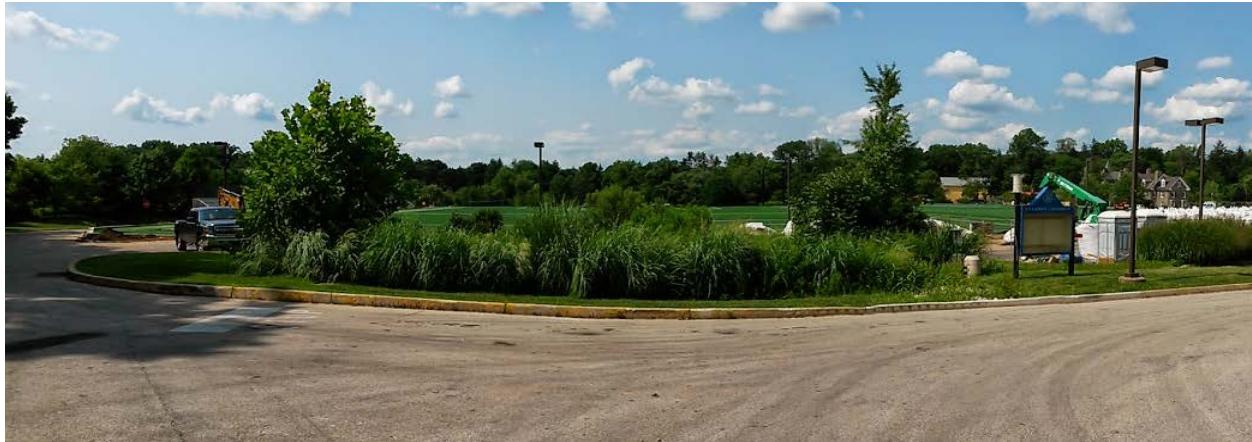
Figure 1.5 The Bioinfiltration Traffic Island (photograph courtesy of Villanova Urban Stormwater Partnership)

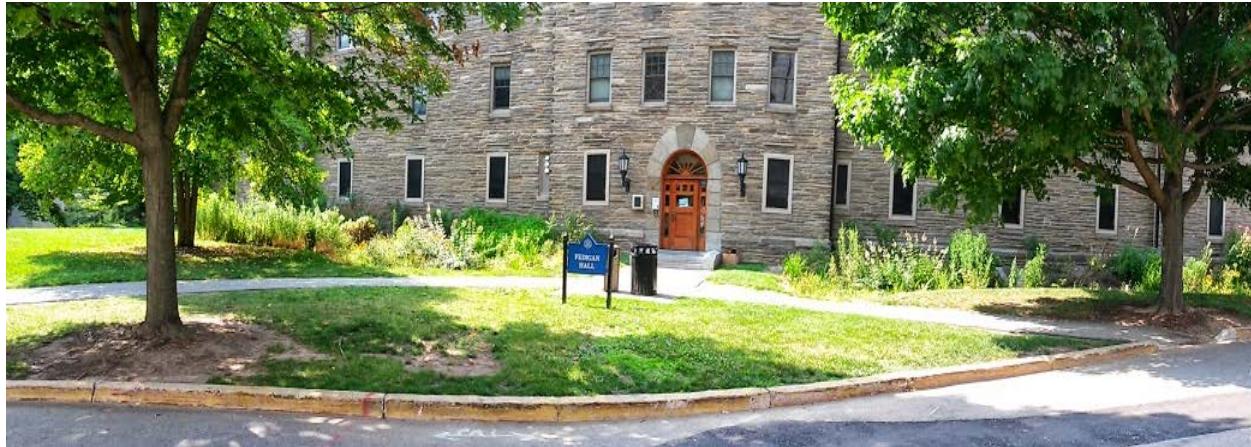
Figure 1.6 The Fedigan Rain Gardens (photograph courtesy of Villanova Urban Stormwater Partnership)

The Fedigan Rain Gardens were also chosen for this study because they are a rain garden cluster, with one rain garden being a bioretention rain garden and the other being a bioinfiltration rain garden. The Fedigan Rain Gardens have an engineered media with a high sand content, and have the lowest impervious drainage-area-to-infiltration area in this study. The Fedigan Rain Gardens are shown in Figure 1.6. In Figure 1.6, the bioretention rain garden is on the left and the bioinfiltration rain garden is on the right.

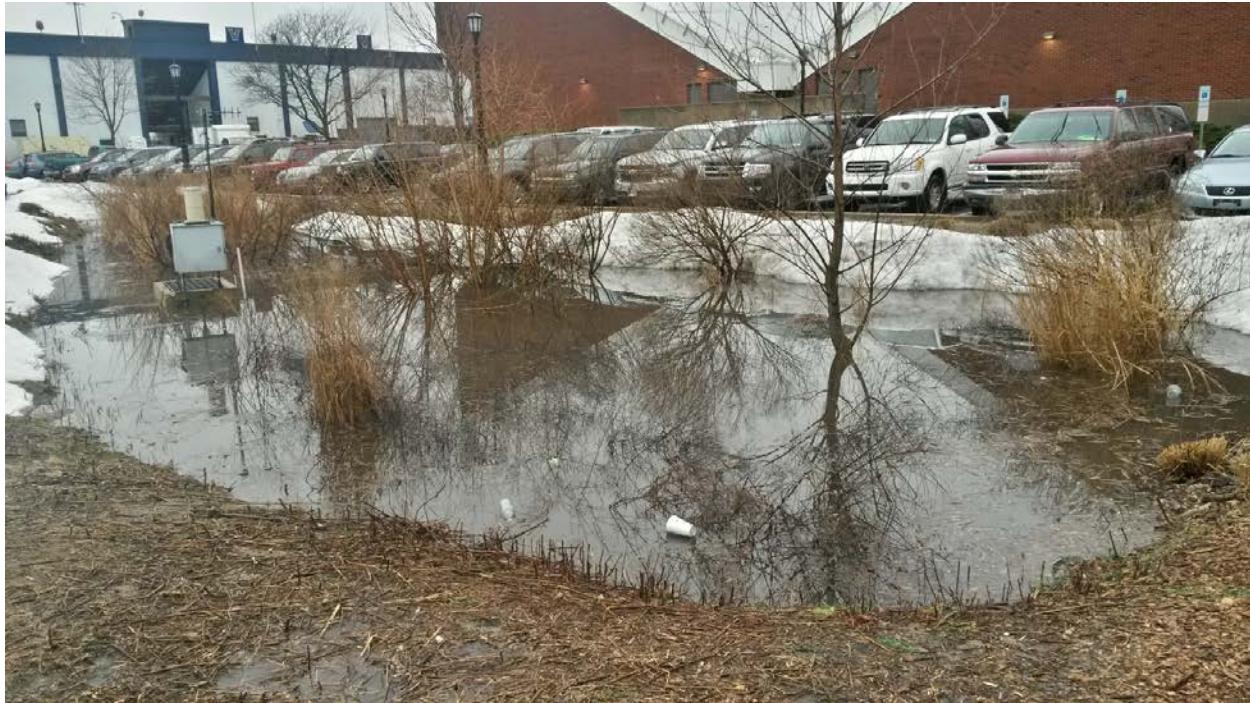
Figure 1.7 The Pavilion Traffic Island

Finally, the Pavilion Traffic Island was selected for the comparison study because it was found to be behaving differently than expected. Despite having an engineered media with the most sand of all of the rain gardens in this study, long periods of ponding and a perched water table were observed at the Pavilion Traffic Island, making it behave more like a “failed” rain garden. For this study, the Pavilion Traffic Island was selected to determine design aspects which may have led to this “failure,” as well as determining how the rain garden performs despite its limitations. The Pavilion Traffic Island is depicted in Figure 1.7.

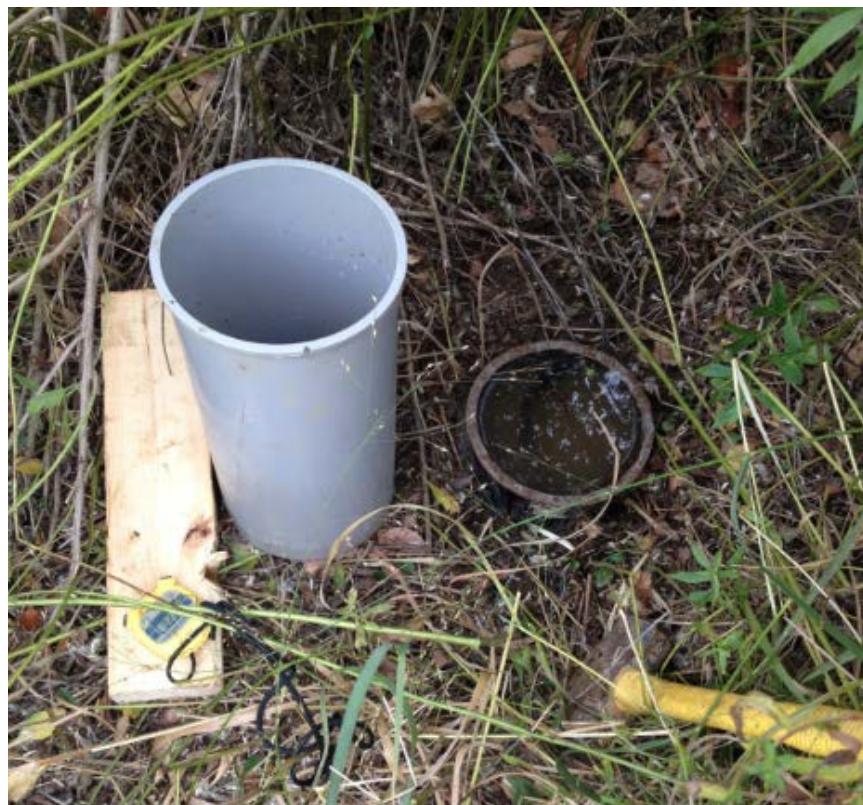
Figure 1.8 A single-ring infiltrometer test

This part of the study aims to make recommendations on infiltration testing at rain gardens by conducting infiltration testing investigations and comparing different methods. The first investigation compared test results from a simple, inexpensive single-ring infiltrometer

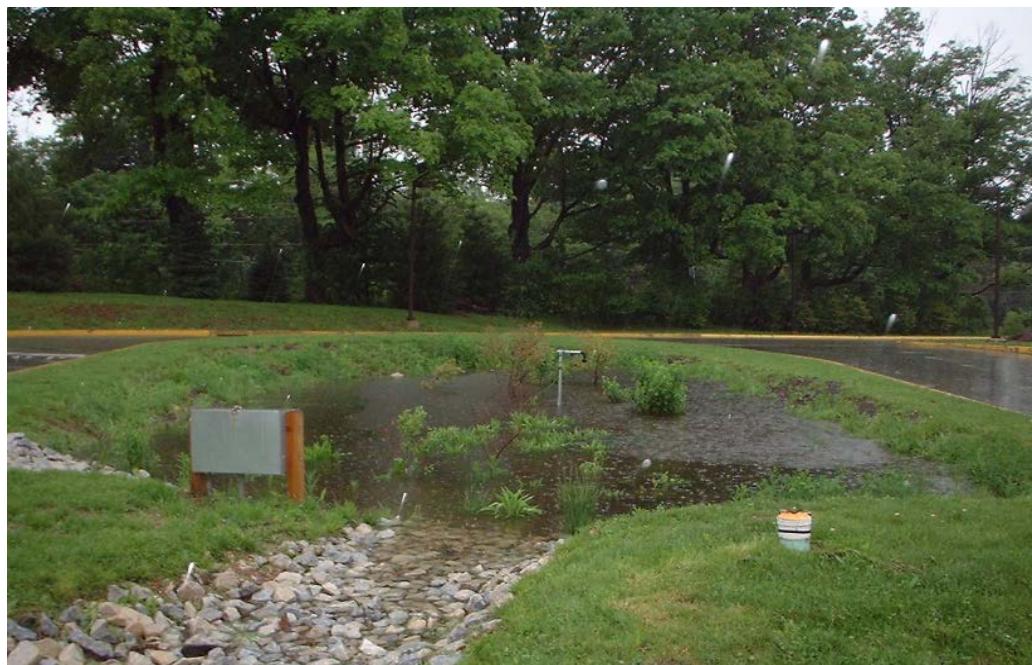
Figure 1.9 The BTI ponded during a rain event (photograph courtesy of Villanova Urban Stormwater Partnership)

conducted at the BTI to the average recession rate at the BTI for its lifetime. The recession rate is how quickly water is drained from the pond after a rain event. This is considered the most accurate hydraulic conductivity measurement of an SCM, since the rain event would act as a large-scale test covering all portions of the SCM. The purpose of this test was to determine if the single-ring infiltrometer could accurately predict the hydraulic conductivity considering that the average recession rate is the average hydraulic conductivity at the BTI. This is done because the single-ring infiltrometer is much more inexpensive purchasing water monitoring equipment. Therefore, if the single-ring infiltrometer is deemed accurate, it can be used as a feasible infiltration testing technique prior to and post-construction of an SCM. Since it is smaller and more inexpensive than the double-ring infiltrometer, more can be conducted in the same amount of time, which allows for more of the SCM to be tested. Figure 1.8 depicts a single-ring infiltration test and Figure 1.9 shows the BTI ponded after a rain event, which provides a large-scale infiltration test.

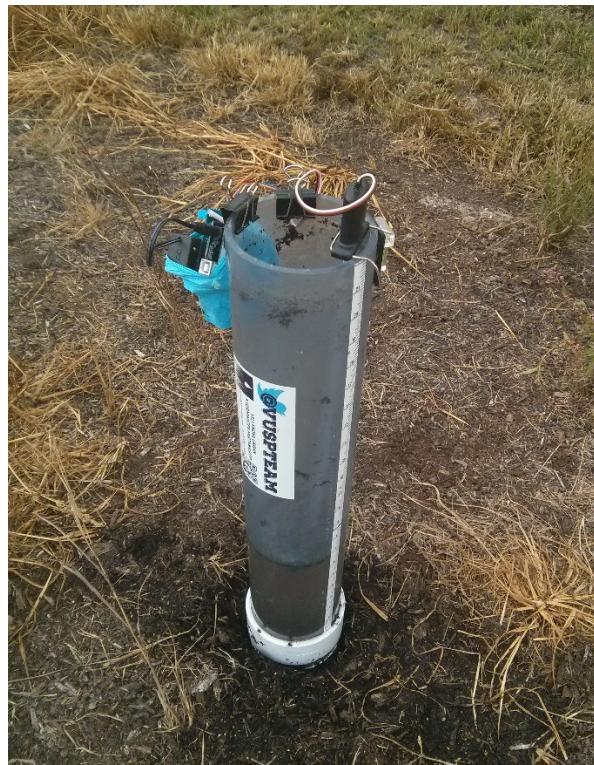
Figure 1.10 The modified Philip-Dunne infiltrometer (photograph courtesy of Villanova Urban Stormwater Partnership)

The second investigation aims to compare a many different infiltration testing techniques at the BTI, the FRG, and a native soil site in Upper Moreland Township, PA. The main purpose of the study is to determine if an infiltrometer built at Villanova University compares to field and laboratory hydraulic conductivity testing techniques. If the infiltrometer built at Villanova, known as a Modified Philip-Dunne infiltrometer, compares favorably to the double-ring infiltrometer and other methods, it can be used to determine hydraulic conductivity in place of the much larger double-ring infiltrometer. Figure 1.10 depicts a Modified Philip-Dunne infiltrometer which was built at Villanova University. This infiltrometer is outfitted with electronic components to measure water and collect GPS measurements. This allows the test to be conducted without a field engineer being at the infiltrometer to measure water drop, and allows for ease of plotting test locations afterwards. In addition to the field methods compared, a laboratory method known as the UMS KSAT was used in the study to determine how it compared to the field methods. Figure 1.11 shows the UMS KSAT laboratory testing apparatus. The study used double-ring infiltrometer tests, single-ring infiltrometer tests, Modified Philip-Dunne infiltrometer tests, and UMS KSAT laboratory tests to determine if the Modified Philip-Dunne infiltrometer is an appropriate test method for measuring the hydraulic conductivity of an SCM. Table 1.1 provides the tests conducted at each location. More Modified Philip-Dunne tests can be conducted than the double-ring infiltrometer in the same amount of time because the procedure for the Modified Philip-Dunne infiltrometer is faster to install and requires less water than the double-ring infiltrometer. This allows better understanding of the hydraulic conductivity at an SCM. Furthermore, the addition of electronic measuring components allows for easy data collection, manipulation, and storage.

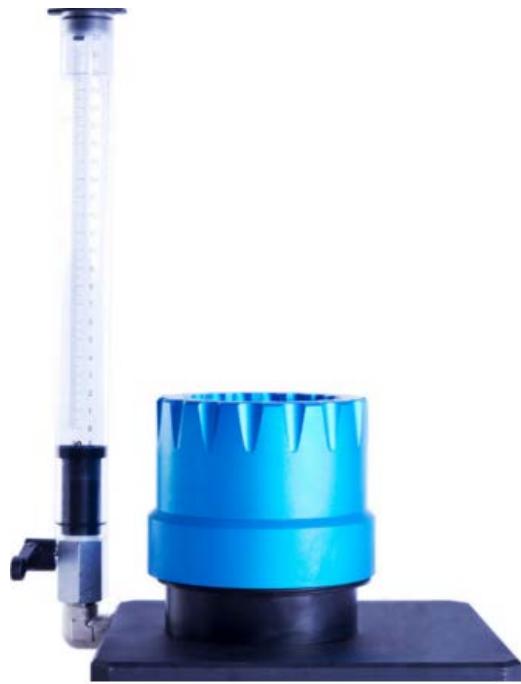
Figure 1.11 The UMS KSAT (Decagon Devices 2016)

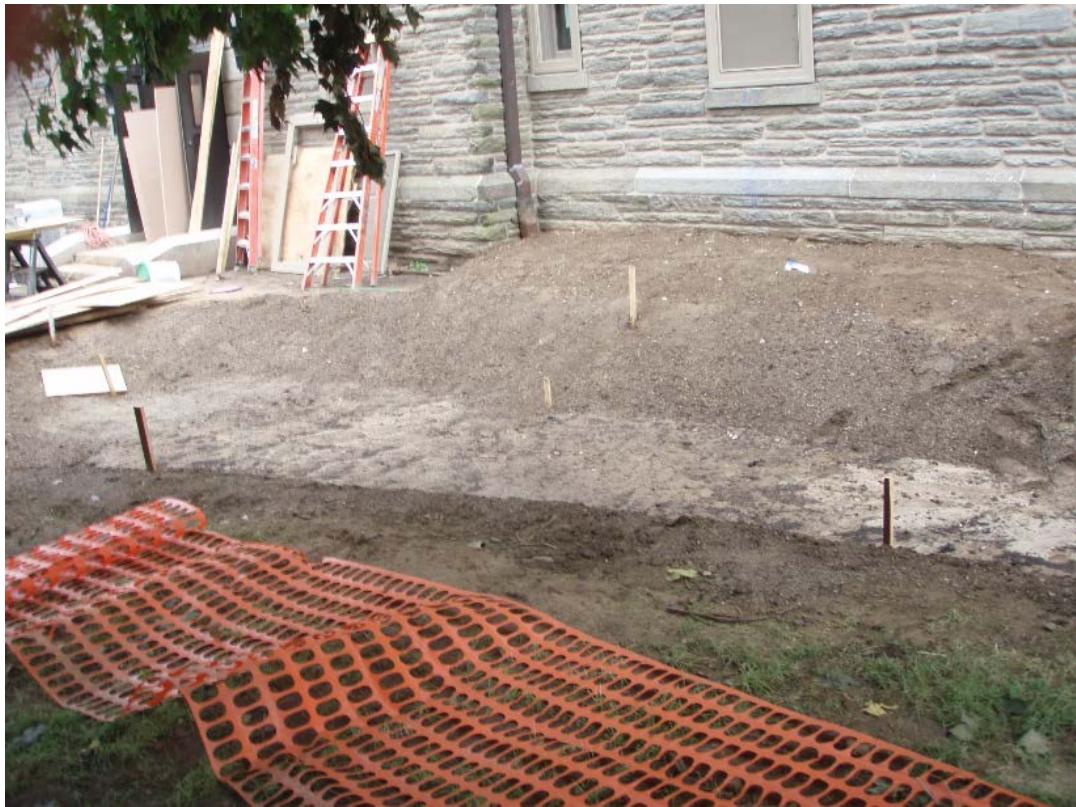
Figure 3.2 Construction of the FRGI at Fedigan Hall (photograph courtesy of Villanova Urban Stormwater Partnership).

The rain gardens were constructed similarly, with the major differences being that the FRGR was built with a liner and an underdrain beneath the rain garden and the FRGR has a deeper engineered media depth. Figure 3.2 shows construction of the FRGI, and Figure 3.3 depicts the completed FRGI. Similarly, Figure 3.4 shows construction of the FRGR, and Figure 3.5 shows the completed FRGR. The estimated cost of construction of both rain gardens was around \$30,000. Cost of construction was mostly paid for by Villanova University while the instrumentation cost was paid for by the PADEP Growing Greener Grant.

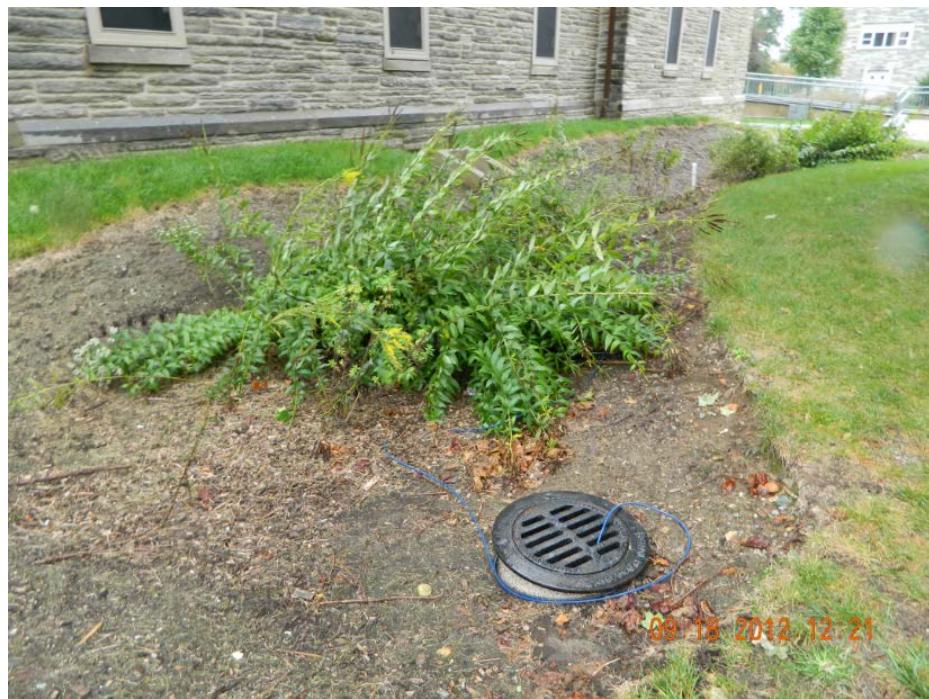
Figure 3.3 The completed FRGI at Fedigan Hall (photograph courtesy of Villanova Urban Stormwater Partnership)

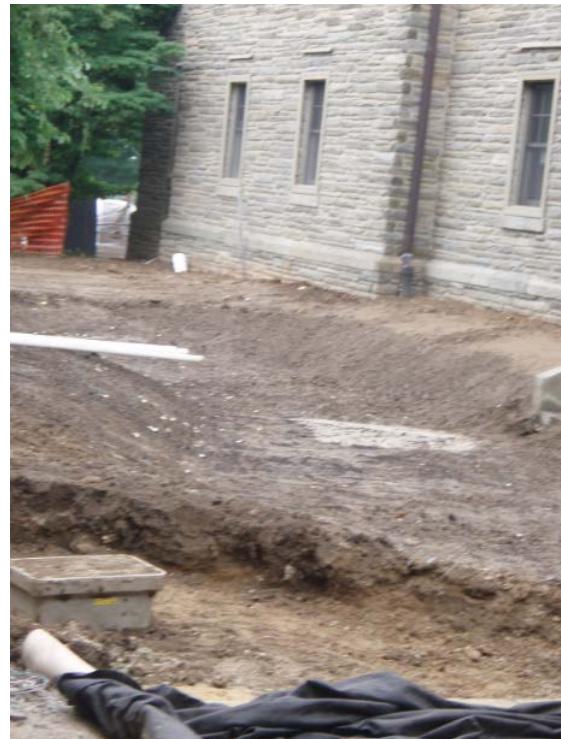
Figure 3.4 Construction of the FRGR at Fedigan Hall (photograph courtesy of Villanova Urban Stormwater Partnership)

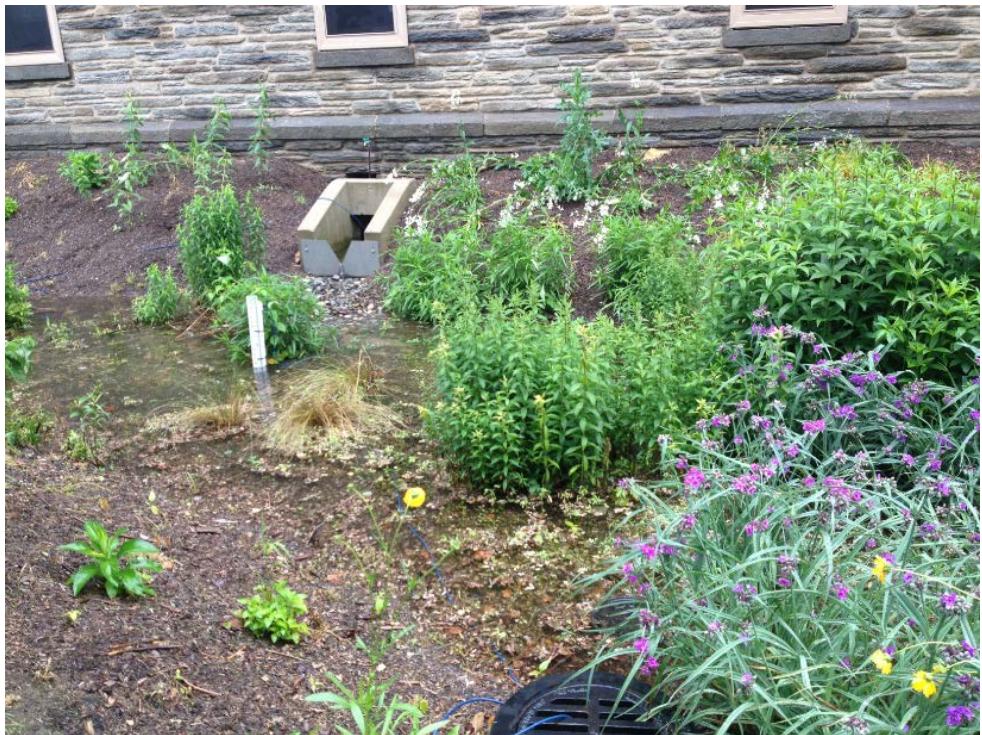
Figure 3.5 The completed FRGR at Fedigan Hall (photograph courtesy of Villanova Urban Stormwater Partnership)

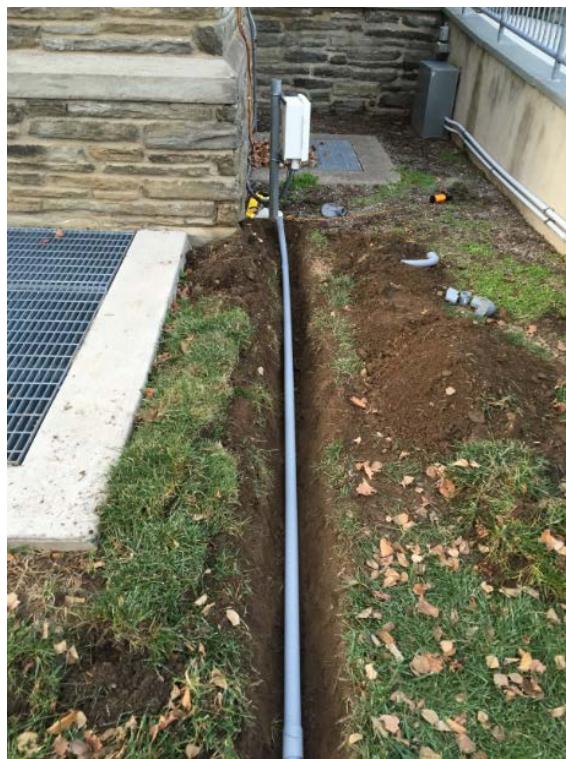
Figure 3.6 Conduit installation at the FRGI

Additional minor construction elements occurred during 2014 and 2015. Prior to instrumentation installation, conduit was installed to protect wires and cables. Flexible conduit was installed inside the rain garden and polyvinyl chloride (PVC) electrical conduit was installed along Fedigan Hall up to data logger boxes. Figure 3.6 displays conduit being installed at the FRGI and Figure 3.7 depicts conduit installation at the FRGR.

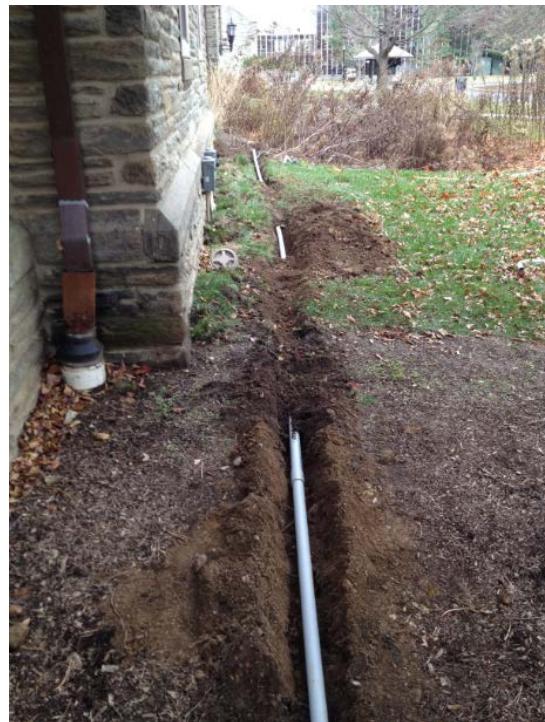
Figure 3.7 Conduit installation at the FRGR

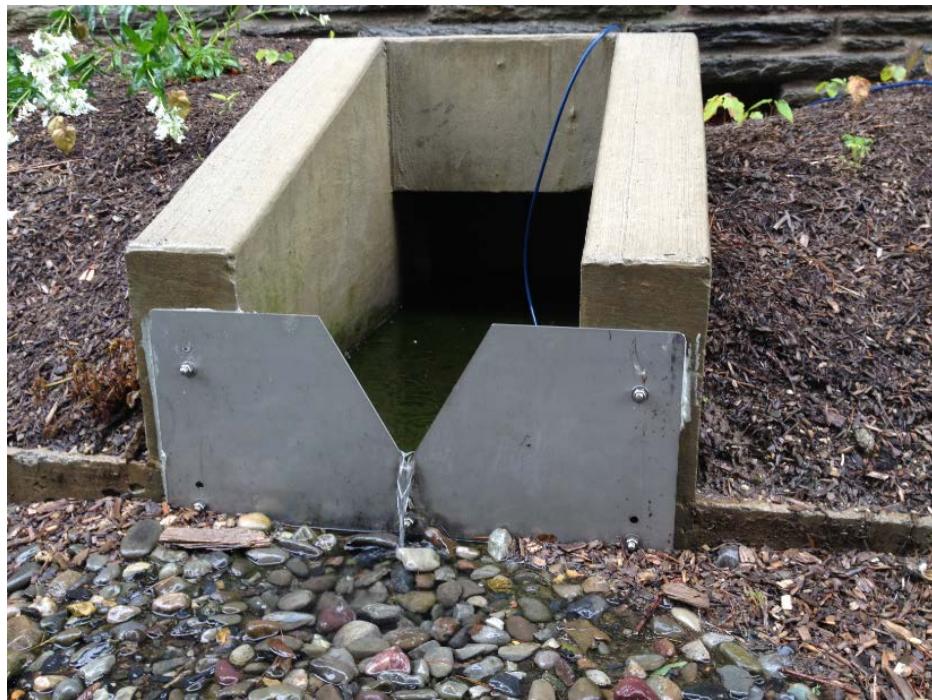
Figure 3.8 A concrete inlet box with a V-notch weir at Fedigan Hall (photograph courtesy of Villanova Urban Stormwater Partnership)

The initial design of the rain gardens called for a maximum of 5:1 impervious drainage area-to-infiltration area ratio. All of the impervious runoff entering the rain gardens comes from the roof of Fedigan Hall. The engineered media used for both rain gardens was designed to contain 85% sand, 10% fines (silts and clays), and 5% organics. Both rain gardens also were designed to have a ponding depth of 0.30 m, and both are designed to empty within 72 hours to mitigate the possibility of mosquito growth at Fedigan Hall. Both rain gardens have a 0.46 m PVC riser for overflow. Within each overflow riser, there is a 0.20 m volumetric weir at the 0.30 m discharge pipe to measure outflow. Outflow is measured when water enters the overflow riser and builds up to the crest of the volumetric weir. As water leaves the riser via the volumetric weir, the flow rate can be measured similarly to the regular V-notch weir at the inlet boxes. Each rain garden also contains a concrete inlet box with a 60° sharp crested V-notch weir to measure inflow. Water from the roof at Fedigan Hall travels to the gutters which take water to the inlet boxes. Figure 3.8 shows one of the inlet boxes and Figure 3.9 shows the overflow riser at the FRGI.

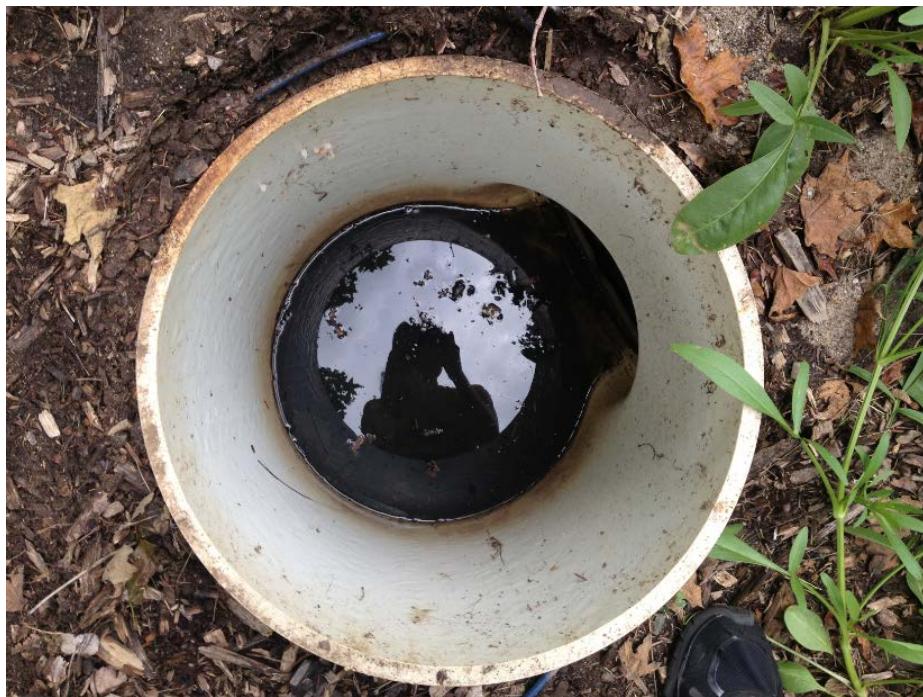
Figure 3.9 The overflow PVC riser, volumetric weir, and discharge pipe (photo credit Villanova Urban Stormwater Partnership). The volumetric weir is located in the discharge pipe that is connected to the overflow riser

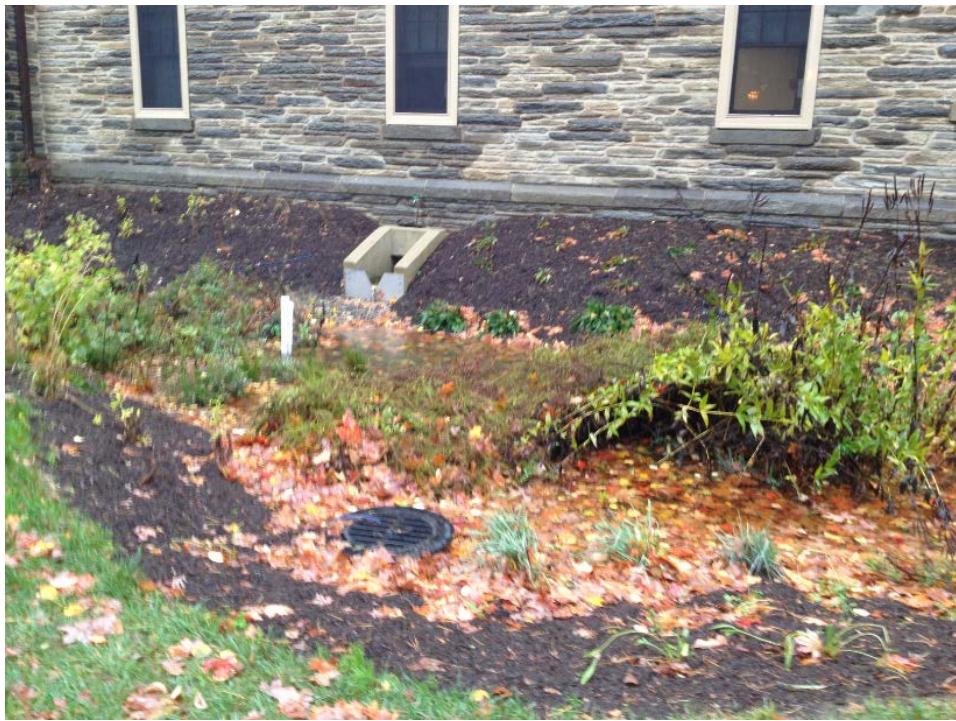
Figure 3.12 Leaves in the FRGR at Fedigan Hall (photograph courtesy of Villanova Urban Stormwater Partnership)

The rain gardens were inspected quarterly to note bare spaces, invasive species, and debris. These inspections were also used to determine possible deficiencies in plant life, which indicate the need for new plants. The inlet boxes and overflow risers were also inspected quarterly to remove trash, debris, and leaves which may have affected flow rates. Figure 3.12 shows a rain garden with an excessive amount of leaves in the pond, and Figure 3.13 shows leaf removal. The rain gardens were also checked for long periods of ponding, which would indicate soil clogging. However, the runoff was not expected to have a high amount of suspended solids, so clogging was very unlikely.

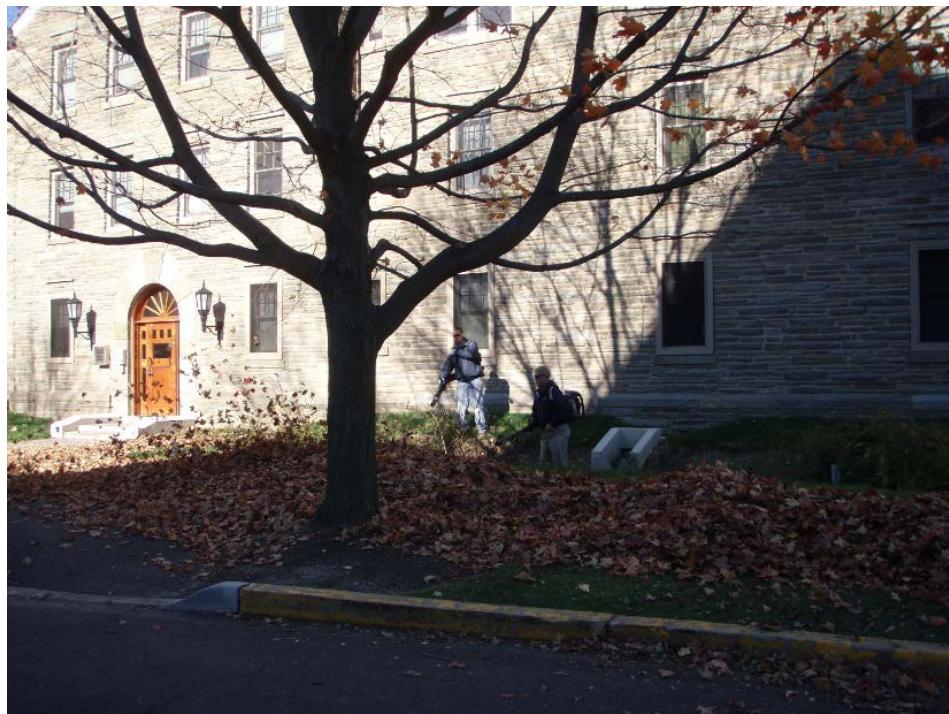
Figure 3.13 Leaf removal at the FRGI at Fedigan Hall (photograph courtesy of Villanova Urban Stormwater Partnership)

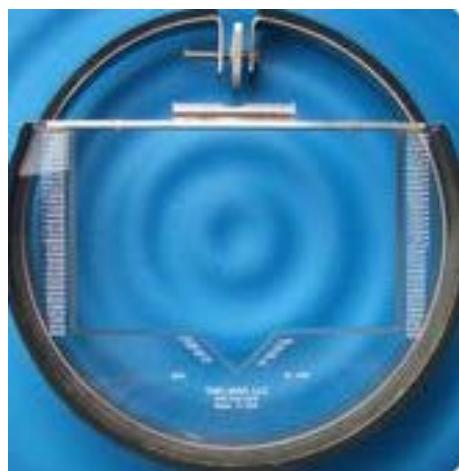
Figure 3.15 An example of a volumetric weir (Thel-mar 2016)

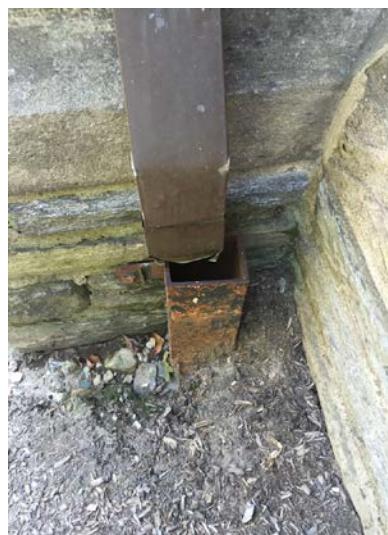
Figure 3.16 A damaged downspout at Fedigan Hall (photograph courtesy of Villanova Urban Stormwater Partnership)

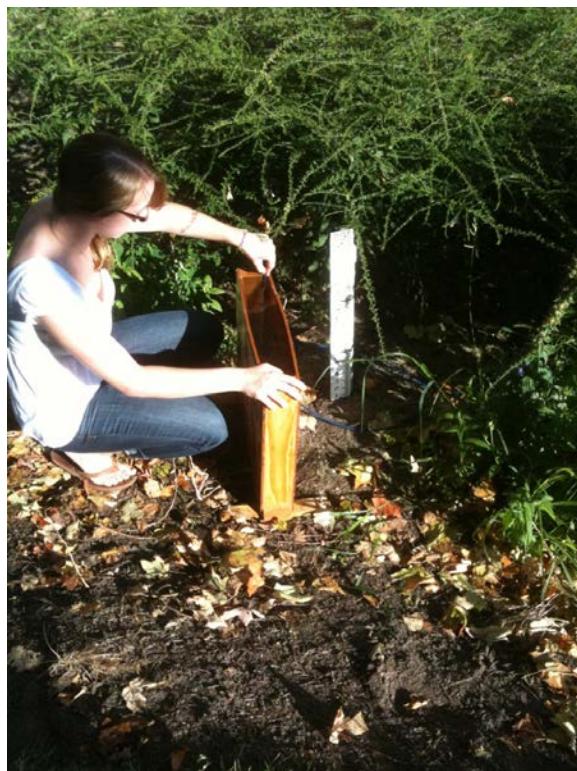
Figure 3.17 Pressure transducer calibration at the FRG (photograph courtesy of Villanova Urban Stormwater Partnership)

The Campbell Scientific CS451 pressure transducers at the Fedigan Rain Gardens were calibrated every six months, or when data showed that a calibration was required. There was no required pressure transducer setup for rain storm events. Calibration was performed by removing the pressure transducers from their locations and placing them in containers which were gradually filled with water. The output values were required to be reset prior to calibration. This involved setting the “m” value to 1 and the “b” value to 0 in the pressure transducer code. These values follow the standard slope equation, which is provided in Appendix B. Water was filled to five or six points and measured manually, then compared to the level that the pressure transducer indicated at each filling point. The data was then plotted with the pressure transducer readings on the x-axis and measured values on the y-axis. When the points were plotted on a scatter plot, a trendline was made and the equation of the trendline was found. Additionally, the  $R^2$  value was found, and calibration was deemed acceptable if this value was greater than 0.97. Furthermore, calibration points were checked with the new trendline equation. The pressure transducer reading was entered as the “x” value and the new “y” value was determined. This was done and compared to the manual reading for all calibration points. If the error between the manual reading and pressure transducer reading exceeded 10%, it was necessary to re-calibrate the pressure transducer. Figure 3.17 and Figure 3.18 demonstrate the calibration of the pond pressure transducers. Pressure transducer calibrations are provided in Appendix B. An example plot is provided in Figure 3.19.

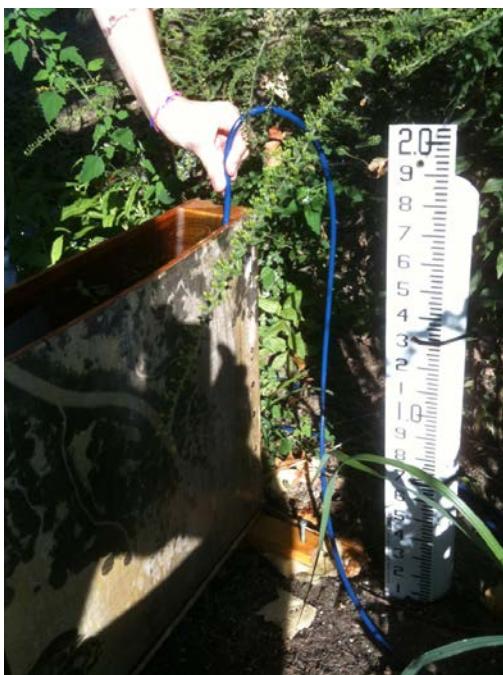
Figure 3.18 A pressure transducer in a calibration container at the FRG (photograph courtesy of Villanova Urban Stormwater Partnership)

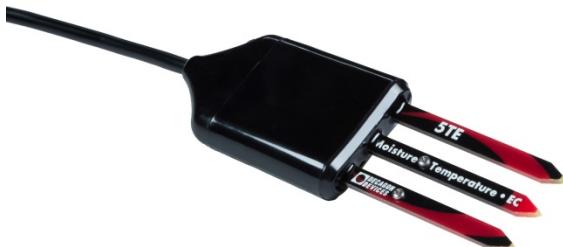
Figure 3.20 Decagon 5TE soil moisture sensor (Decagon Devices 2016)

Both rain gardens have one Decagon 5TE soil moisture sensor. These sensors are used to measure the volumetric water content, temperature, and conductivity at specific points. The sensor at the FRGI is installed at a depth of 35 cm and the sensor at the FRGI is installed at a depth of 66 cm. This is because the native soil interface at the FRGI is around 35 cm deep and the depth to the liner at the FRGR is approximately 66 cm. These points are particularly important because they provide information on the soil conditions at the points where water exits the rain gardens. At the FRGI, the volumetric water content at the native soil interface provides information on how much water actually infiltrates to the interface and how much is stored in the soil media above it. At the FRGR, the volumetric water content above the liner can be used to determine how much water is retained at this soil depth in a system where water cannot infiltrate

The Decagon 5TE soil moisture sensors needed to be calibrated only once with the specific soil in which they were placed. Soil samples were taken from the depths of sensor placement, and these cores were wetted until the soil was completely saturated. The weight of the sensor was recorded, and the weight of the saturated soil sample was also recorded. Afterwards, the soil moisture sensor was placed into the soil sample and readings of soil moisture were recorded. Periodically, weights of the soil sample were taken as the soil moisture sensor continuously

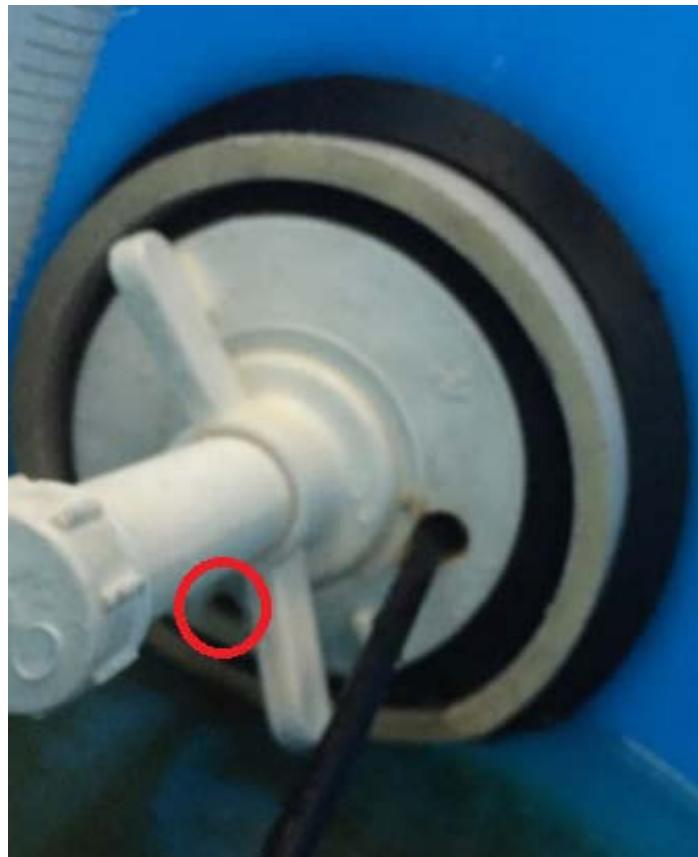
Figure 3.21 depicts the well cap with an orifice being tested in the lab. The area where the orifice is located is circled in red. The orifice diameter is approximately 0.71 cm, which was determined by testing the well cap at expected flow rates and finding the optimum orifice diameter for accurate low-flow data collection.

Figure 3.21 The well cap with an orifice installed in the testing apparatus

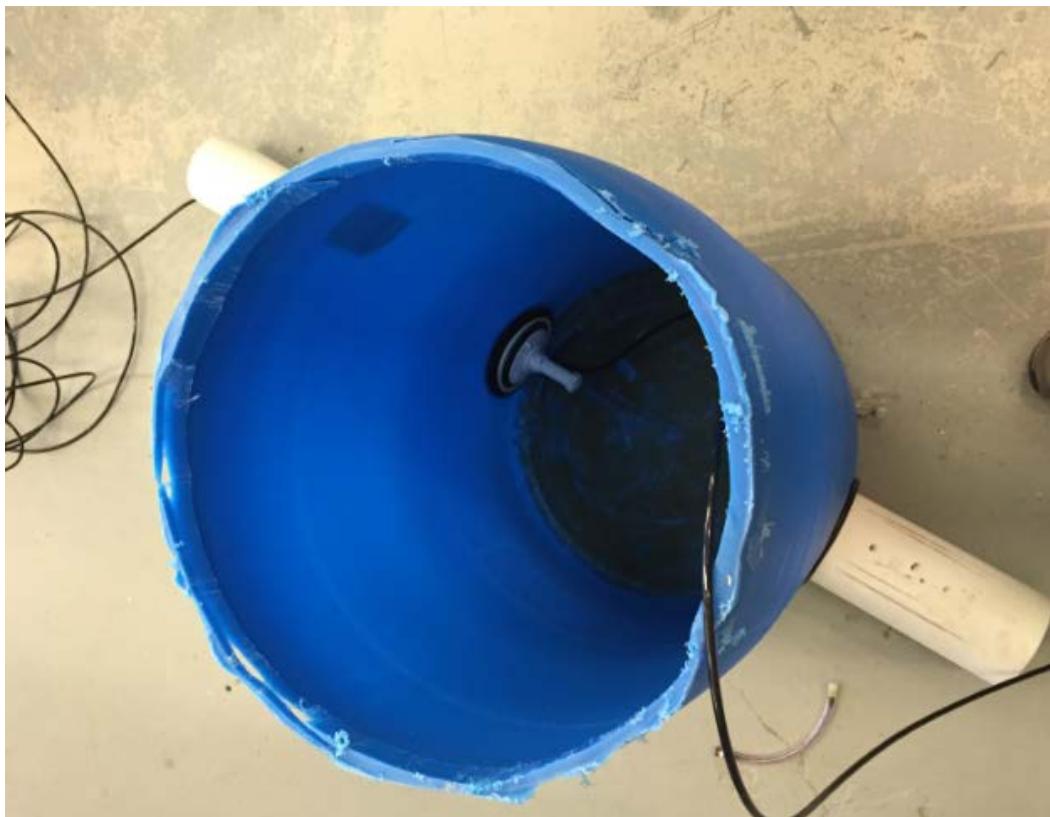
The well cap with an orifice designed for the underdrain was calibrated in the laboratory with the apparatus shown in Figure 3.22. With this apparatus, a Campbell Scientific CS451 pressure

transducer was placed in a piece of perforated PVC pipe while water was added to the drum at a known inflow. This inflow was recorded using an IFM SW Mag Flowmeter in the laboratory. When the pressure transducer stabilized, flow was considered stable, which meant that the inflow rate was equal to the outflow rate. The flow rate and pressure transducer level were recorded at various points when this stabilization occurred. Figure 3.23 demonstrates the well cap laboratory testing, which was done to determine the flow equation for the orifice and the coefficient of discharge.

Figure 3.22 The laboratory apparatus used to test the well cap with an orifice

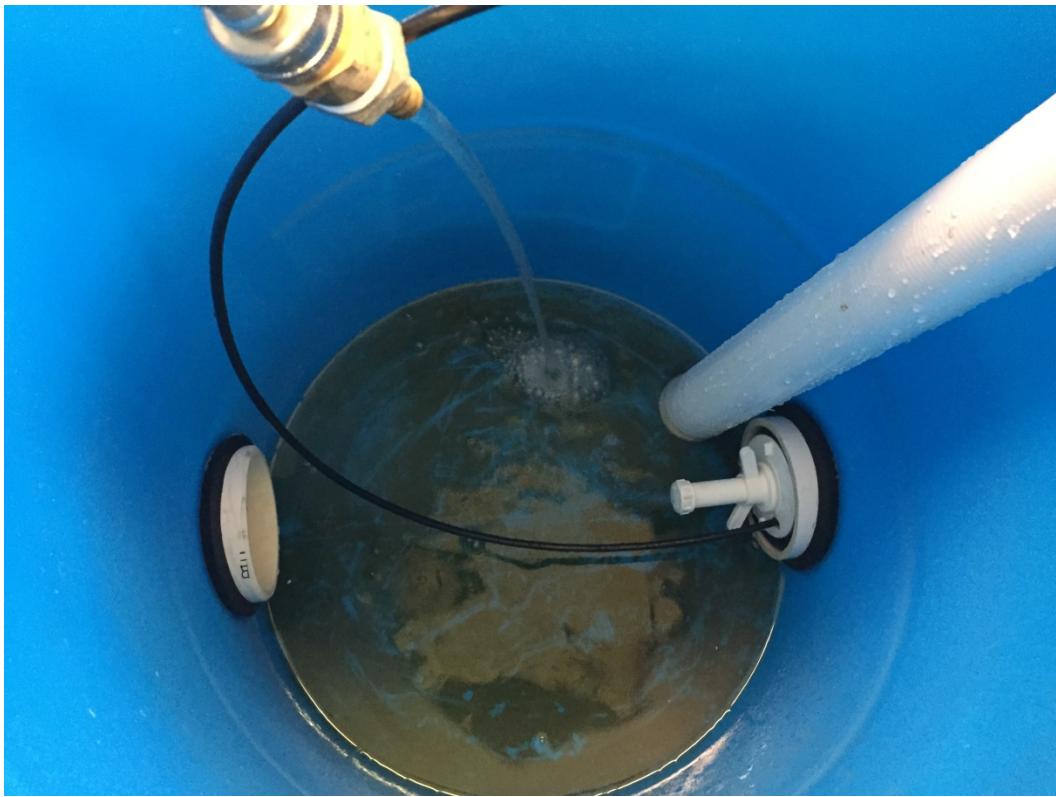
Figure 3.23 Well cap testing being conducted in the laboratory apparatus

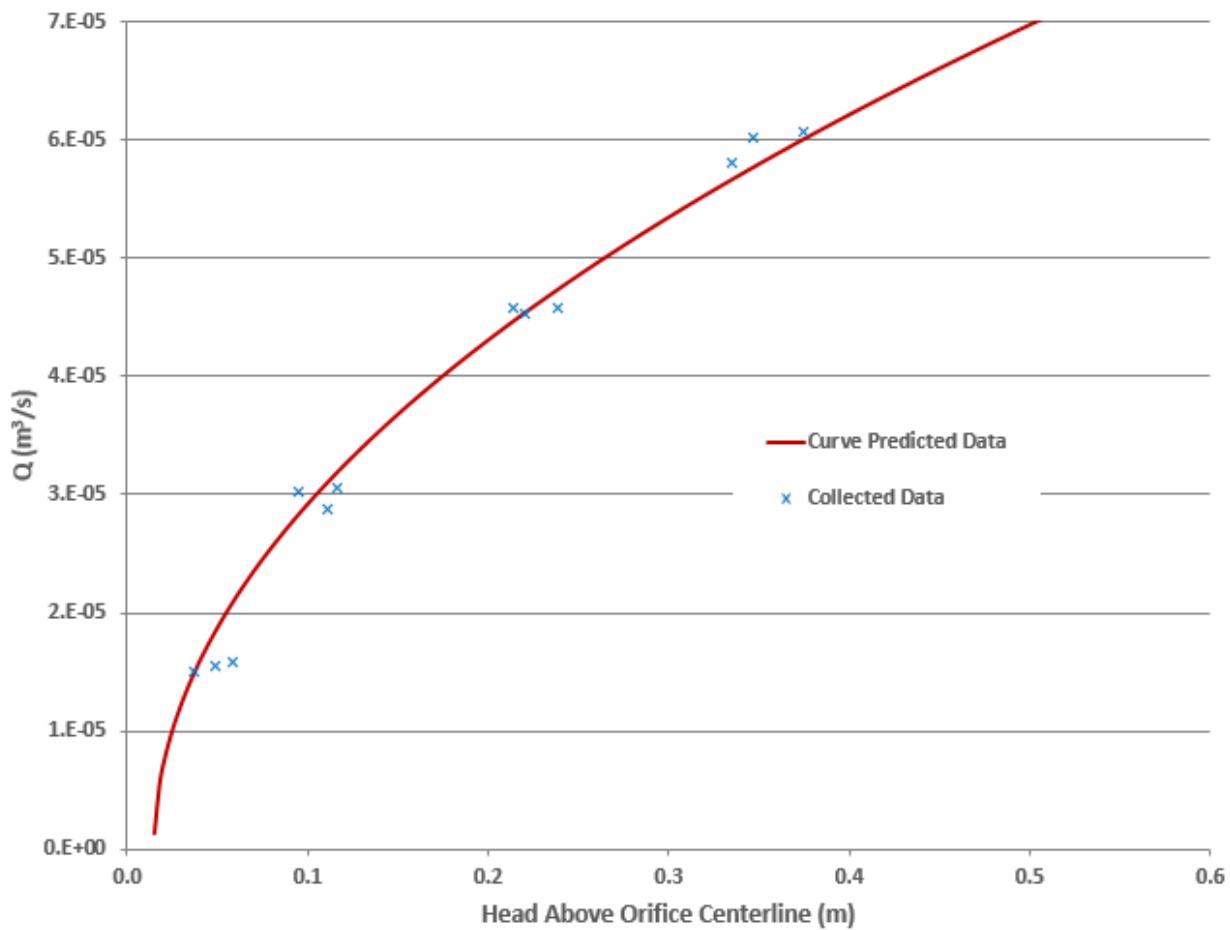
front of the well cap and one being located at the back of the well cap. Figure 3.24 shows the calibration curve created when the well cap was tested three times. In Figure 3.24, the collected stabilized flows at given heads above the centerline of the orifice was plotted with the data that would be provided by the orifice equation with the determined coefficient of discharge and shift parameter. The plot shows that the collected data does closely follow the calibration curve from the equation determined from laboratory testing, validating the coefficient of discharge and shift parameter that accurately predict flow through the orifice in the well cap. The reason the plot does not go through the zero point is because of this added shift parameter. The well cap was installed on the underdrain with a pressure transducer behind it to measure the water level and determine the outflow. The underdrain head levels recorded were used with the orifice equation provided above to determine the underdrain flow at specific times. The pressure transducer wire requires another hole in the well cap; however, this hole is sealed with putty. This well cap does not need to be re-calibrated, but is removed and checked periodically to ensure putty seals are still in place and clogging of the orifice is not occurring. The well cap was inserted into the underdrain and tightened to ensure what was not bypassing the orifice into the overflow riser. The pressure transducer is calibrated similarly as stated above in this section.

Figure 3.24 Calibration curve found from laboratory testing

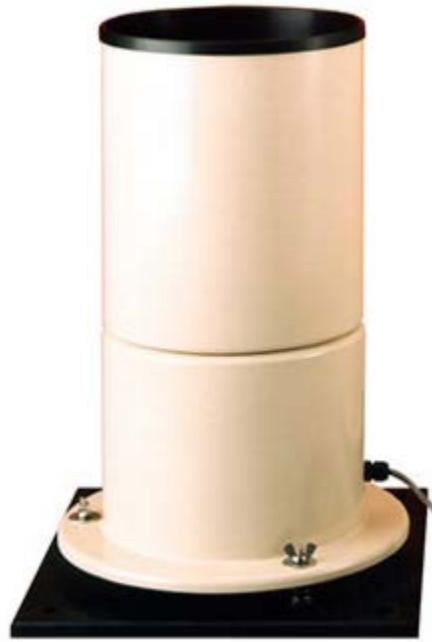
Figure 3.25 American Sigma rain gage (Hach Flow 2016)

A 20 cm American Sigma tipping bucket rain gage on the roof of the Center for Engineering Education and Research (CEER) building was used to determine rainfall at the site. The rain gage measured rainfall at 5 minute intervals, and was calibrated once per year. Bird wire was installed on the rain gage to prevent birds from landing on the rain gage and creating inaccurate data. Figure 3.25 displays the American Sigma rain gage used for the Fedigan Rain Gardens. The rain gage tips after 0.0254 cm of rainfall. It is calibrated by placing around 473 mL of water in a container and letting it drop through a very small hole into the rain gage. The water should empty through the container into the rain gage in a time period longer than 45 minutes. After the water

empties into the rain gage, the collected should indicate that  $1.45 \text{ cm} \pm 0.05 \text{ cm}$  of water fell into the rain gage. If this fails, the tipping screws are adjusted in increase or decrease the number of tips necessary.

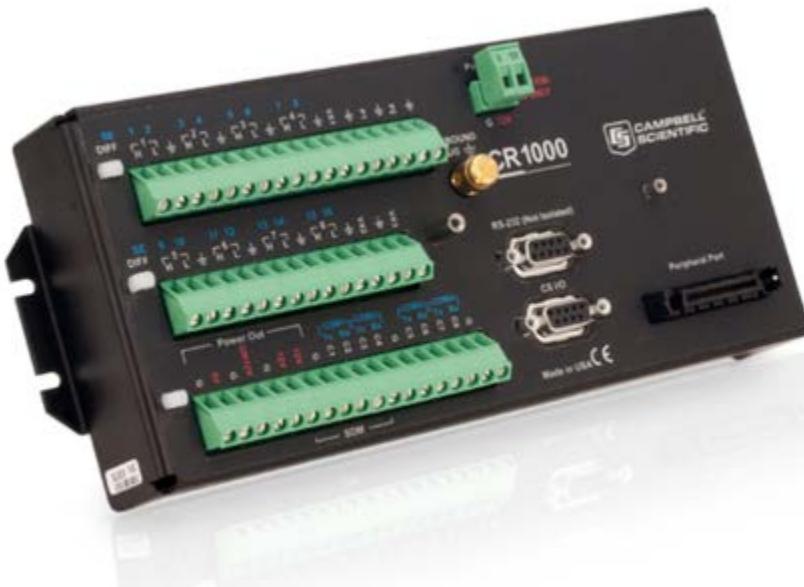
Figure 3.26 Campbell Scientific CR1000 data logger (Campbell Scientific 2016)

Both rain gardens at Fedigan Hall have a Campbell Scientific CR1000 data logger box. All instrumentation for each rain garden is hardwired to the CR1000 dedicated to that particular rain garden. Figure 3.26 depicts the Campbell Scientific CR1000 data logger. The data logger at the FRGR is connected to the internet, while the rain garden at the FRGI uses a radio to connect wirelessly to the internet. The data logger box at the FRGI uses a Campbell Scientific RF401 900 MHz spread-spectrum radio, which is shown in Figure 3.27. This radio is attached to an antenna located on Fedigan Hall, which transmits data from the FRGI. The data is then collected with

Campbell Scientific software. The data logger box must be kept dry. A sealed bag of desiccant, which is changed regularly, was used inside the box to keep moisture levels low. Indicator paper was used to monitor ambient moisture within the box, which noted when the desiccant bag needed to be replaced. A tube of desiccant is attached to each pressure transducer wire and changed color when it indicates saturation. Putty seals, which were used to keep the box dry, were checked periodically. Higher ambient moisture or insects within the box indicated the need for new putty seals.

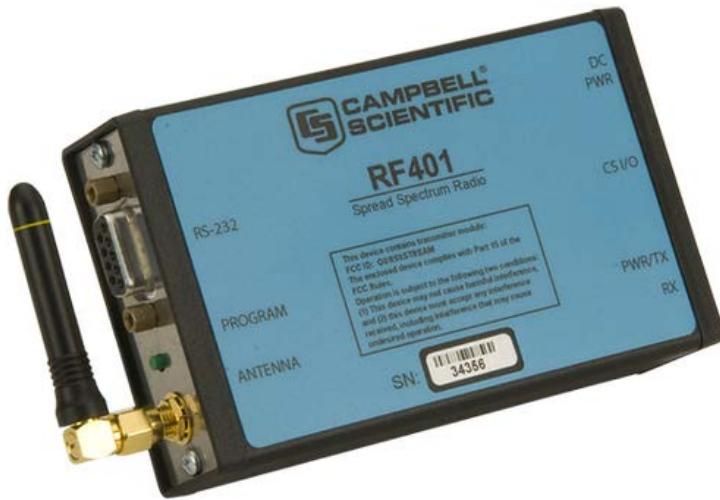
Figure 3.27 Campbell Scientific RF401 spread-spectrum radio (Campbell Scientific 2016)
