**EVALUATING RAIN GARDENS OF DIFFERENT  
CONFIGURATIONS AND SCM INFILTRATION TESTING  
METHODS TO DETERMINE RAIN GARDEN DESIGN AND  
SITE INVESTIGATION RECOMMENDATIONS**

Thesis

Civil Engineering

April, 2016

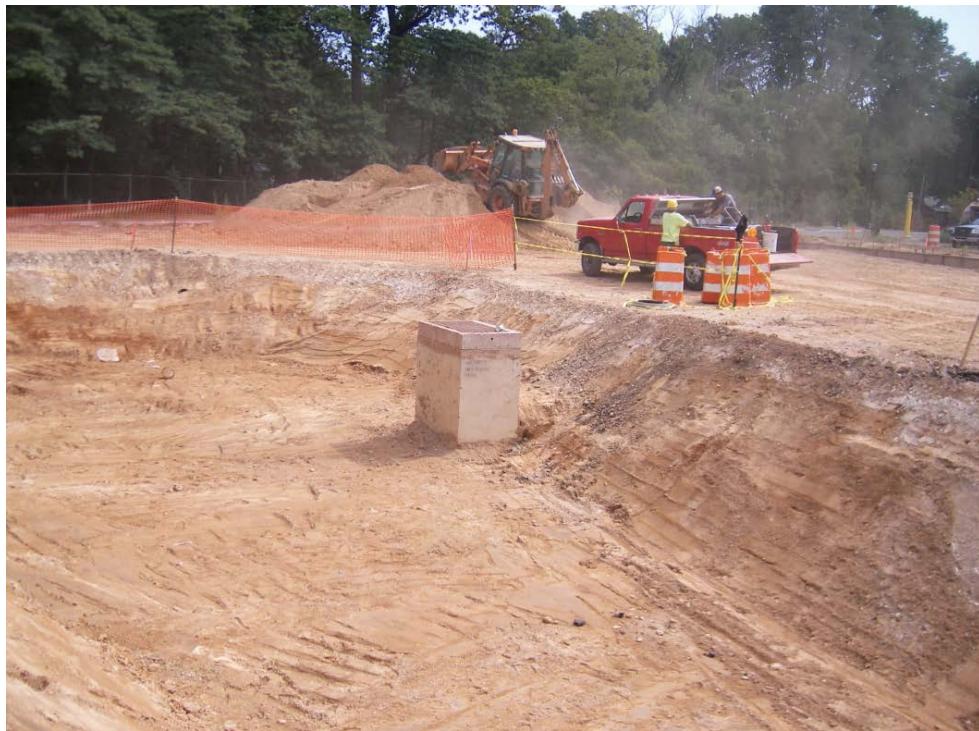
Figure 3.28 Construction of the PTI (photograph courtesy of Villanova Urban Stormwater Partnership)

The native soil beneath the engineered media is believed to have been compacted prior to or during construction of the rain garden. Some compaction can be witnessed in Figure 3.28, which shows that there are some areas of ruts in the native soil. Figure 3.35 indicates that compaction of the native soil layer is an issue because water from a storm is seen ponded in the system prior to complete placement of the engineered media.

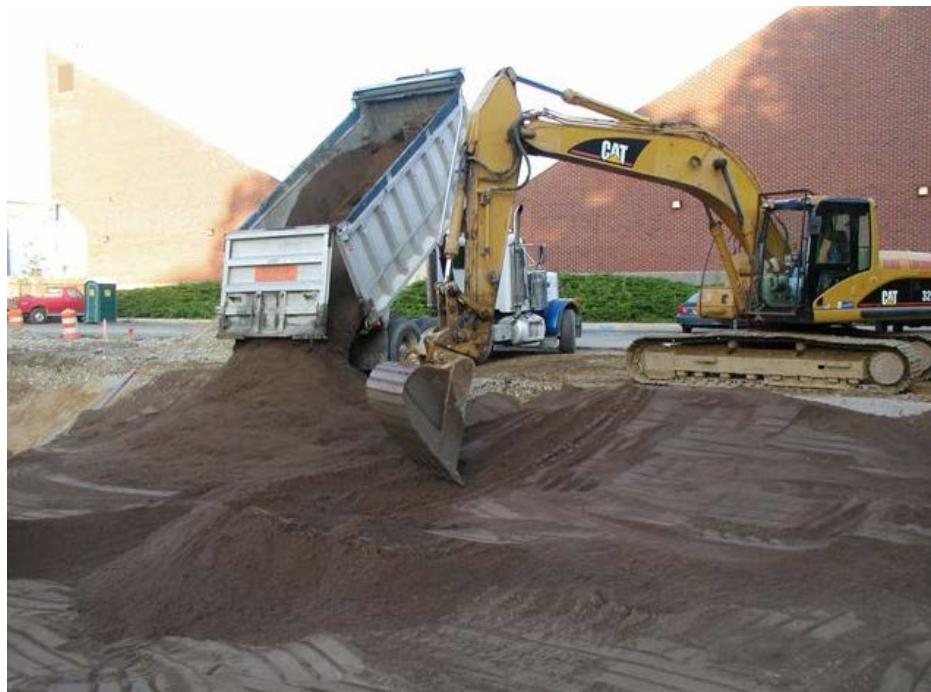
Figure 3.29 Placement of engineered media during construction of the PTI (photograph courtesy of Villanova Urban Stormwater Partnership)

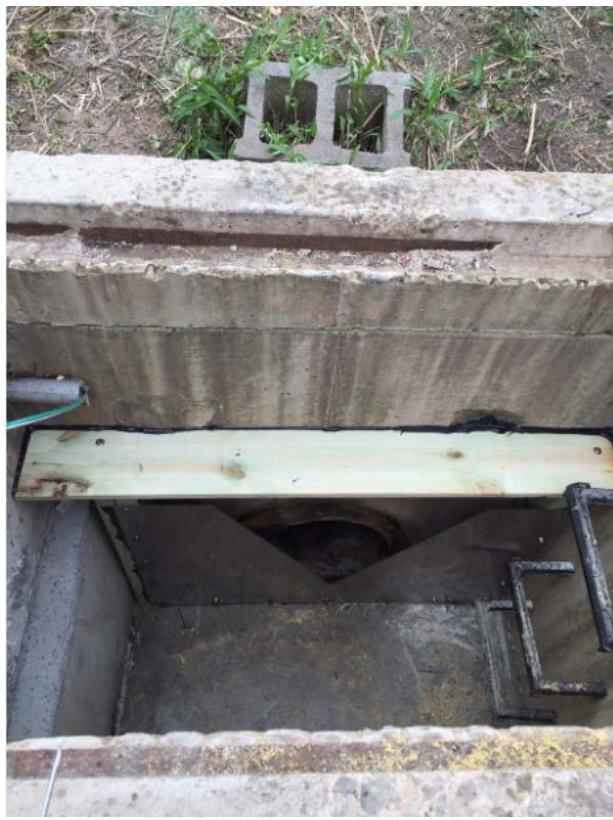
directly falling behind the weir. Figure 3.34 depicts the repairs made and completed weir and frame in the PTI concrete box.

Figure 3.34 Concrete box repairs and new 60° V-notch weir at the PTI

A volumetric weir that was present at the discharge pipe at the PTI was found to be washed away prior to site instrumentation. A new weir was designed, fabricated, and installed in the concrete box at the PTI. The weir, as demonstrated in Figure 3.33, is a  $60^\circ$  sharp crested V-notch weir used to measure outflow. Prior to weir installation, it was found that water was leaking from the PTI pond into the inlet box. Additionally, the ground surface of the box was not level during inspection. Concrete was used to level the bottom of the box, and concrete and rebar was used to rebuild part one of the walls of the box which was found to be the cause of major leakage. The weir was installed with the bottom of the weir at the same elevation as the bottom of the discharge pipe. Treated wood was used to create frame for the new weir, and concrete sealant and flashing were used to plug any remaining leakage areas within the box or in the weir frame. Additionally, a piece of treated wood was placed over the top of the weir to prevent water from

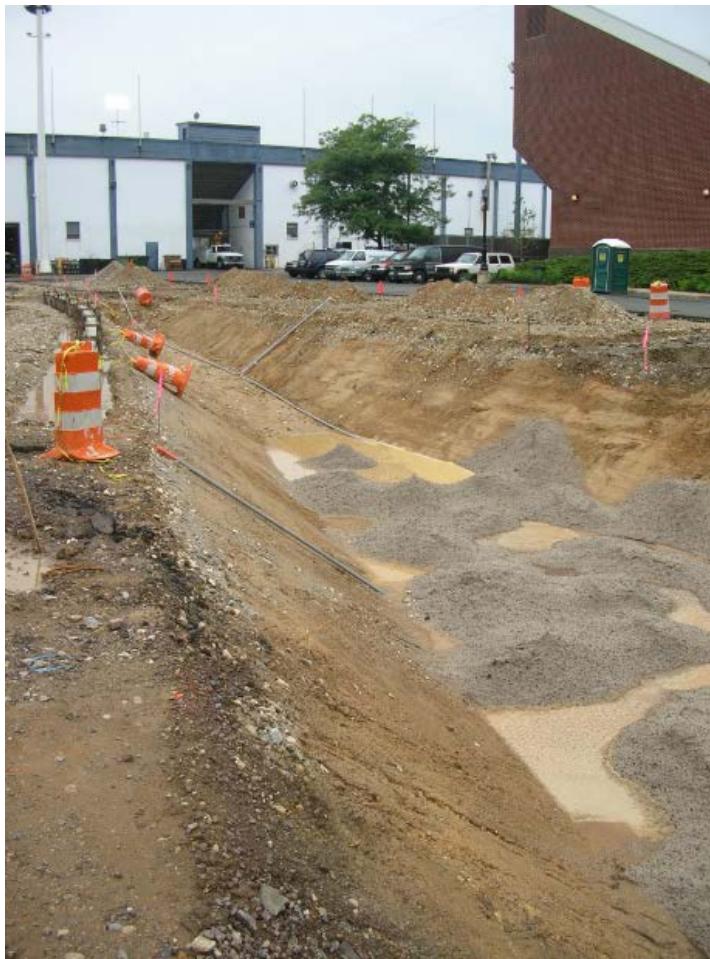
Figure 3.35 The PTI ponded during construction (photograph courtesy of Villanova Urban Stormwater Partnership)

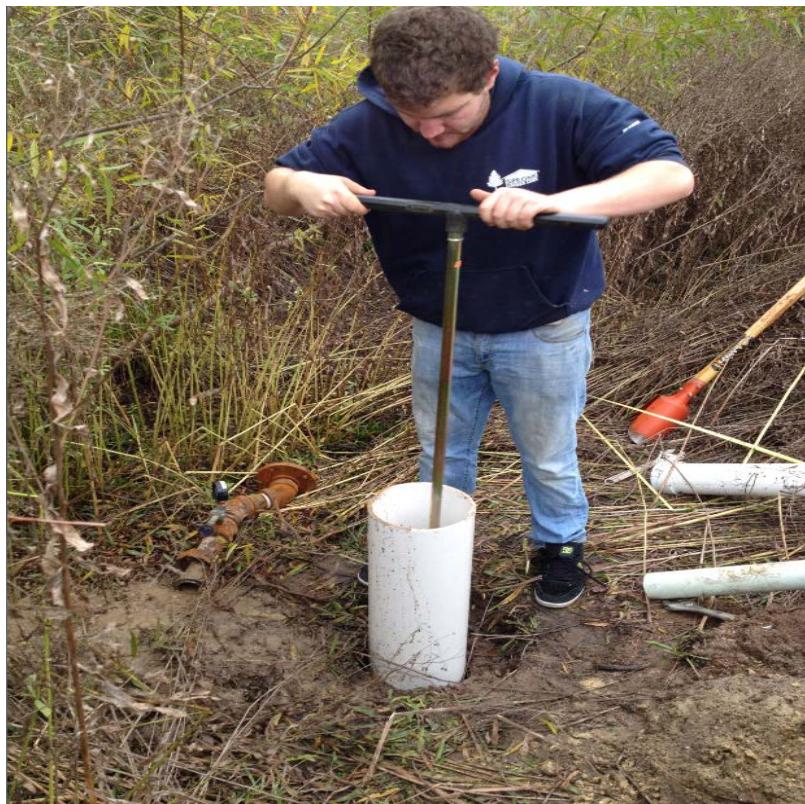
garden. Figure 3.36 demonstrates the monitoring well installation. Due to the sandy material collapsing during the auguring process, a 0.30 m diameter PVC pipe was driven into the material first. After this, the material inside the 0.30 m PVC pipe was augured, and the monitoring well was placed into the media. The area around the well was backfilled with sand and bentonite. Figure 3.37 depicts the completed monitoring well in the PTI pond. From data collected, it was determined that around 0.6 m of the media can be above the water table within the PTI during a dry period.

Figure 3.36 Monitoring well installation at the PTI

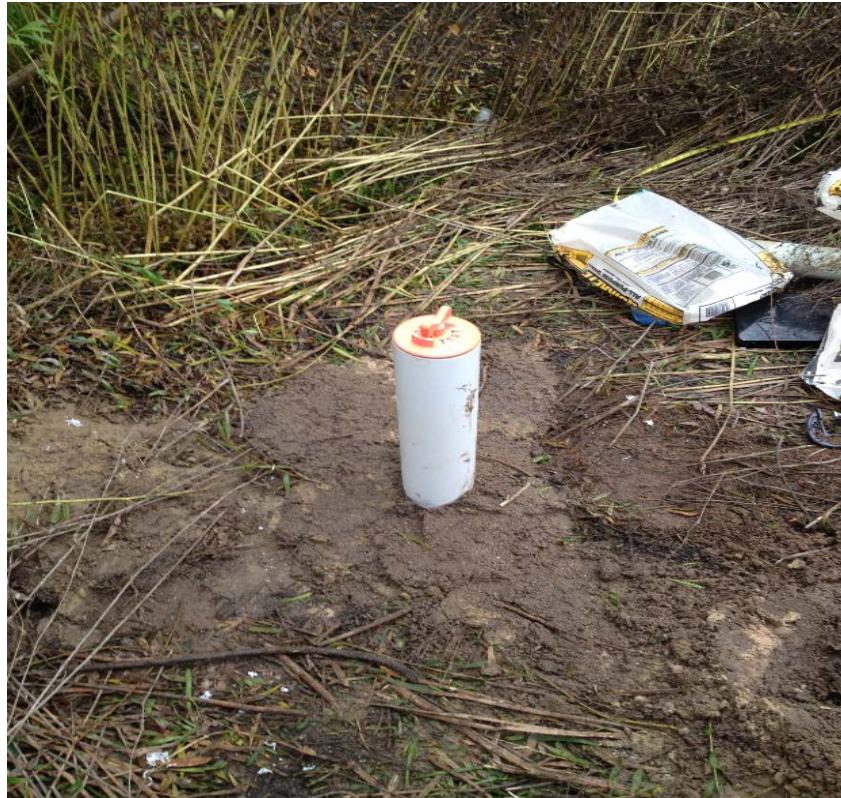
Figure 3.37 The monitoring well in the pond at the PTI

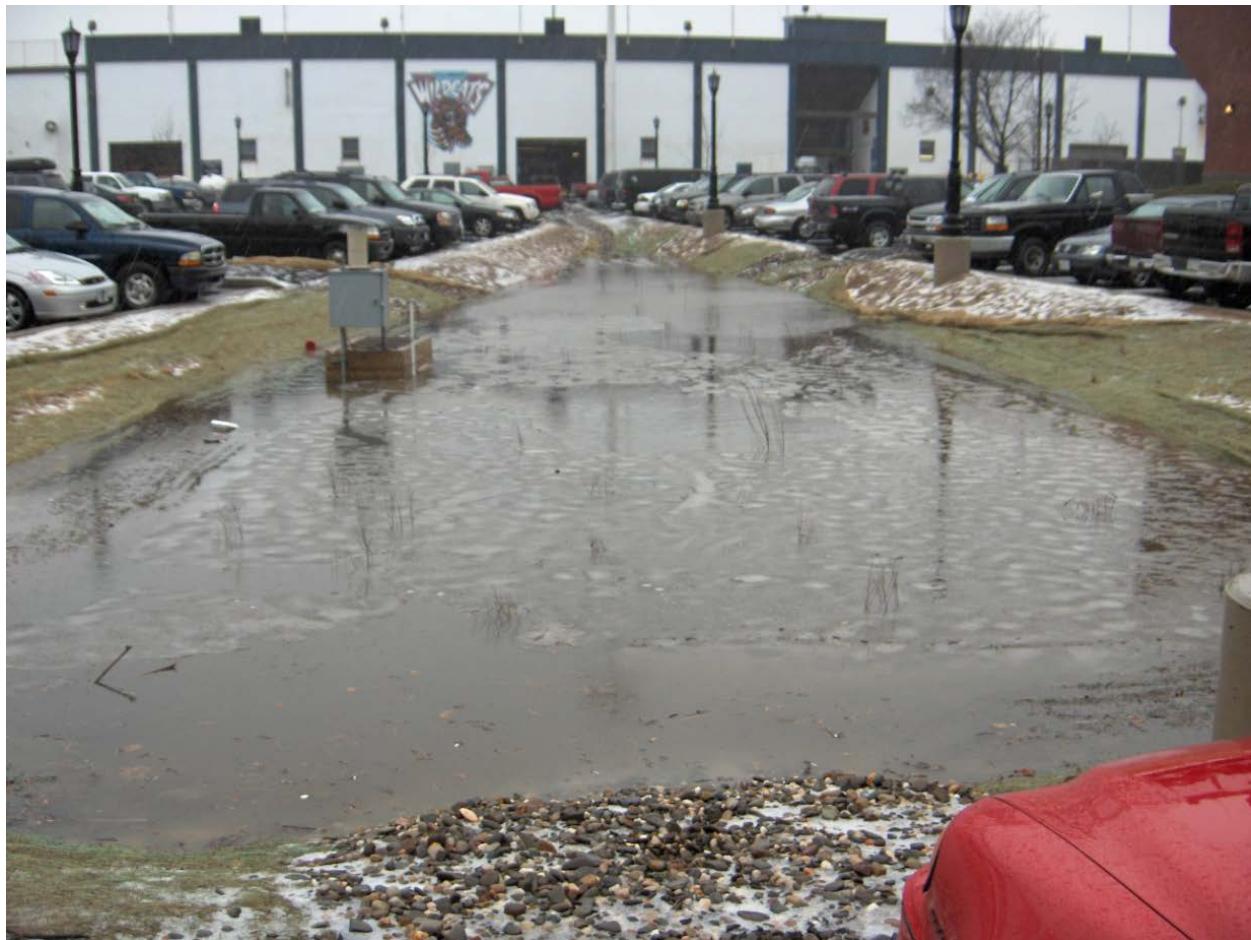
Figure 3.40 Ponding at the PTI after a rain event (photograph courtesy of Villanova Urban Stormwater Partnership)

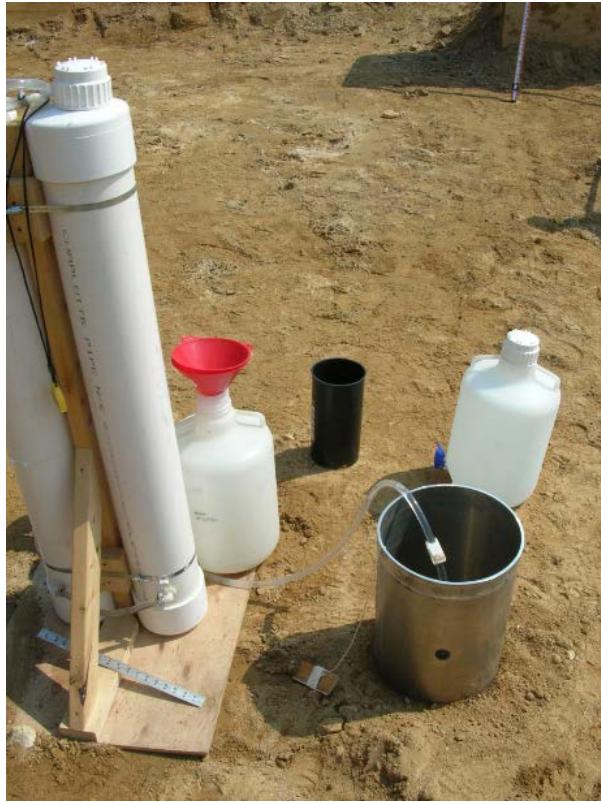
Four constant-head single-ring infiltration tests were conducted in 2007 found that the hydraulic conductivity of the native soil beneath the engineered media was between  $1.6 \times 10^{-3}$  cm/s and  $2.7 \times 10^{-3}$  cm/s, with an average value of  $2.1 \times 10^{-3}$  cm/s. The test technicians noted that prior to the infiltration tests, around 2.5 cm to 5.0 cm of soil was removed. This demonstrates that the native soil, when it was not compacted, had a suitable hydraulic conductivity. Figure 3.41 depicts an infiltration test being performed at the PTI.

Figure 3.41 Single-ring infiltration test being performed at the PTI (photograph courtesy of Villanova Urban Stormwater Partnership)

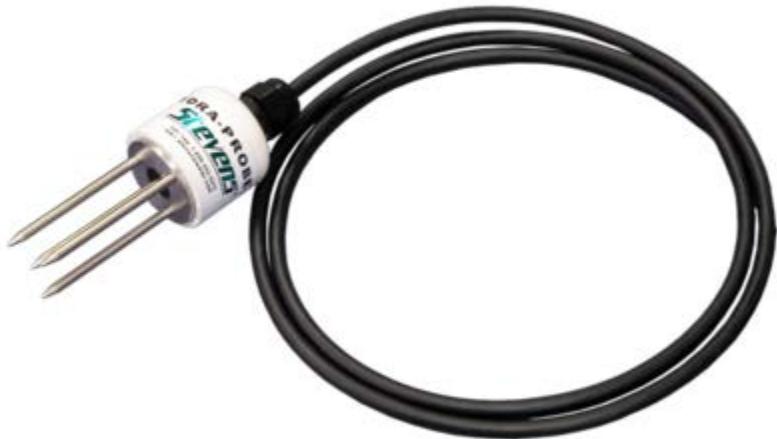
Stevens HydraProbe II soil moisture sensors were installed within the engineered media at the PTI to measure volumetric water content, conductivity, and temperature at specified points. HydraProbe II sensors were installed at depths of 10 cm, 35 cm, and 66 cm. Figure 3.42 displays a Stevens HydraProbe II. These sensors were calibrated in the same manner as the Decagon 5TE soil moisture sensors. However, a different equation was used in the calibration, which is

Figure 3.42 Stevens HydraProbe II (Stevens Water Monitoring Systems 2016)

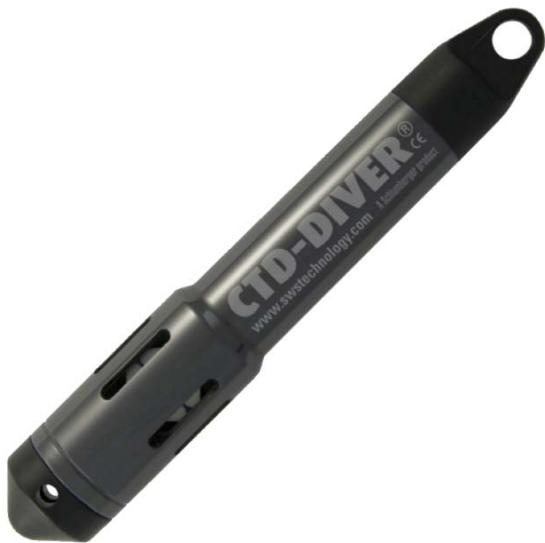
A Schlumberger (now Van Essen) CTD-Diver was installed in the monitoring well in the PTI pond. The CTD-Diver has the capability of recording water level, conductivity, and temperature. An SDI-12 DCX interface unit was necessary to use a Campbell Scientific SDI-12 data logger with the CTD-Diver. A CTD-Diver is depicted in Figure 3.43 and Figure 3.44 displays the DCX interface unit. The CTD-Diver was calibrated by Stevens Water Monitoring Systems, Inc., prior to installation. The calibration of the CTD-Diver was checked every 6 months. This was done by putting the sensor in three known conductivities and determining what conductivity the sensor reads. If the sensor was reading accurately, the same procedure was done with three known water depths to determine if the water level was working properly. Finally, the sensor was placed in three buckets of water with three known temperatures, and the sensor temperature readings were compared. If the sensor was reading within the accuracy for each parameter, recalibration was not deemed necessary. This was within  $\pm 1\%$  for the conductivity measurement,  $\pm 0.18$  °F for the temperature measurement, and 0.05% for the water level measurement (Stevens Water Monitoring Systems 2016). During all calibration checks that occurred during this study, it was determined that recalibration was not necessary. This calibration information is provided in Appendix B.

Figure 3.43 Van Essen CTD-Diver (Stevens Water Monitoring Systems 2016)

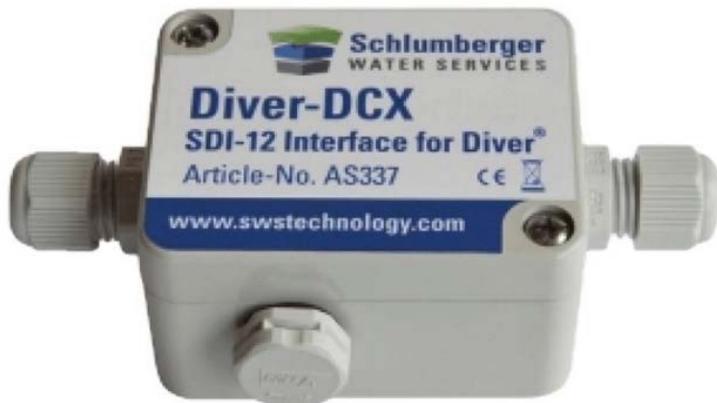
Figure 3.44 Diver DCX used for CTD-Diver SDI-12 communication (Stevens Water Monitoring Systems 2016)

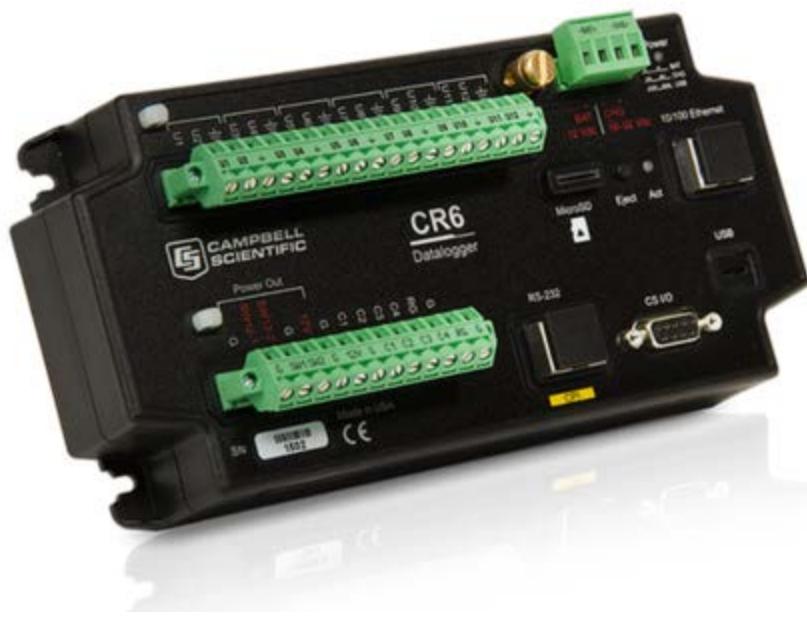
The PTI uses a Campbell Scientific CR6 data logger box, which is depicted in Figure 3.45. All instrumentation for the rain garden is hardwired to the CR6, which is located in a box in front of and above the concrete box. To collect data remotely, a Campbell Scientific RF401A 900 MHz spread-spectrum radio is used with a 900 MHz 9 dBd Yagi antenna to communicate with a RF401 spread-spectrum radio at a site near the constructed stormwater wetlands on Villanova University's campus. This site is hardwired to the internet, which allows the PTI data to be collected using Campbell Scientific LoggerNet software. The RF401A radio is displayed in Figure 3.46, and the Yagi antenna is shown in Figure 3.47. The antenna is attached to a metal angle, which is attached to the poles which hold up the metal housing which contains the CR6 data logger box. The data logger box must be kept dry. A sealed bag of desiccant, which is changed regularly, was used inside the box to keep moisture levels low. Indicator paper was used to monitor ambient moisture within the box, which noted when the desiccant bag needed to be replaced. A tube of desiccant is attached to each pressure transducer wire and changed color when it indicates saturation. Putty seals, which were used to keep the box dry, were checked periodically. Higher ambient moisture or insects within the box indicated the need for new putty seals.

Figure 3.45 Campbell Scientific CR6 data logger (Campbell Scientific 2016)

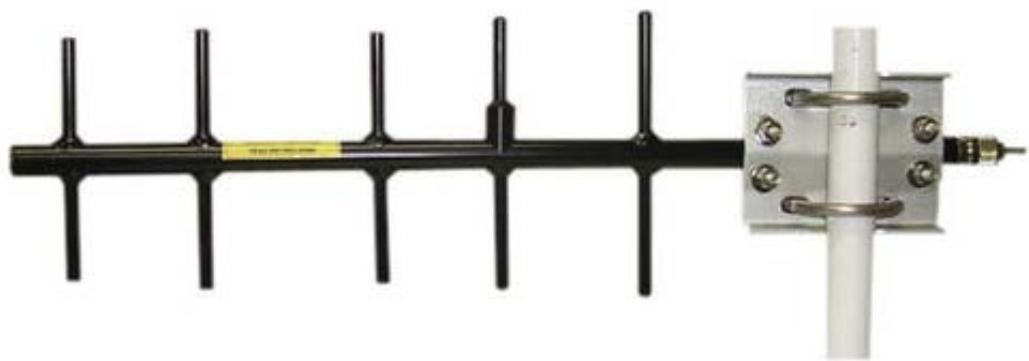
Figure 3.46 Yagi antenna used at the PTI (Campbell Scientific 2016)

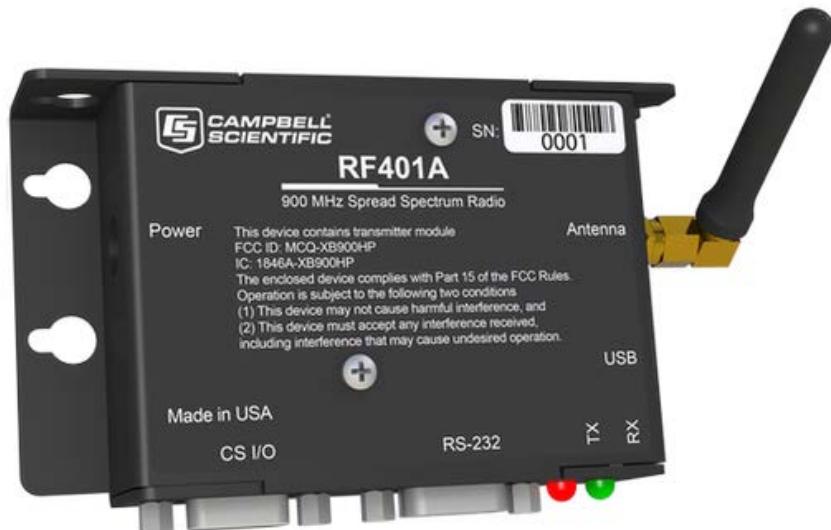
Figure 3.47 Campbell Scientific RF401A spread-spectrum radio (Campbell Scientific 2016)

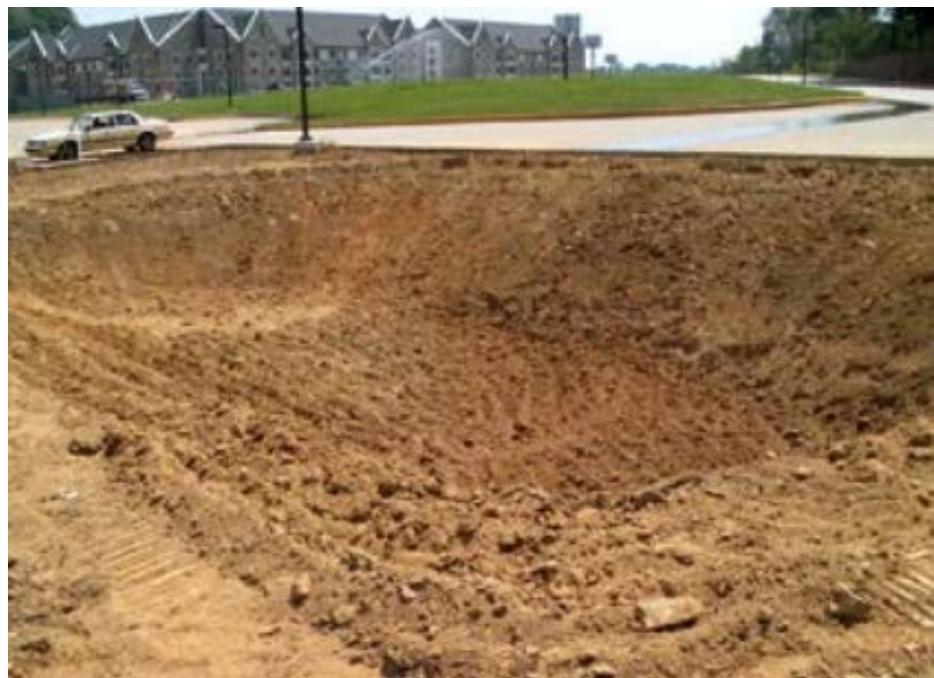
The Bioinfiltration Traffic Island (BTI) is located on west campus at Villanova University. The SCM is a retrofit unlined rain garden and is an existing traffic island. The BTI was constructed in 2001 and has been monitored continuously for water quantity data since 2003. The BTI was constructed by excavating the traffic island to a depth of 1.8 m and mixing the soil with construction sand at a 1:1 ratio to a depth of 1.2 m. The site was designed and constructed to retain and infiltrate a 2.54 cm storm event. The total construction cost was around \$29,000. Figure 3.48 and Figure 3.49 show construction at the BTI in 2001, and Figure 3.50 depicts the BTI in 2010.

Figure 3.48 Construction at the BTI in 2001 (Prokop 2003)

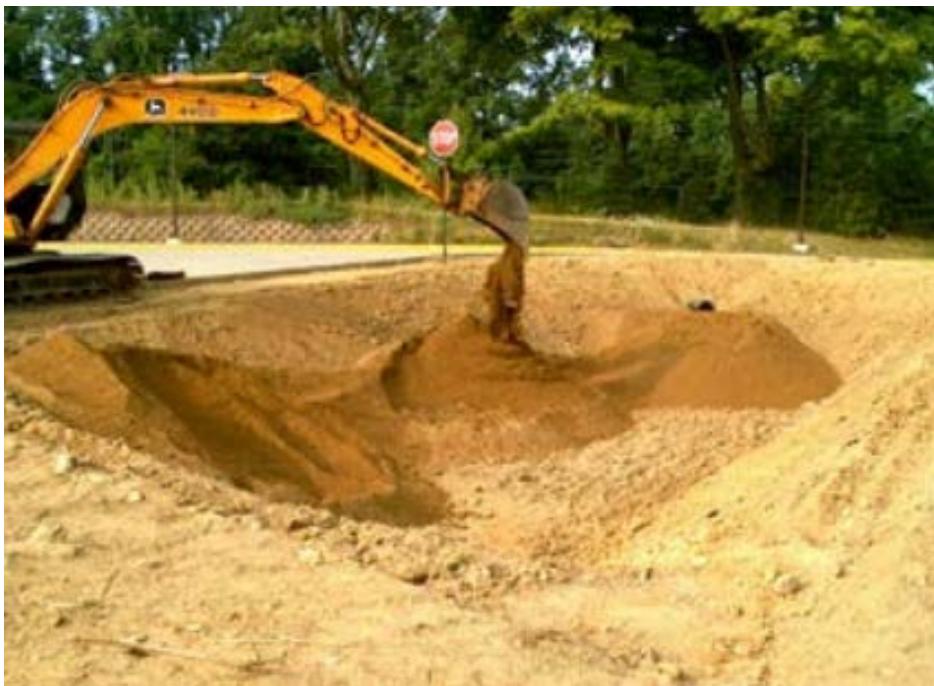
Figure 3.49 Soil mix being placed at the BTI in 2001 (Prokop)

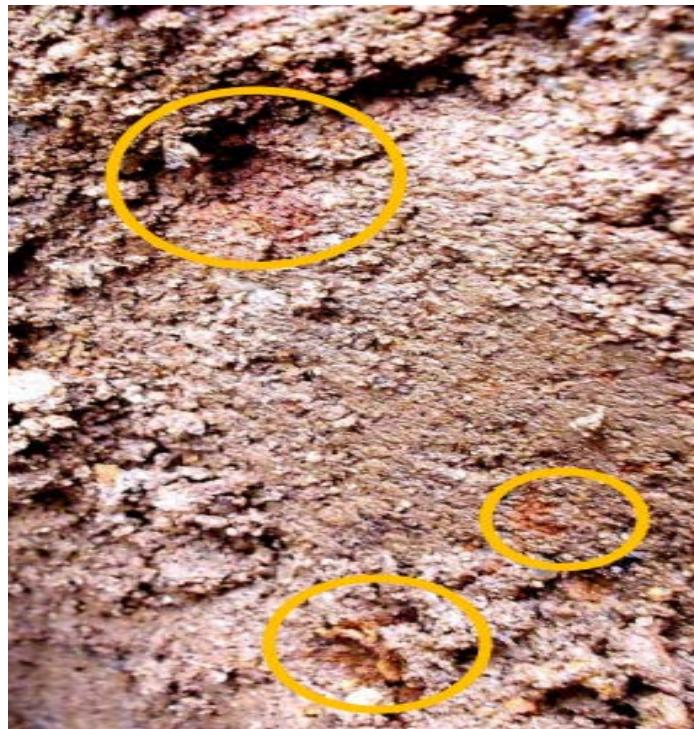
During a site investigation in November 2014, two samples were collected at depths of 0 cm to 5 cm and 5 cm to 36 cm, respectively (Zukowski et al. 2016). At the sampling location, it was determined that the first 5 cm of the soil within the BTI bowl was a silt loam or loam with many fine roots, and the following 31 cm of soil was a sandy loam with little gravel (Zukowski et al. 2016). In addition to this, the soils were observed to have redoximorphic features such as small iron concentrations, which can be seen in Figure 3.54 (Zukowski et al. 2016). The upper soil

Figure 3.54 Redoximorphic features in the BTI soil (Emerson et al. 2015)

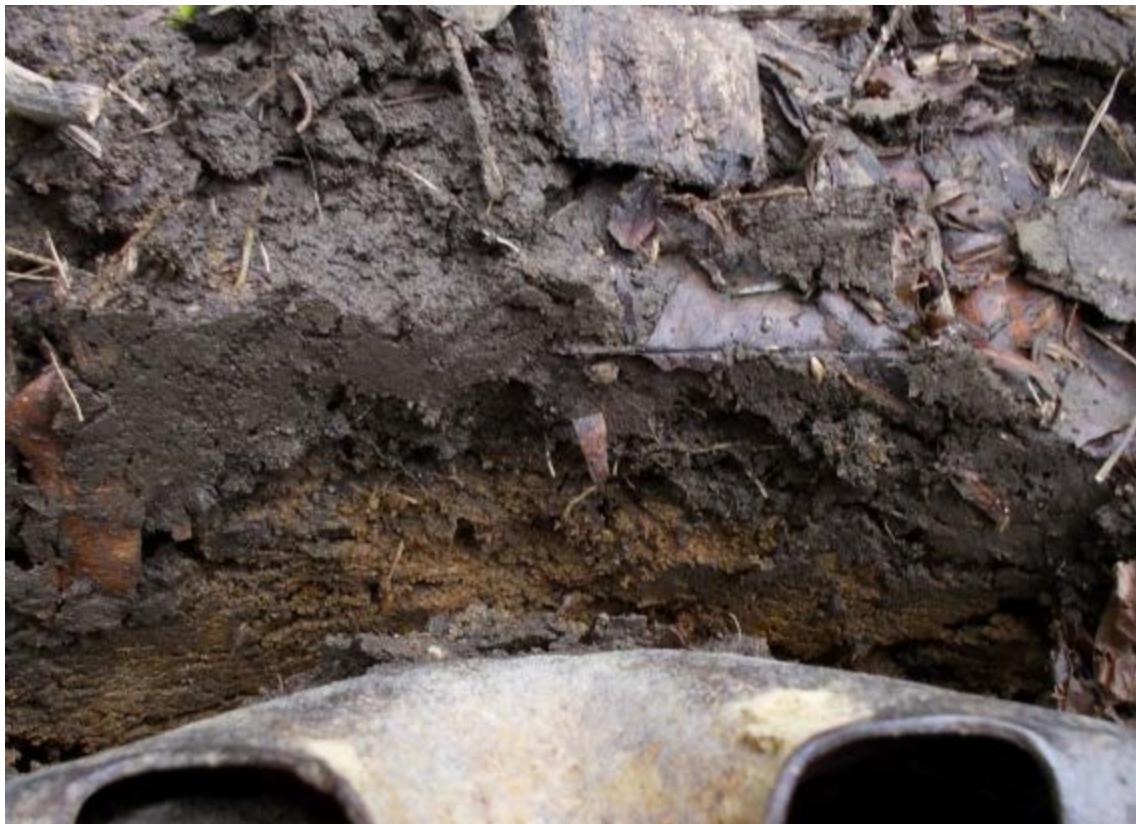
layer was deemed to be an organic material layer that has built up at the BTI over the course of its 15 year life. The thickness of this layer ranged from 2.54 cm to 7.62 cm throughout the BTI (Zukowski et al. 2016). The soil layer change can be observed in Figure 3.55.

Figure 3.55 The organic layer overlaying the BTI soil mix (Emerson et al. 2015)

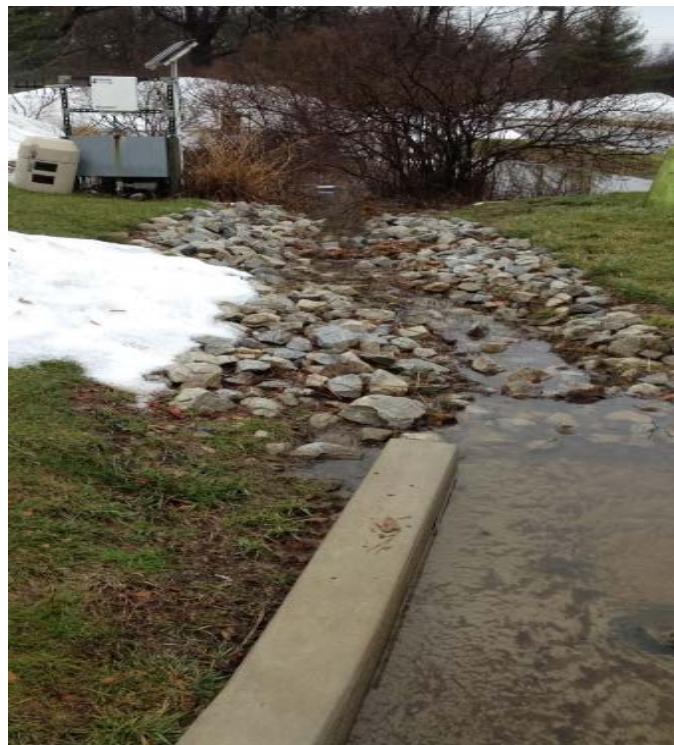
The BTI has a soil mix depth of 1.22 m, a maximum ponding depth of 0.46 m, and around 3:1 (H:V) slopes. A profile schematic of the BTI is provided in Figure 3.56. Native vegetation that has been planted sustains well throughout the year. The vegetation is cut back prior to the winter months and grows back during the spring months without additional planting. Dead vegetation is also removed in the early spring to enhance aesthetics. Prior to September 2013, inflow was controlled by two curb cuts on the north end and two inlet grates on the south end. The curb cuts were connected to the pond via channels lined with rip-rap. In September 2013, the site was modified so that flow at the north end was channelized to one transition area which consists of a sloped concrete pad leading into a rip-rap channel. Figure 3.57 shows the inlet channel in 2016. Water travels into this inlet channel and into the bowl of the BTI.

Figure 3.57 The inlet channel leading into the BTI (photograph courtesy of Villanova Urban Stormwater Partnership)

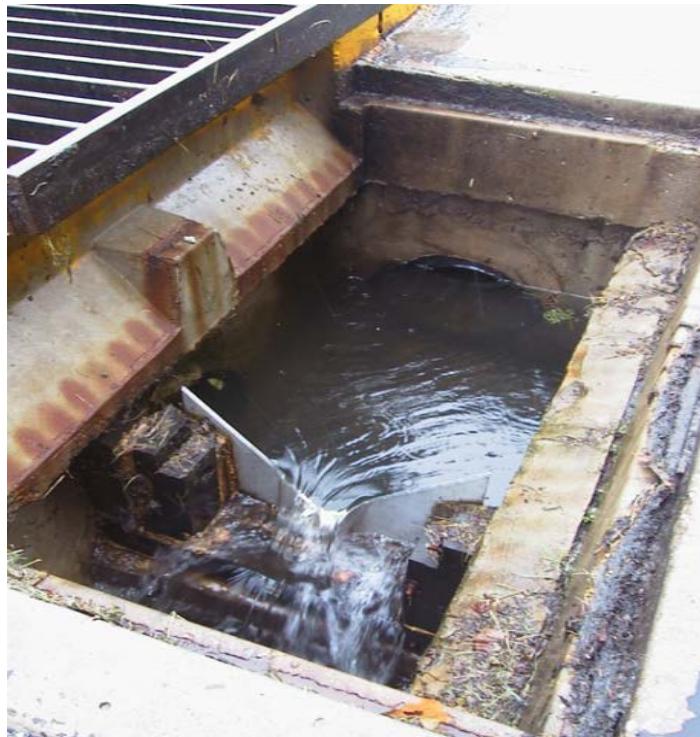
An inlet/outlet box installed at the BTI was outfitted with a V-notch weir to measure outflow. The original weir was a 0.46 m square aluminum plate with a maximum head of 0.23 m and a 90° angle. The original weir was replaced in June 2014 with a larger, wider aluminum weir to provide more accurate flow measurements during larger events. The inlet/outlet box and weir are shown in Figure 3.58. The current weir at the BTI has a maximum head of 0.38 m and a 60° angle.

Figure 3.58 The outlet box and weir at the BTI (photograph courtesy of Villanova Urban Stormwater Partnership)

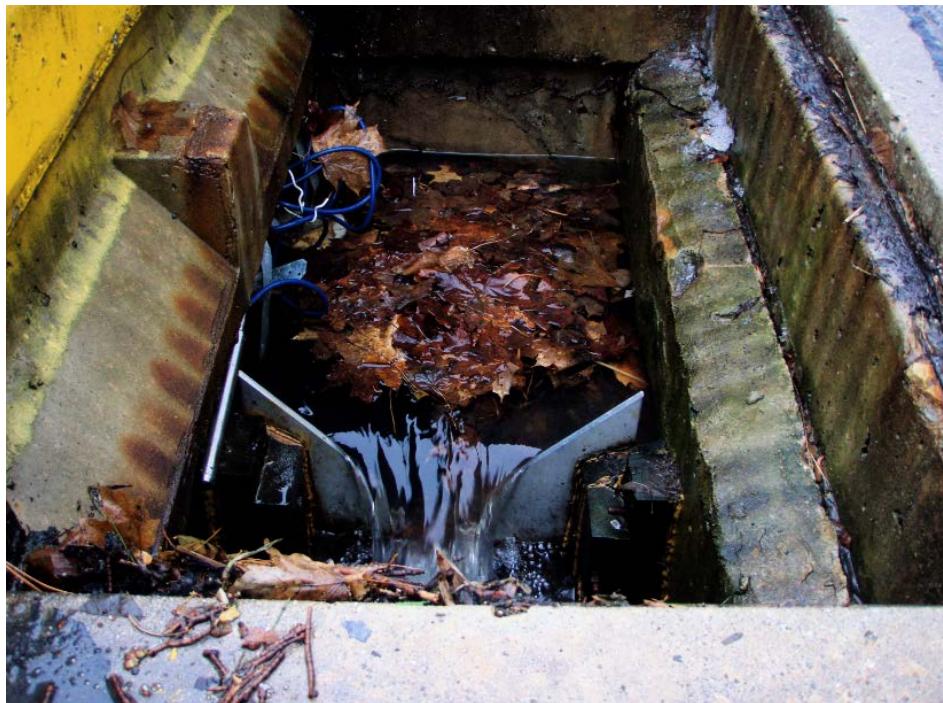
Every six months, general maintenance checks are done at the BTI to clean out any debris in the pond, inlet channel, and outlet box. Leaf litter in the outlet box is removed to prevent clogging or inaccurate flow measurements. Figure 3.59 demonstrates leaf build up in the outlet box. During the fall especially, leaves can build up in the outlet box and become frozen in place behind the weir during the winter months. Figure 3.60 demonstrates frozen conditions in the outlet box at

Figure 3.59 Leaves in the outlet box at the BTI (photograph courtesy of Villanova Urban Stormwater Partnership)

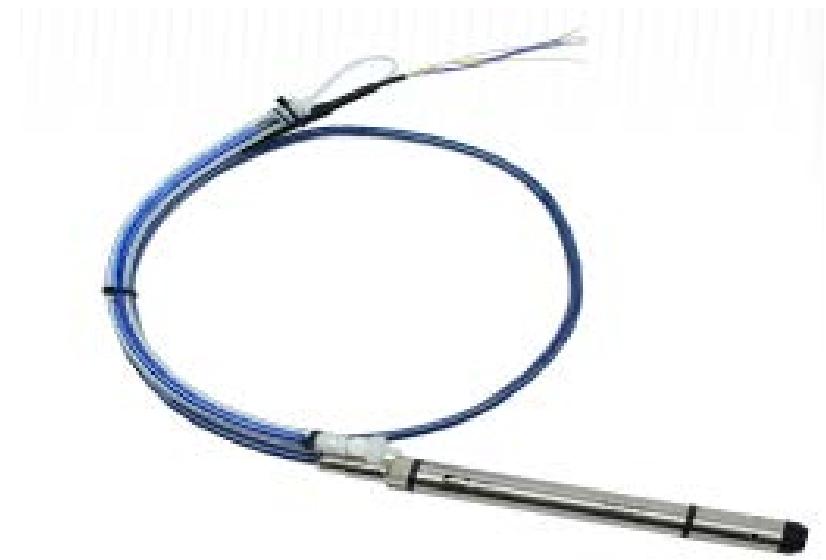
In addition to the soil moisture sensors installed in the BTI pond, there is an Instrumentation Northwest (INW) PS9800 pressure transducer used to measure ponding levels. The INW PS9800 pressure transducer is shown in Figure 3.62. This pressure transducer behaves and is calibrated similarly to the Campbell Scientific CS451 pressure transducers used at the PTI and the FRG.

Figure 3.62 The INW PS9800 (Instrumentation Northwest USA 2016)

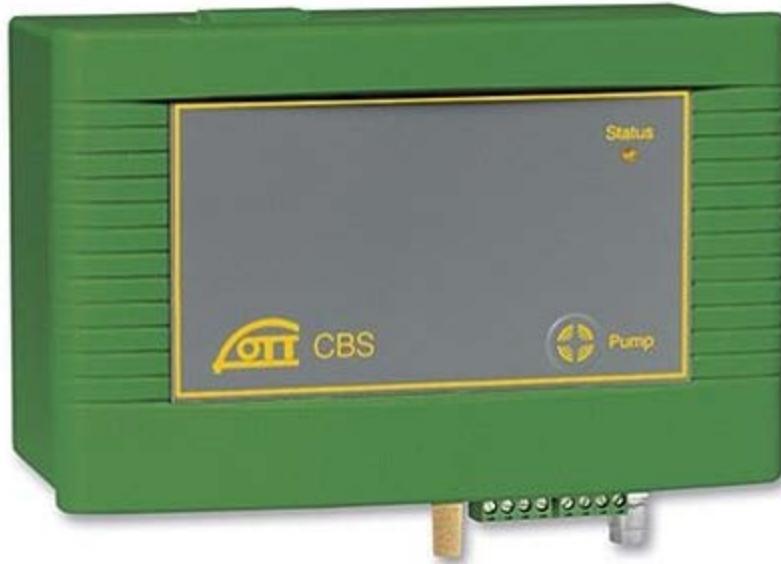
Figure 3.63 The OTT CBS bubbler sensor (OTT Hydromet 2016)

Additionally, an OTT CBS bubbler was installed in the pond to measure water levels. The INW PS9800 is used more as a double-checking measure with ponding measurements being recorded by the bubbler. The OTT CBS bubbler is shown in Figure 3.63. A tube that runs from the bubbler and feeds into an EPS 50 bubble chamber, which is depicted in Figure 3.64. When ponded, the pressure above the EPS 50 bubble chamber introduces bubbles which travel to the bubbler sensor device. These bubbler sensor correlates these bubbles with water depth to determine the depth of ponded water. The bubbler self-calibrates, so routine calibrations are not necessary as is the case with the pressure transducers used at the rain garden sites.

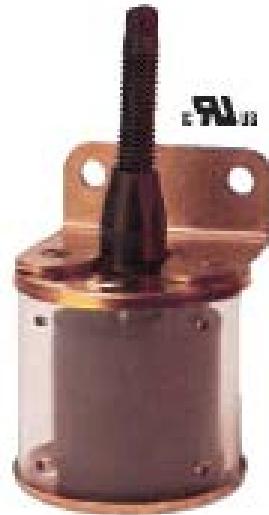
Figure 3.65 The Gems LS-270 level switch (Gems Sensors 2016)

An additional pond instrument used as a checking mechanism for the bubbler is the Gems LS-270 level float switch, which is illustrated in Figure 3.65. These level switches operate by

detecting water and returning a 5V reading when it is wet. This reading is simplified as a “1”, which provides confirmation that ponding is occurring at the BTI. These instruments are also used to measure pressure transducer drift over time.

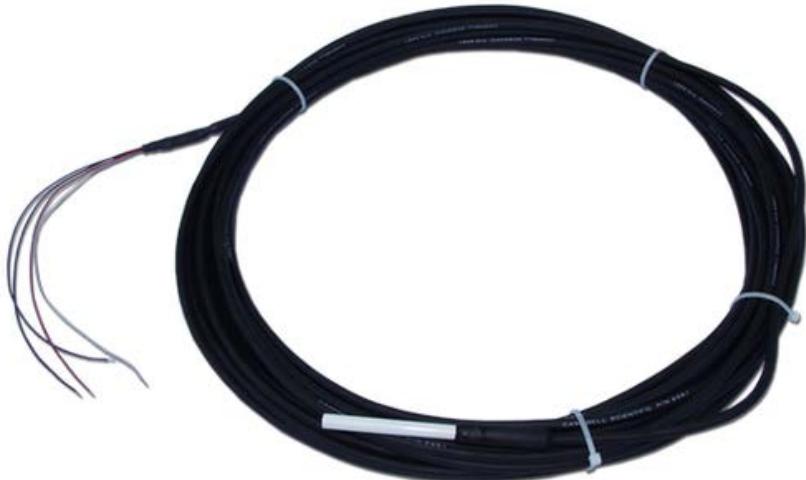
Figure 3.66 The Campbell Scientific T107 temperature probe (Campbell Scientific 2016)

A Campbell Scientific T107 temperature probe is used to measure water temperature within the bowl at the BTI. If ponding is not present, this instrument measure air temperature. The Campbell Scientific T107 temperature probe is illustrated in Figure 3.66.

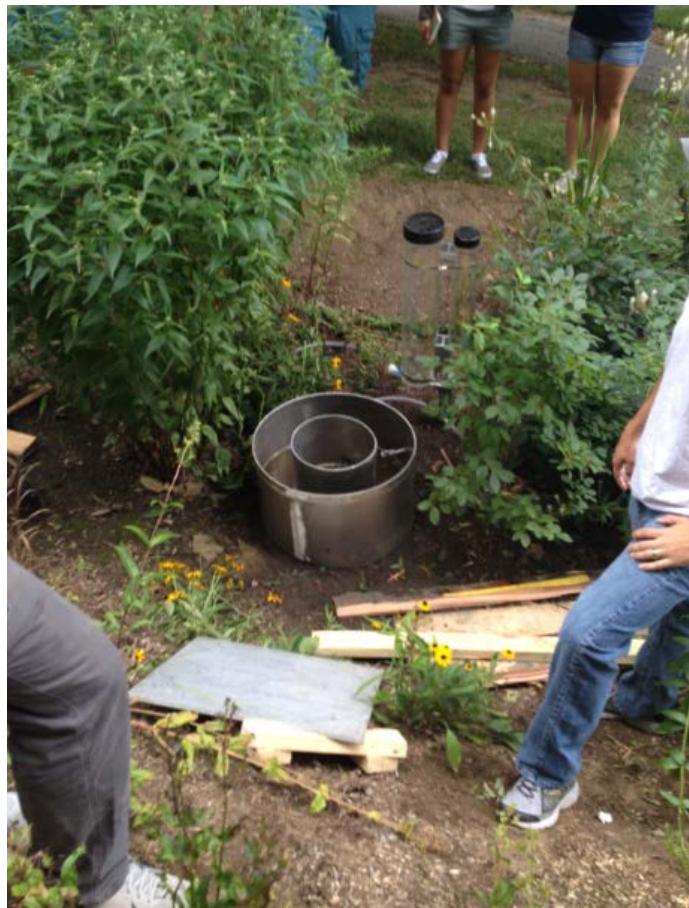
Figure 4.2 A double-ring infiltrometer test being conducted at the FRGI

could be recorded at 24-hour or longer intervals. Figure 4.2 demonstrates a double-ring infiltration test conducted at the FRGI. After the tests were installed, the steel driving plate was placed over the rings to limit evaporation of water within the double-ring infiltrometer. This recommendation is not explicitly stated in the PADEP (2006) guidelines, but is mentioned in the ASTM D3385 standard.

The double-ring infiltrometer utilized at Villanova has a 61 cm diameter outer ring and a 30 cm diameter inner ring. Both rings have a thickness of 0.64 cm, although ASTM D3385 states that rings should have a thickness of 0.32 cm. Figure 4.1 depicts the typical double-ring infiltrometer used in infiltration testing. Double-ring infiltrometers can be fabricated from steel or aluminum, with steel rings being more durable during installations and aluminum rings being lighter and easier to transport.

scrap wood and a steel driving plate were used to install the rings with a sledge hammer. It was difficult to install the rings using wood and a rubber mallet, so a combination of the two methods was implemented. After installation, the soil around the rings was tamped to prevent water from leaking outside of the rings. Alternatively, in some cases, bentonite was used to prevent lateral leakage of water from the rings.

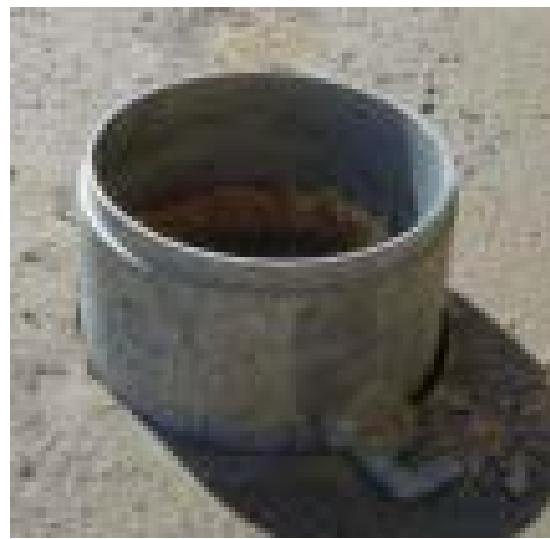
Figure 4.3 The single-ring infiltrometer test (photograph courtesy of Princeton Hydro, LLC)

The single-ring infiltrometer used in this study was created by Princeton Hydro, LLC. The goal of the test, according to Zukowski et al. (2016), is “achieving test accuracy and repeatability, rapid testing times, and adequate precision within the range of relevant hydraulic conductivity ( $7.1 \times 10^{-5}$  cm/s to  $7.1 \times 10^{-3}$  cm/s).” The single-ring infiltrometer is considered simple and inexpensive to construct and operate in the field, especially when compared to the double-ring infiltrometer. The single-ring infiltrometer is a steel ring that has a 15.2 cm diameter and is 15.2

cm long with a beveled cutting edge (Zukowski et al. 2016). The single-ring infiltrometer is marked on the outer diameter at the midpoint, which is 7.6 cm from the top of the ring. The steel ring is driven into the ground to this point, typically using a hammer and a piece of scrap wood. This means that the ring is driven 7.6 cm into the soil and 7.6 cm is left above the surface of the soil to allow for water placement within the device (Zukowski et al. 2016). The single-ring infiltrometer is shown in Figure 4.3. A filter fabric is placed in the ring prior to adding water to prevent water from causing surficial soil disturbance which can affect the infiltration rate (Zukowski et al. 2016). Water is added to the top of the ring after the filter fabric is placed, and the filter fabric is removed after the single-ring infiltrometer is filled with water (Zukowski et al. 2016). After the water drops 2.5 cm, the time is recorded with a stopwatch, and the single-ring infiltrometer is filled again. The ring is continuously filled to ensure that the head difference for readings is negligible. According to Zukowski et al. (2016), the test is run as many times as necessary until the time required for a 2.5 cm drop becomes stable. This stabilization would indicate that soils are saturated, and the infiltration rate is then correlated to the saturated hydraulic conductivity. Figure 4.4 displays a single-ring infiltration test being conducted, with the typical necessary tools also visible. In Figure 4.4, the hammer and piece of wood were used to install the ring, the red stopwatch was used to measure time required for a 2.5 cm drop, and the concrete sample container was full of water and used to add water to the ring after each 2.5 cm drop.

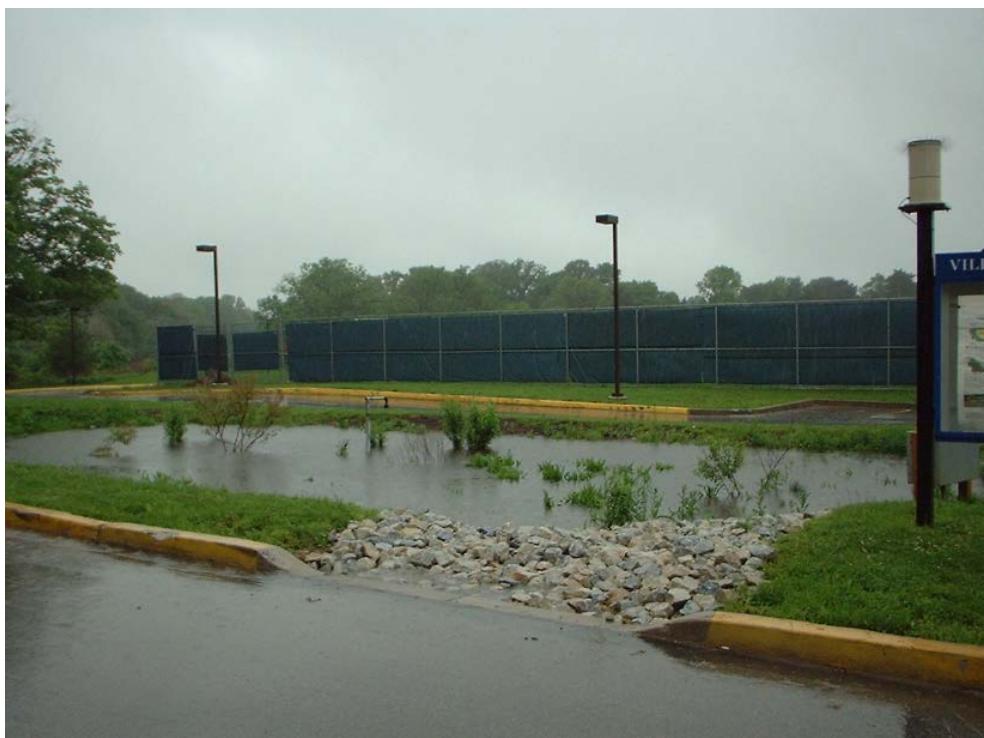
Figure 4.5 A ponding event occurring at the BTI where the recession rate can be determined (photograph courtesy of Villanova Urban Stormwater Partnership)

conductivity of a rain garden. Figure 4.5 shows a ponding event occurring at the BTI, which acts as a large-scale infiltration test. Single spot infiltrometer testing will vary across the pond due to the changing soil parameters; however, the entire area with all of these soil differences is included in the recession rate. The recession rate is assumed to follow the physics of steady ponded infiltration which includes insignificant effects of soil suction and infiltration effected by gravimetric forces and saturated hydraulic conductivity of the soil (Zukowski et al. 2016). With these valid assumptions, it is possible to then assume that the recession rate is an effective approximation of the hydraulic conductivity at the SCM (Emerson 2008).

The recession rate of an SCM can be considered an estimate of an area-averaged hydraulic conductivity (Zukowski et al. 2016). Emerson (2008) conducted single-ring infiltrometer tests and determined that infiltration is not constant within an SCM. Therefore, to account for the heterogeneity of soil within an SCM, the recession rate can be considered an accurate prediction of the hydraulic conductivity of the entire SCM. The as-built performance of a rain garden is affected by the soil likely heterogeneous, anisotropic, and affected by entrapped air and macroporosity (Zukowski et al. 2016). Therefore, since the recession rate after a storm acting as a large-scale infiltration tests can determine what would be considered the actual hydraulic

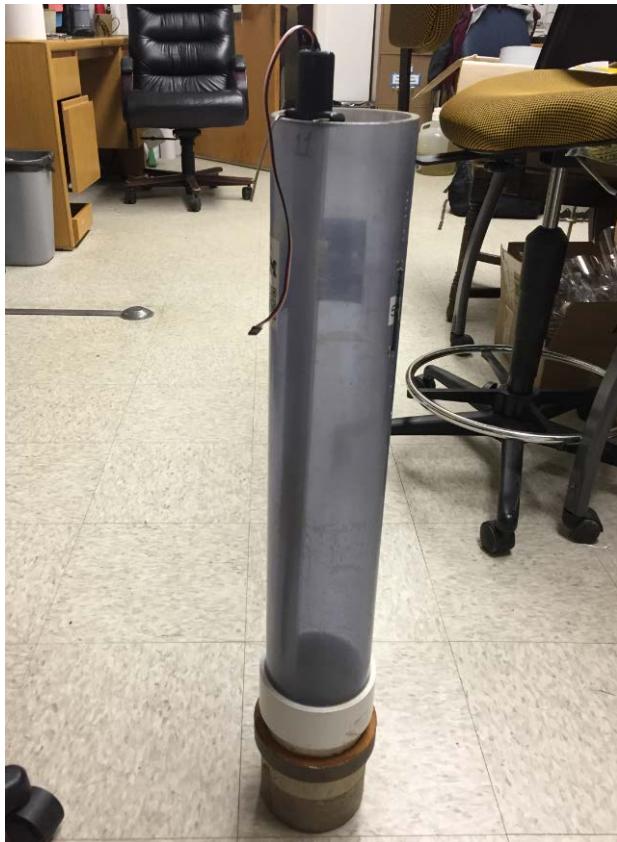
Figure 4.6 A Modified Philip-Dunne infiltrometer with a steel driving ring

The Modified Philip-Dunne infiltrometer (Munoz-Carpena et al. 2002) uses a 10 cm diameter tub with a steel or aluminum driving ring. The driving ring has a beveled edge and can be unscrewed

from the tube itself. This is beneficial to the infiltrometer because if the infiltrometer has difficulty being installed in tough soils, the ring can be hammered in by itself and the tube can be screwed back in afterwards. This prevents hammering directly onto the tube, which can damage the infiltrometer. The infiltrometer ring is installed to a minimum depth of around 5 cm, and the tube has a height of around 61 cm. Figure 4.6 shows the Modified Philip-Dunne infiltrometer used at Villanova University. The range of hydraulic conductivities calculable with the Modified Philip-Dunne is around  $1 \times 10^{-6}$  cm/s to  $1 \times 10^{-2}$  cm/s.

After the infiltrometer is installed, bentonite is applied around the cylinder to prevent lateral leakage. A silicon seal or thread seal tape is used to prevent leakage at the driving cylinder-tube interface. The current iteration of the Modified Philip-Dunne infiltrometer built at Villanova uses

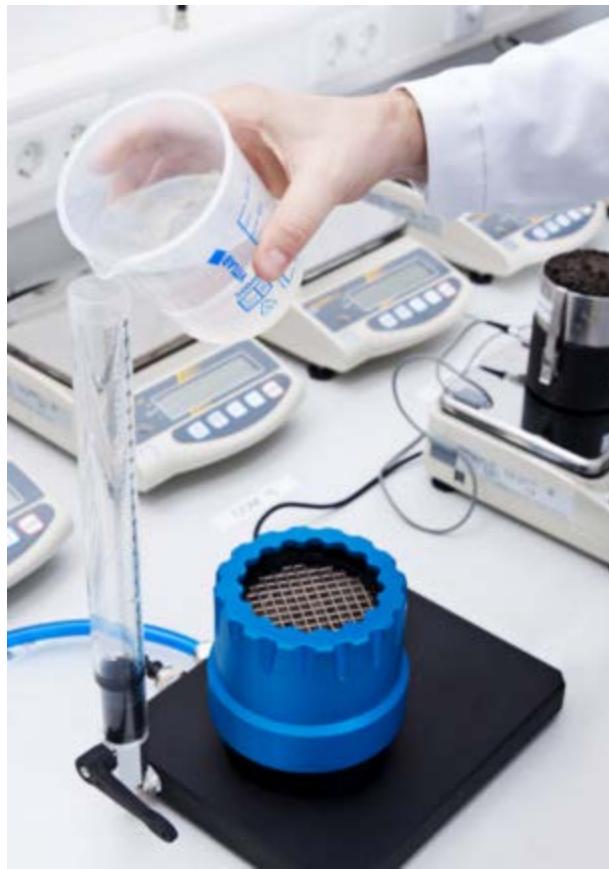
Figure 4.7 A UMS KSAT test (Decagon Devices 2016)

where  $K_s$  is the saturated hydraulic conductivity,  $L$  is the length of the sample,  $V$  is the volume of water which infiltrated into the sample,  $H$  is the head provided by the column of water,  $A$  is the area of the sample, and  $t$  is the time required to infiltrate the volume of water through the sample (Darcy 1856). A UMS KSAT test is shown in Figure 4.7.

The UMS sampler with a beveled edge is used to extract an undisturbed soil sample. To ensure soil disturbance does not occur, the soil sample is extracted by digging around and underneath the UMS sampler. When the sampler is extracted, the excess soil is scraped off and a lid is placed on the sampler (UMS 2013). The sample is then cleaned and attached to a porous plate, which is then placed into a tub of deionized water that has a depth of around 2 cm (UMS 2013). Water in the tub is then raised to the height of the sample with water flowing into the soil vertically downward. Rather, water moves upwards from the porous plate into the soil, which reduces entrapped air within the soil (UMS 2013). Saturating the samples in this way ensure that the saturated hydraulic conductivity is measured by the KSAT. This procedure to saturate the KSAT samples is illustrated in Figure 4.8.
