**EVALUATING RAIN GARDENS OF DIFFERENT  
CONFIGURATIONS AND SCM INFILTRATION TESTING  
METHODS TO DETERMINE RAIN GARDEN DESIGN AND  
SITE INVESTIGATION RECOMMENDATIONS**

Thesis

Civil Engineering

April, 2016

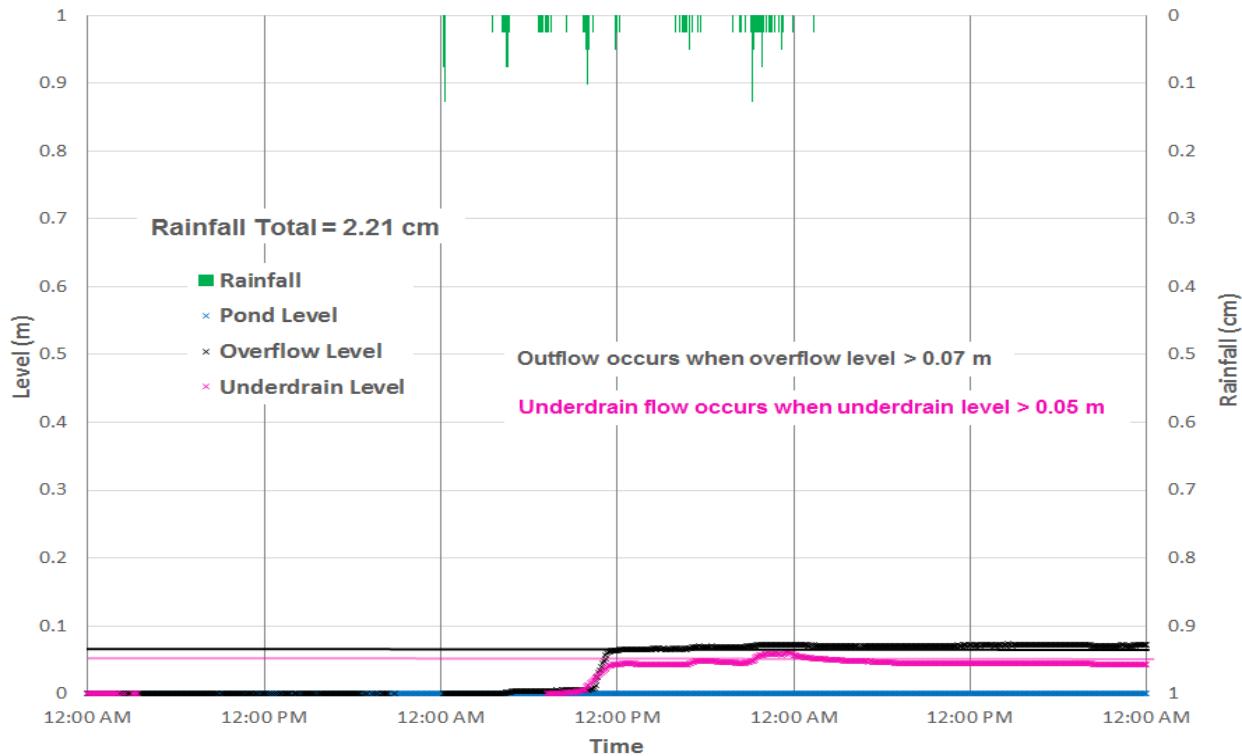
that it takes about this long before the rainfall reaches the liner of the system. The outflow begins shortly before the underdrain flow begins, and has a peak value around the same time as the underdrain flow. This confirms that the underdrain releases water into the overflow riser, which then releases water through the volumetric weir. However, it was shown that the rain caused only minor underdrain flows and outflows. As shown in Figure 5.3, the underdrain pressure transducer and overflow riser pressure transducer begin to read increases around the same time. The underdrain pressure transducer indicates a maximum of 0.077 m above the pressure transducer. This corresponds to roughly 8 cm above the bottom of the underdrain, which means the underdrain was not completely full during the rain event. Also, it is interesting to note that as the underdrain releases water, it follows a curve similar to recession rates in rain garden ponds. Figure 5.4 shows the flow data recorded during the rain event. The second peak in the outflow is likely due to rainfall directly entering the overflow riser or leakage into the riser.

Figure 5.3 FRGR pressure transducer data from the 09/10/2015 event

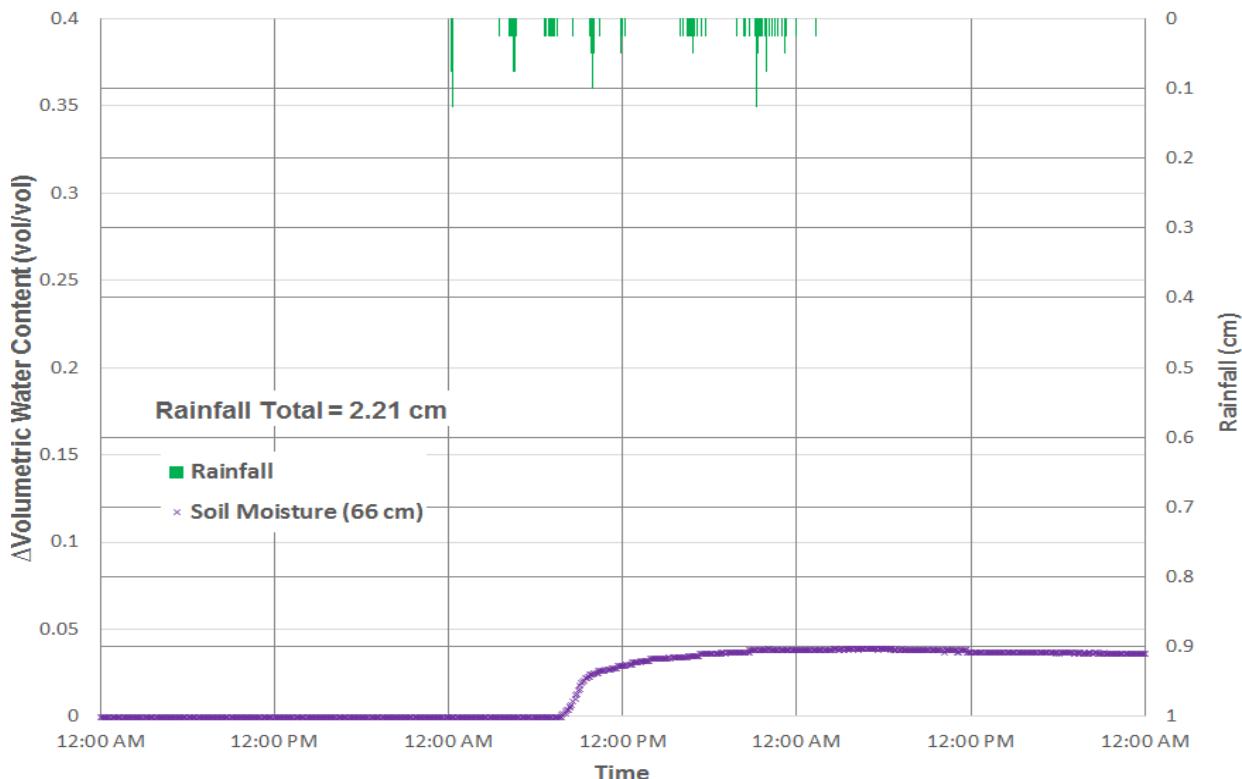
saturation, which shows that the liner and underdrain system retains water as designed. After the event, the soil moisture begins to slowly decrease, but does not decrease below 0.35 (35%). While the outflow from the underdrain is treated and delayed, it is still not necessary during a typical Villanova storm event, since FRGI was able to infiltrate all of the water.

Figure 5.5 FRGR soil moisture data from the 09/10/2015 event

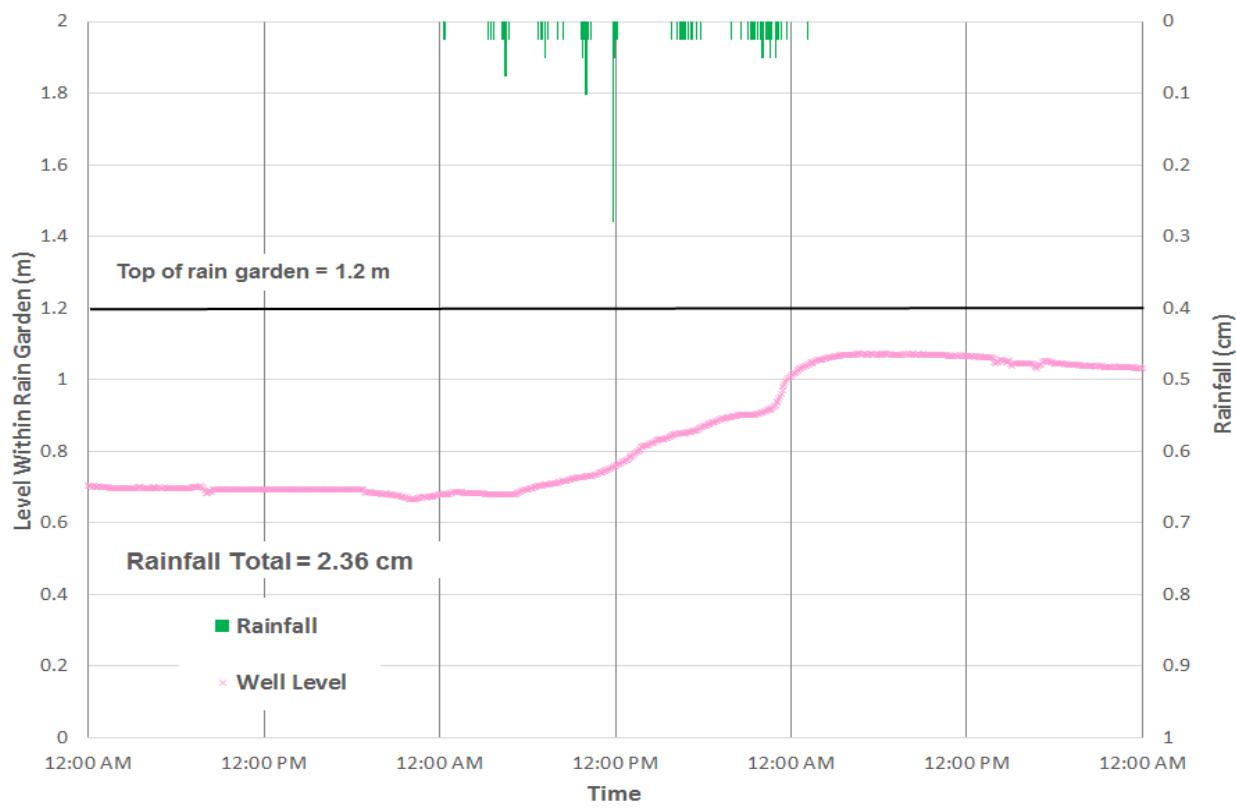
During the 2.29 cm event at the PTI, ponding did not occur. This validates that the event occurred during a very dry period, since the PTI is prone to high, long-lasting ponding due to the compacted layer beneath the system. Since ponding and overflow did not occur, the well pressure transducer was used to verify water level within the system. This instrument read that the water level rose from 0.66 m to 1.07 m within the media. The water level must reach 1.22 m before ponding occurs within the system. The well transducer data are shown in Figure 5.8.

Figure 5.8 PTI well pressure transducer data from the 09/10/2015 event

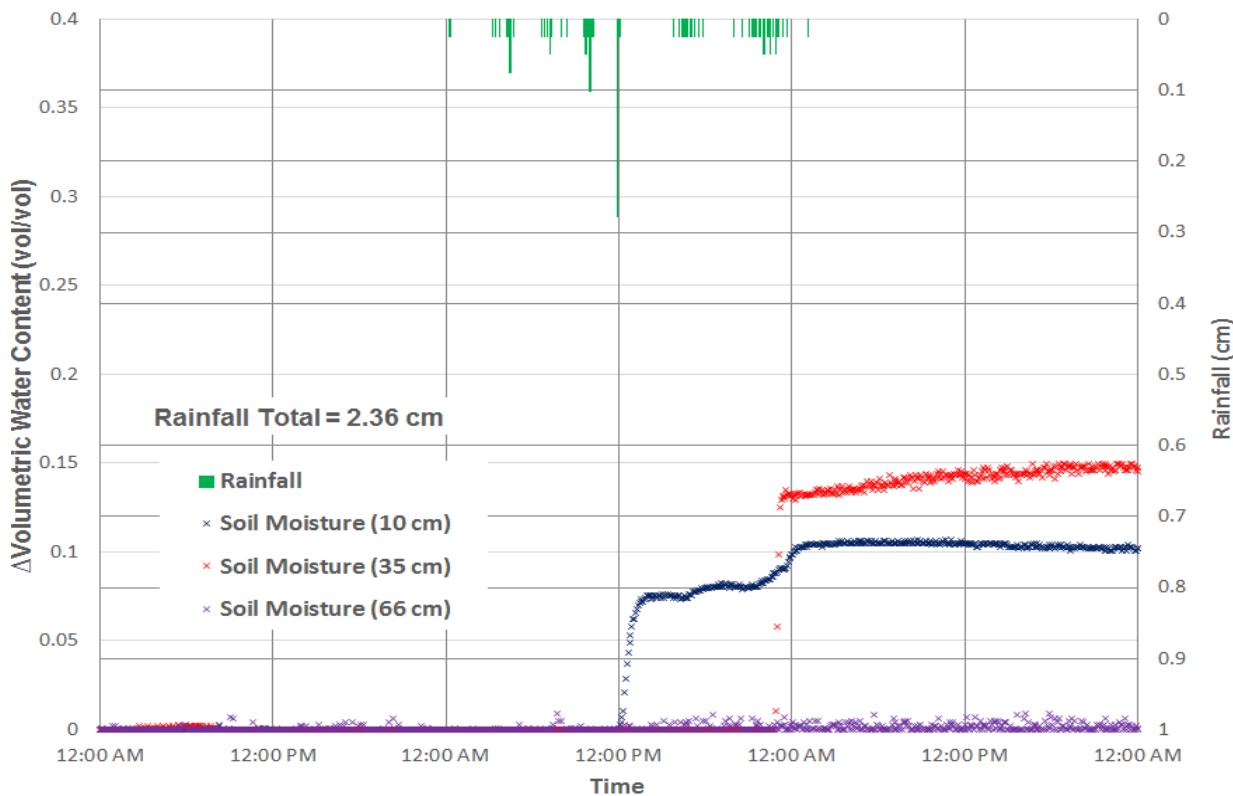
content increase up to saturation, and this increase began after the increase at the 10 cm soil moisture sensor ended. This indicates that macropores and high sand content allowed the water to move through the system extremely quickly, infiltrating after the soil at 10 cm became wetted close to the residual water content of the sensor at 35 cm. The volumetric water content at 10 cm began to increase after 12 hours, and the volumetric water content at 35 cm began to increase after 23 hours. This delay is likely due to the dryness of the soil. These data are shown in Figure 5.9. The perched water table in the system began to increase before the soil at 35 cm began to signify an increase in volumetric water content. However, this is likely due to preferential flow paths from macropores within the system. At the time that the soil moisture sensor at 35 cm begins to read increases in volumetric water content, the well transducer level increases much quicker.

Figure 5.9 PTI soil moisture data from the 09/10/2015 event

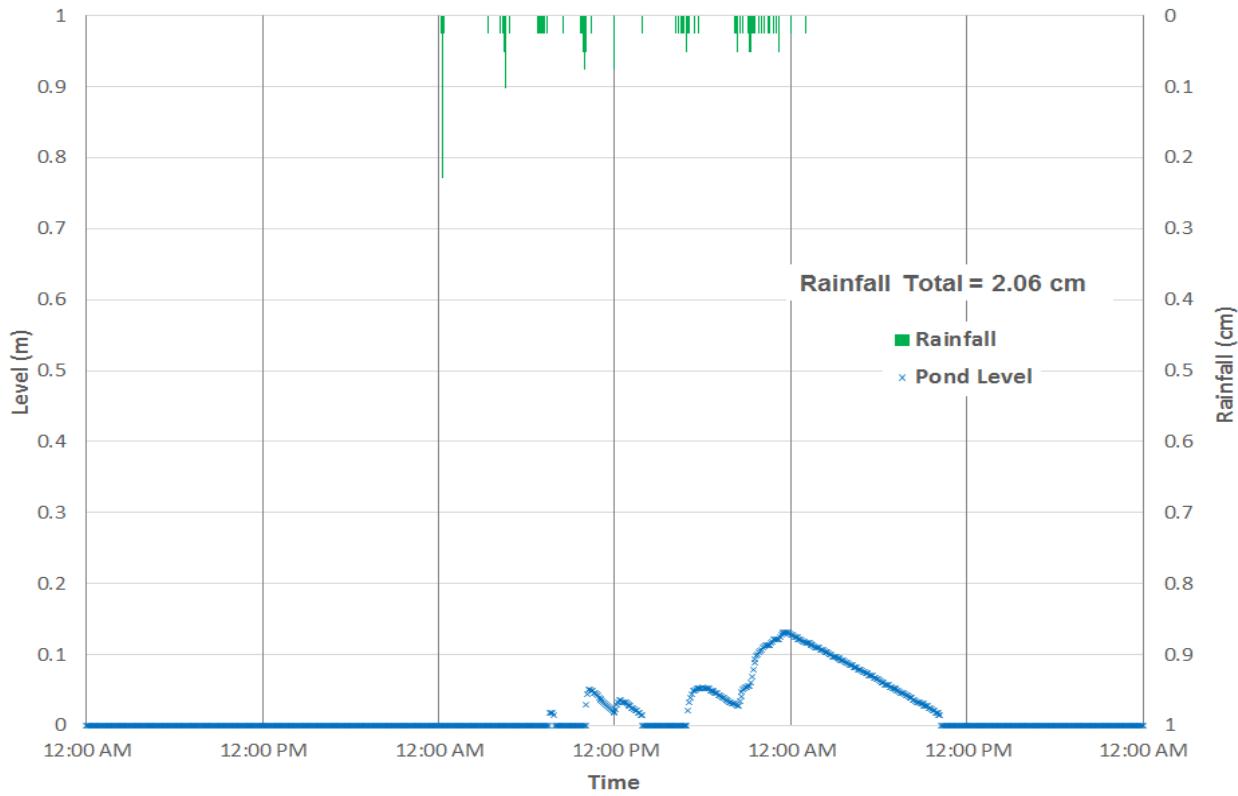
The BTI did not experience any overflow during this event. From data analyses, generally, a 2.54 cm storm event is needed for the BTI to overflow. However, ponding did occur up to 0.13 m. This occurred 24 hours into the 25-hour event. The ponding level increased during periods of rain and decreased during the storm. The BTI pond was empty 13.5 hours after the event ended. This indicates that the BTI empties within the standard time of 72 hours. However, this could be due to the very dry period in which the event occurred. This may also explain why the water ponded, was able to infiltrate, then ponded again during the event. The BTI may have been dry enough for water to infiltrate quickly once it made it through the organic layer which has built up in the BTI over time. Figure 5.10 shows the ponding plot for the 09/10/2015 event at the BTI. Figure 5.11 confirms that infiltration did move into the media during the storm, since the ponding level rose and fell during the event.

Figure 5.10 BTI pond pressure transducer data from the 09/10/2015 event

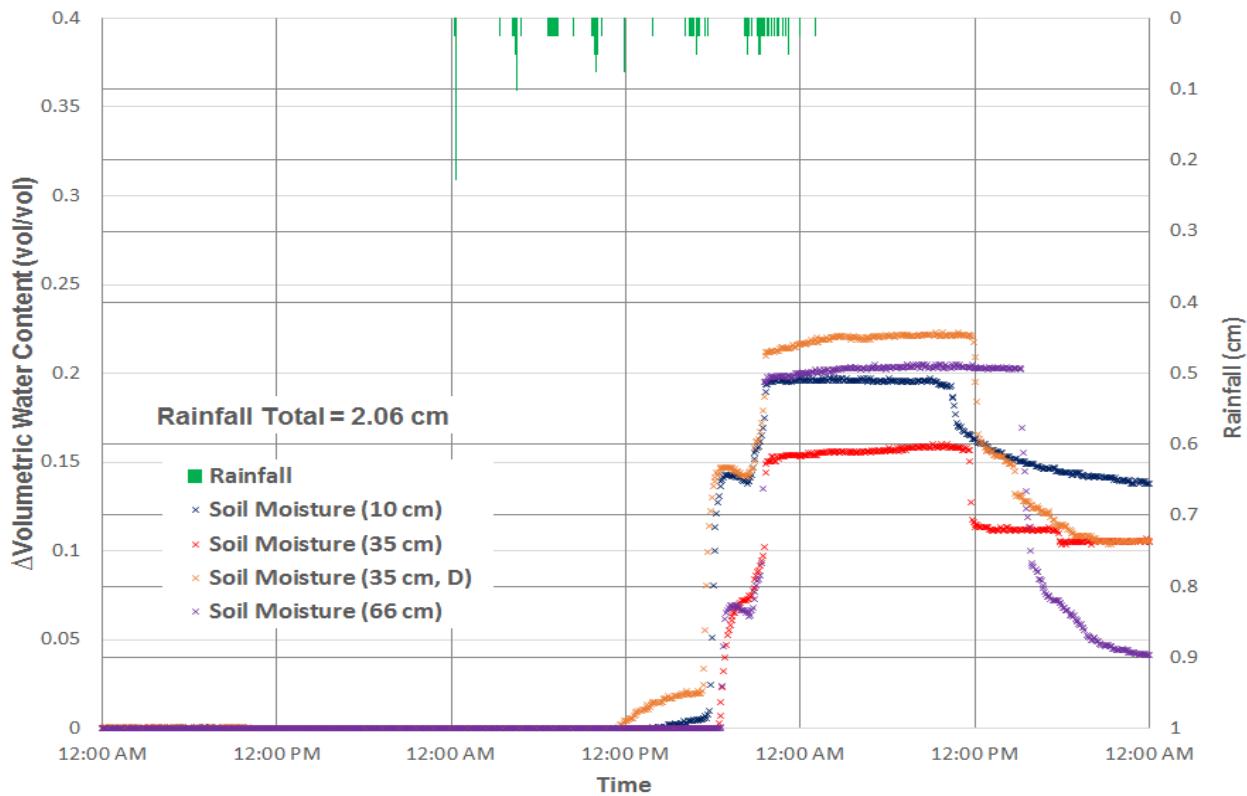
begin to level off. This verifies that the system is working well and water is moving through the system at a sufficient pace.

Figure 5.11 BTI soil moisture sensor data from the 09/10/2015 event

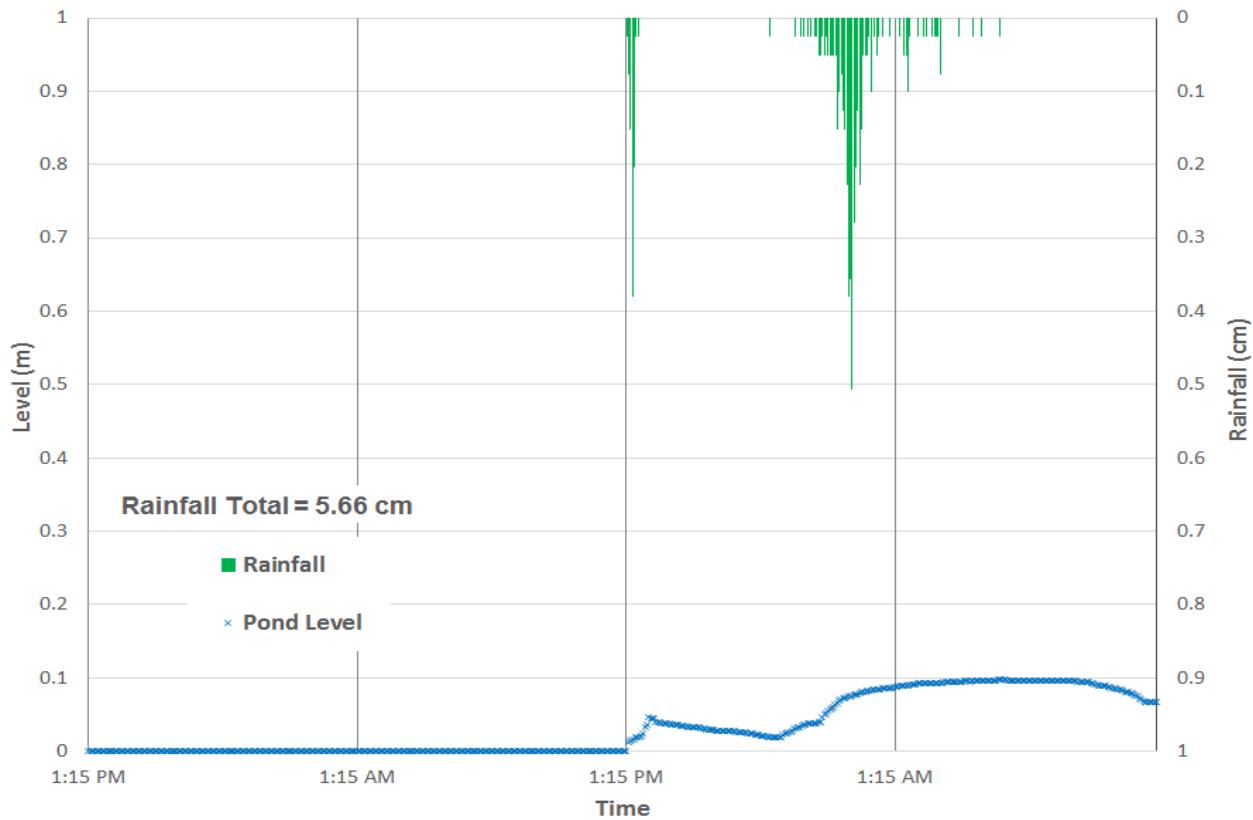
The FRGI indicated ponding occurring with two peaks which closely correspond with rainfall, as shown in Figure 5.12. The first peak occurred simultaneously with the rainfall, and then the FRGI began to empty until the rainfall started again around 6 hours later. At this time, the FRGI shows the highest point of ponding, which was 0.10 m after about 14.5 hours. The pond then slowly began to empty around 3 hours after the rainfall ended. No overflow occurred during this rain event, as 0.15 m of ponding is required before overflow occurs. Therefore, water entering the overflow device must be from leakage or rainfall falling directly into the overflow riser.

Figure 5.12 FRGI pond pressure transducer data from the 09/29/2015 event

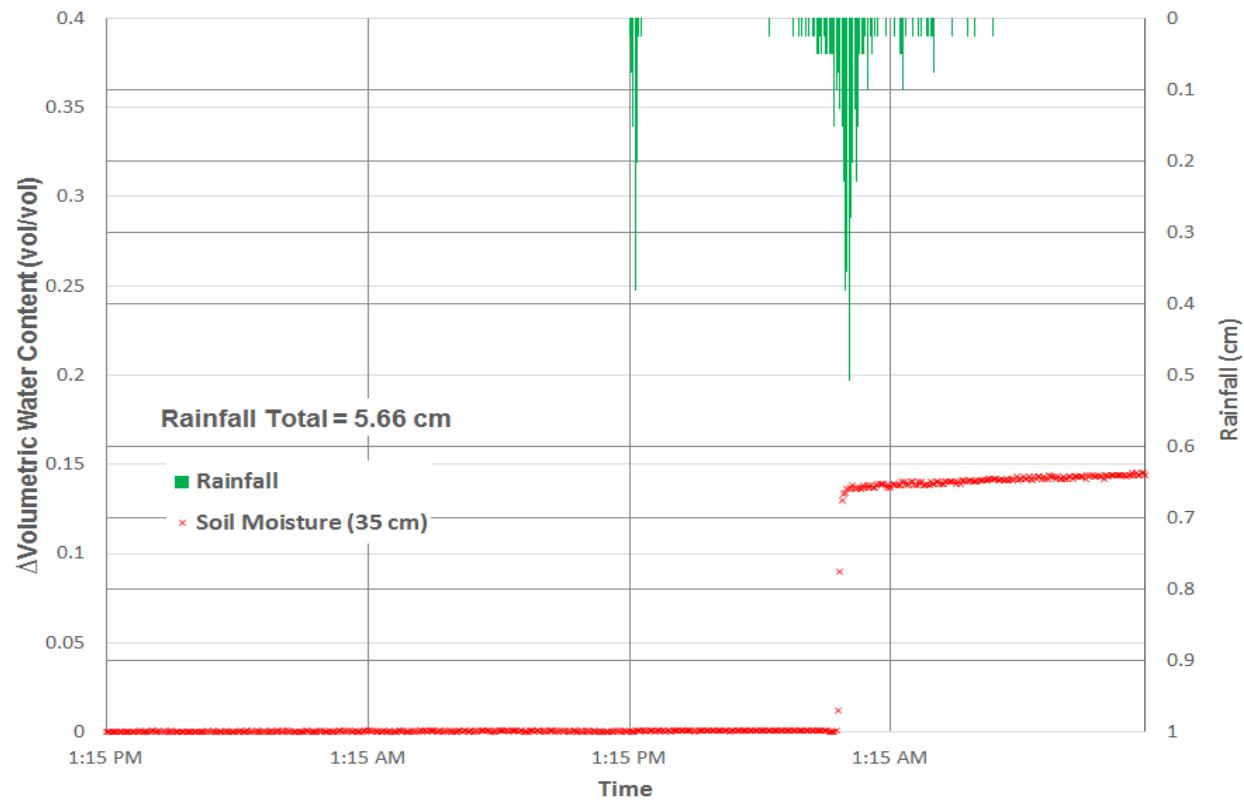
increase. As the pressure transducer demonstrates the pond is emptying, the soil volumetric water content begins to increase again, but not as rapidly as during the rain event.

Figure 5.13 FRGI soil moisture sensor data from the 09/29/2015 event.

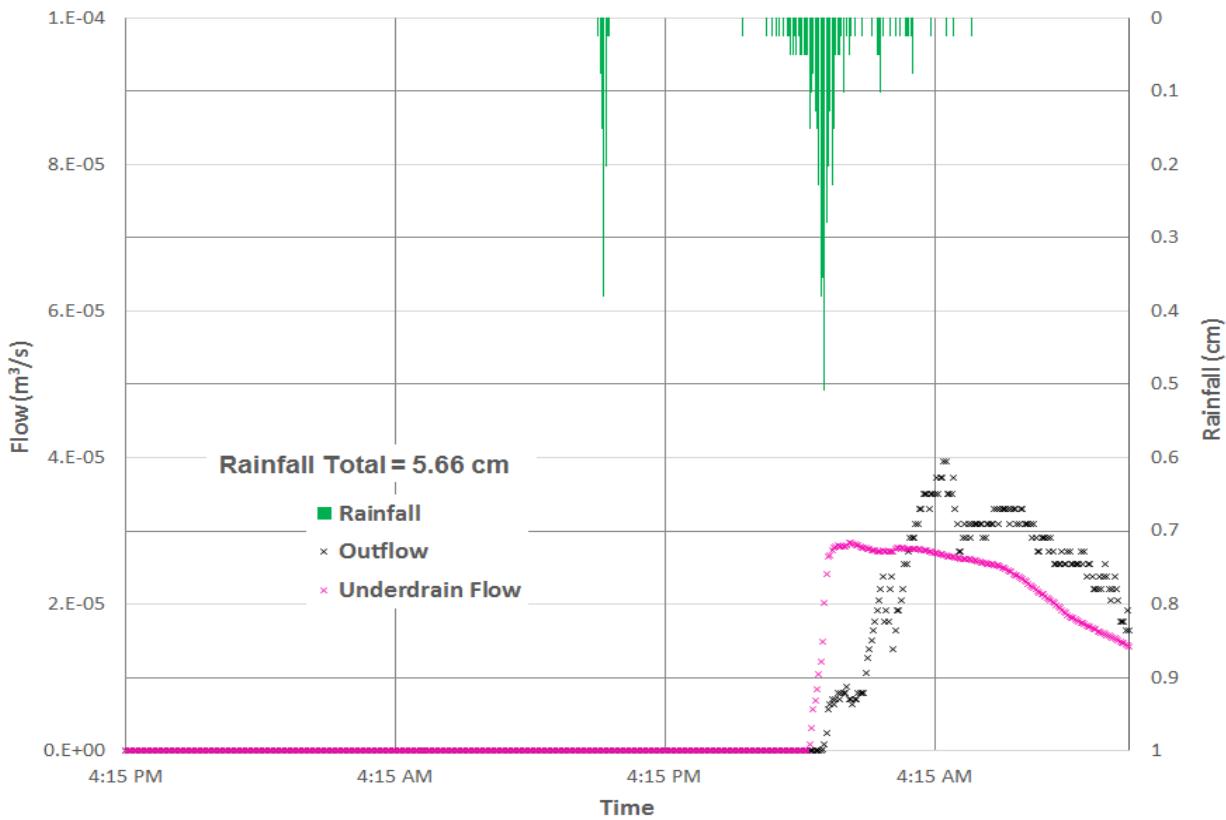
point. This implies that water moves through the system very quickly to the underdrain, where it begins to leave the system. Since there was an additional 5 cm of water above the underdrain, water is slowly exiting the system slowly as it infiltrates to the underdrain. The maximum underdrain flow rate was around  $2.83 \times 10^{-5} \text{ m}^3/\text{s}$  and the maximum outflow rate was around  $3.96 \times 10^{-5} \text{ m}^3/\text{s}$ .

Figure 5.16 FRGR flow data from the 09/29/2015 event

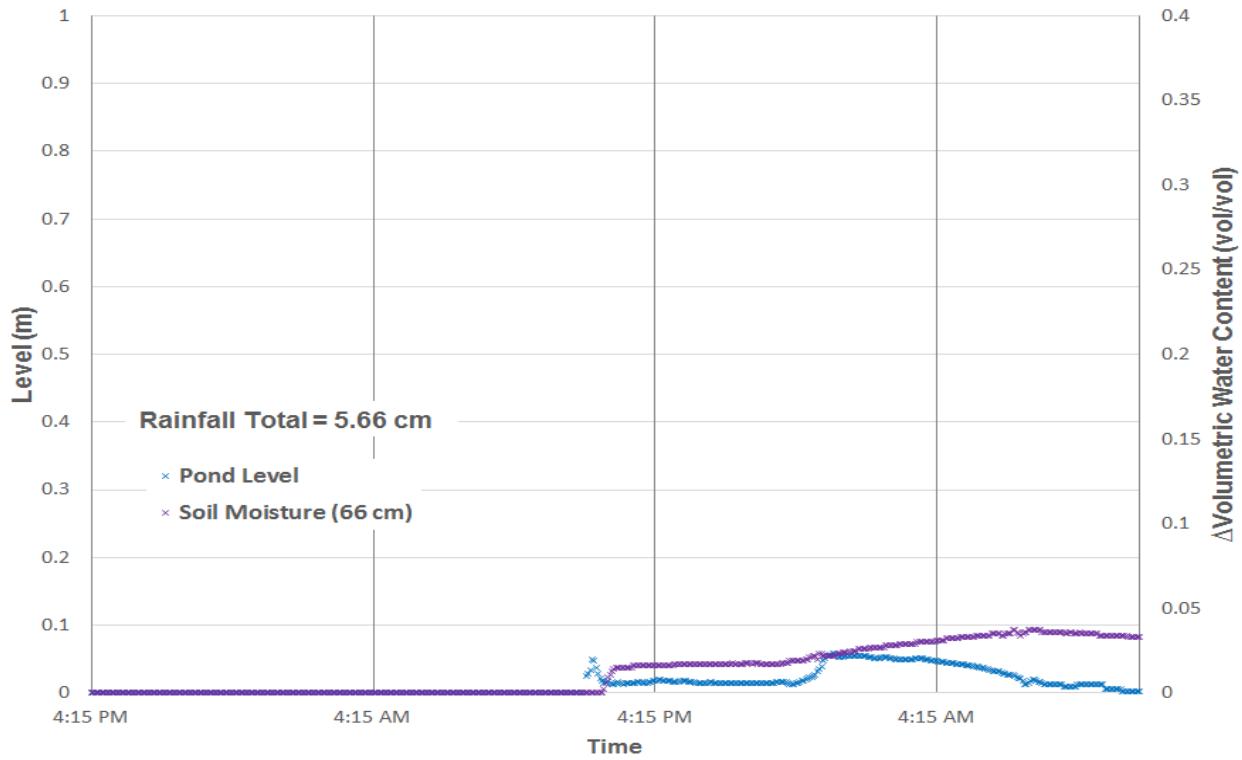
the event ended, and then began to decrease. Figure 5.19 displays the soil moisture sensor data plotted with the pressure transducer levels. From this plot, it can be shown that all pressure transducers and soil moisture sensors read an initial increase during the first 0.5 hours and no increases during the 6 hour break in the storm. All instruments imply additional increases during the second portion of the rain event. The pond level and soil moisture sensor increases occur at almost the same time, suggesting that water moves through the engineered media quickly. Figure 5.20 depicts the soil moisture sensor plotted with the flow data. As shown, flow does not stop increasing until the flows begin decreasing.

Figure 5.19 FRGR pressure transducer data and soil moisture data from the 09/29/2015 event

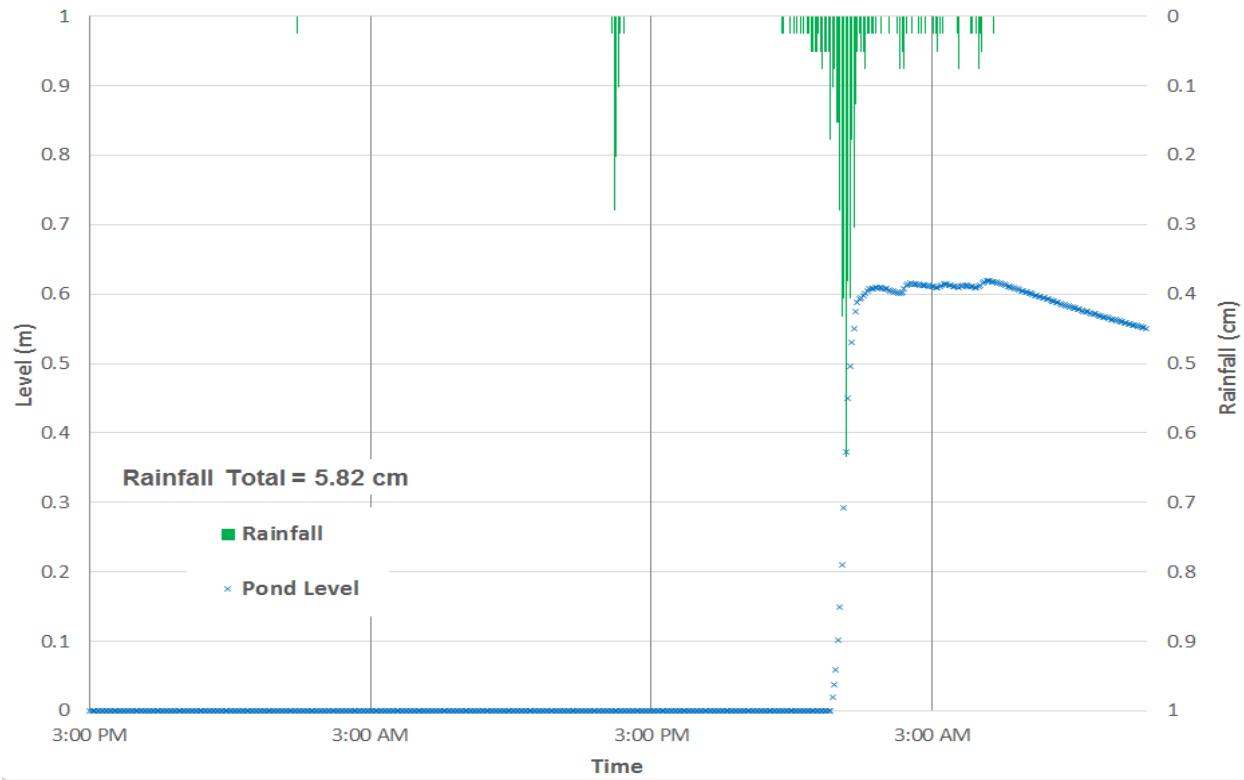
During the event, the PTI did not experience any overflow. As shown in Figure 5.21, the ponding only reached a maximum of 0.62 m, and ponding would need to reach a maximum of 0.83 m before overflow would occur. The rain gage at the PTI did not indicate a 6 hour break in rain as the other rain gages did. It is unclear why this is; however, it could be due to the location of the PTI. The PTI is located on another area of campus than the other sites, so natural rainfall scatter could have caused this difference. Perhaps on this area of campus, small amounts of rainfall continued while it did not on the other side of campus. Ponding began to increase rapidly after around 2 hours, and was above 0.61 m after 4 hours of rainfall. After this, the ponding experienced only slight increases and decreases until 10 minutes after the event. At only 10 minutes after the event, the pond began to empty. However, it is important to note that this decrease is not very rapid.

Figure 5.21 PTI ponding data from the 09/29/2015 event

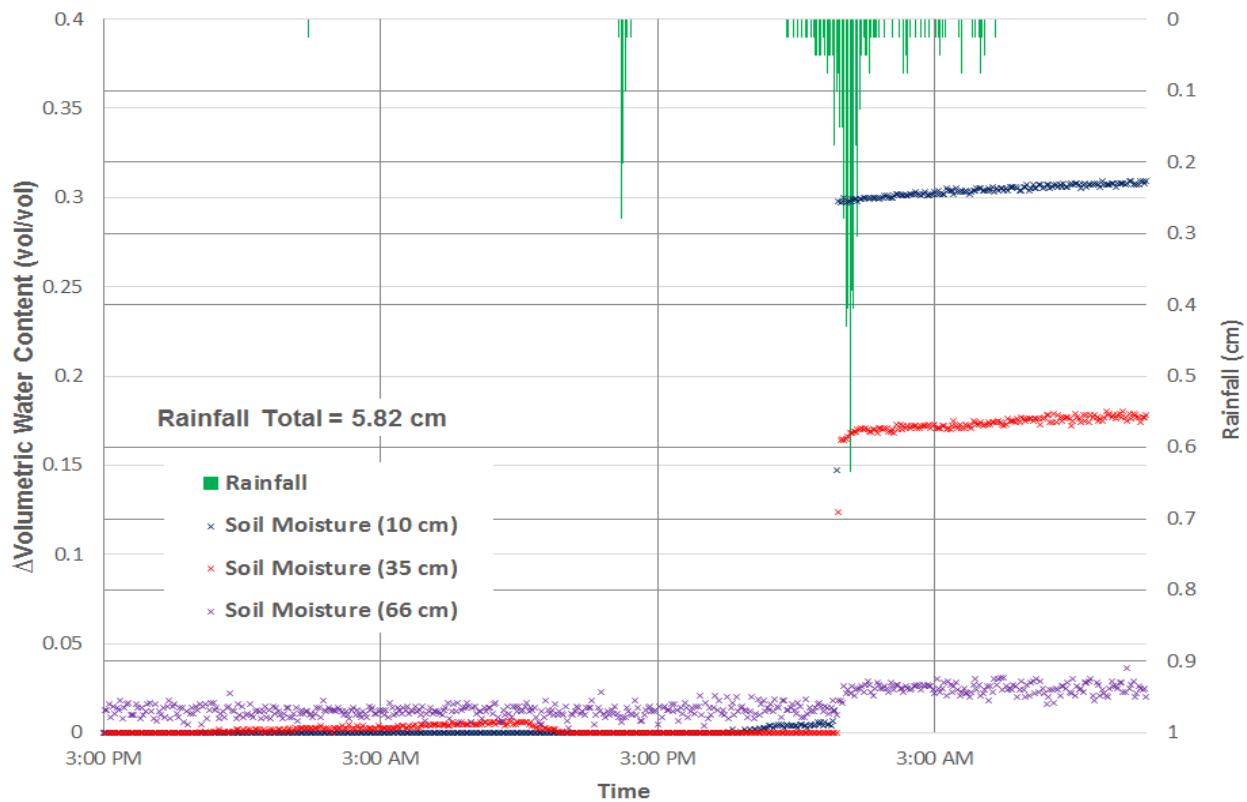
content begin around the same time as the ponding reaches its maximum level. This confirms that the slight increases in volumetric water content are water infiltrating from the pond. The decrease in ponding displayed in this plot is likely related to this as well.

Figure 5.24 PTI soil moisture sensor data from the 09/29/2015 event

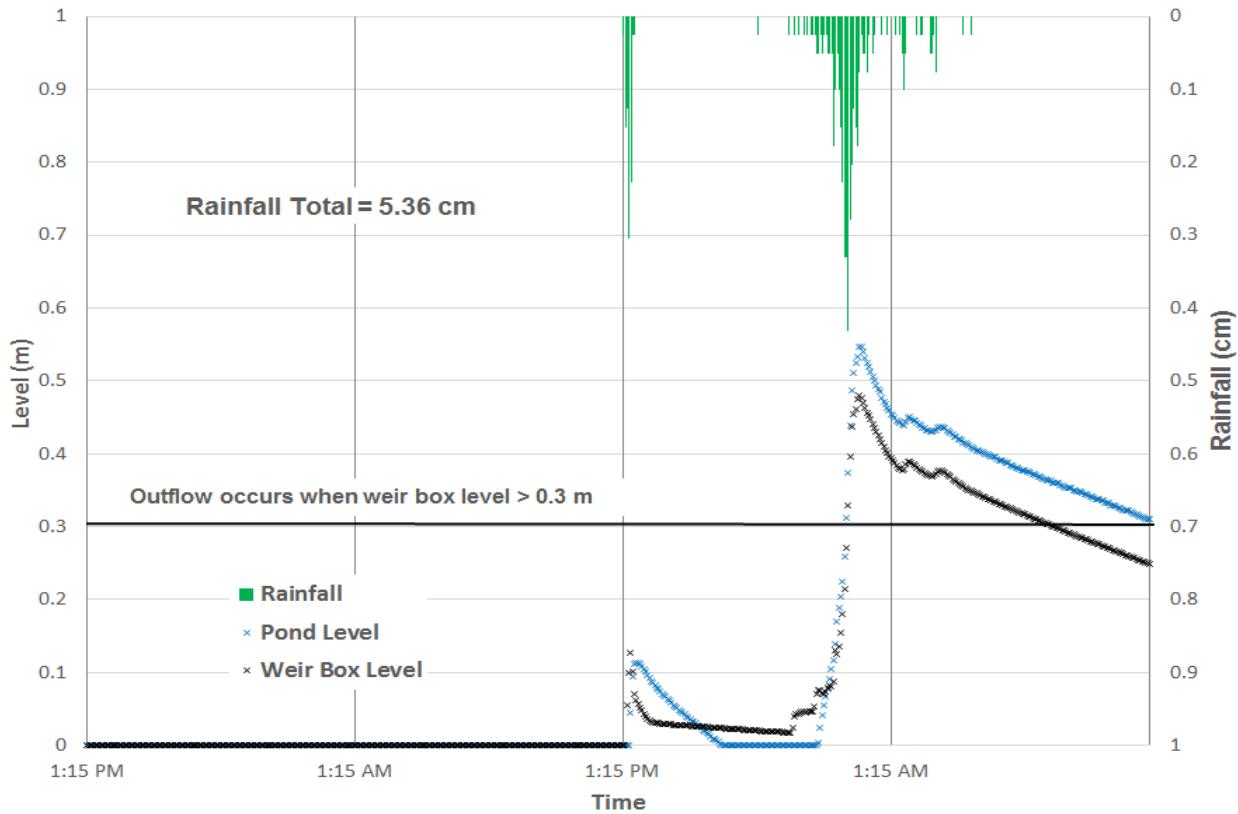
From Figure 5.27, the pressure transducers demonstrate two peaks in both the weir and pond, which is similar to the FRG rain gardens. The BTI rain gage read that there was a 6 hour break in the storm, similar to the rain gage used for the FRG rain gardens. During the break, the pond level fell from 0.19 m to 0.01 m, showing that water does infiltrate quickly after ponding occurs. The pond level reaches a maximum of 0.63 m 10.5 hours after the event begins. Since the BTI has a bowl depth of around 0.5 m, this confirms that overflow did occur within the system. Also, since the rain event caused over 1 inch of rain, overflow was expected. The pressure transducers experience similar recession curves after 10.5 hours of rain, which is when the most intense portion of the event occurs. This implies that water infiltrates quickly when soils are not saturated.

Figure 5.27 BTI pressure transducer data from the 09/29/2015 event

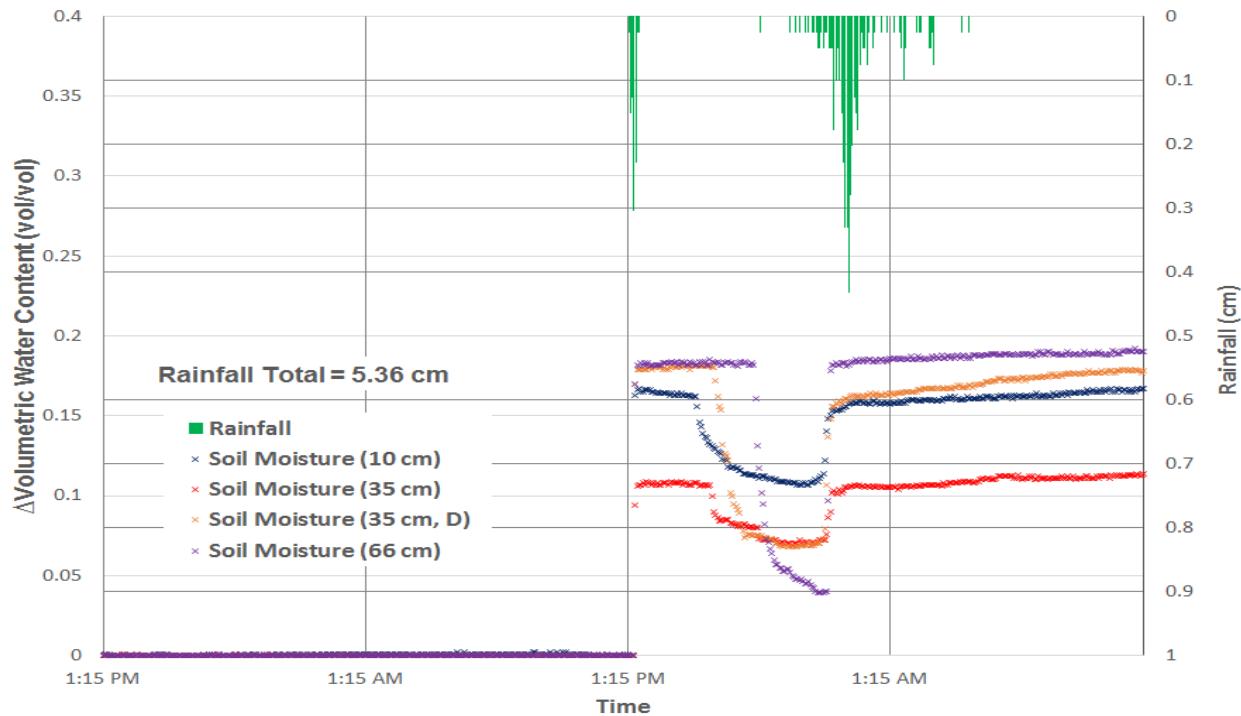
The soil moisture sensors at the BTI indicated rapid increases in volumetric water content until the 6 hour break. At the break, the soil volumetric water content began to drop until the rain began again. When the rain started again (10.5 hours after the event began) the soil volumetric water contents increased back to saturation. During the event, the soil moisture sensors showed very different increases in volumetric water content, as shown in Figure 5.30. This could be due to macroporosity within the system. Since the increases occurred around the same time, it suggests that water moves through the system very quickly. Since the volumetric water content decreased rapidly throughout the system during the break in the storm, it implies that the soil mix drains quickly. Figure 5.31 shows the soil volumetric water content increases plotted with the pressure transducer data. The increases in volumetric water content occur at nearly the same time as the pond begins to fill during the first ponding spike. The second ponding spike does not occur until after the soil moisture sensors spike for the second time. This validates that water was able to continue to infiltrate during the storm after the break in rainfall because water had moved through the soil quickly during the break. As the pond began to empty, the soil moisture sensors read small increases in volumetric water content. This likely suggests infiltration of the water in the pond into the engineered soil mix.

Figure 5.30 BTI soil moisture sensor data from the 09/29/2015 event

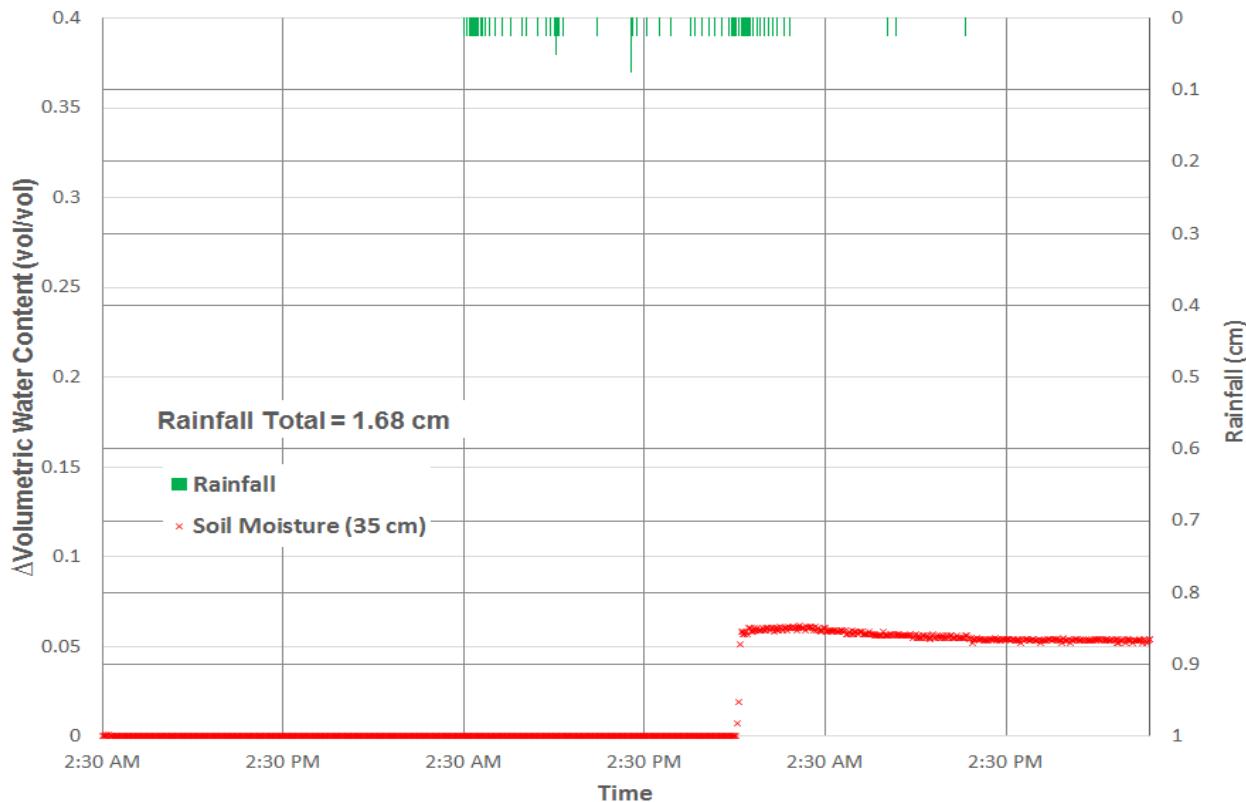
In comparison, the soil moisture sensor at 35 cm did not record any change in volumetric water content during the 9/10/2015 storm. The volumetric water content data from the 11/10/2015 event are displayed in Figure 5.33. The volumetric water content at 35 cm was found to be around 0.300 (30.0%) before the 11/10/2015 storm event, and about 0.222 (22.2%) before the 9/10/2015 storm event. This comparison shows that water can infiltrate to the native soil interface if the soils above are not significantly dry.

Figure 5.33 FRGI soil moisture sensor data from the 11/10/2015 event

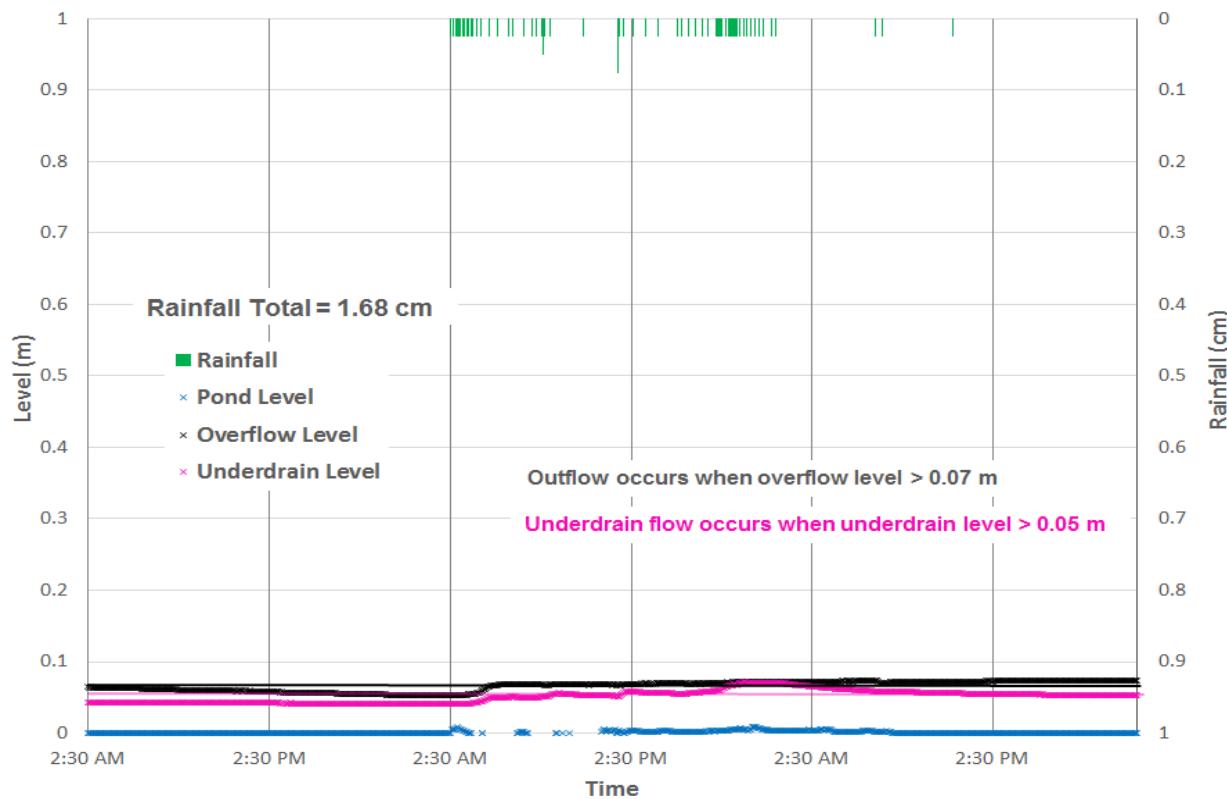
underdrain level and overflow riser level can be observed. The data collected from the FRGR pressure transducer are displayed in Figure 5.34.

Figure 5.34 FRGR pressure transducer data from the 11/10/2015 event

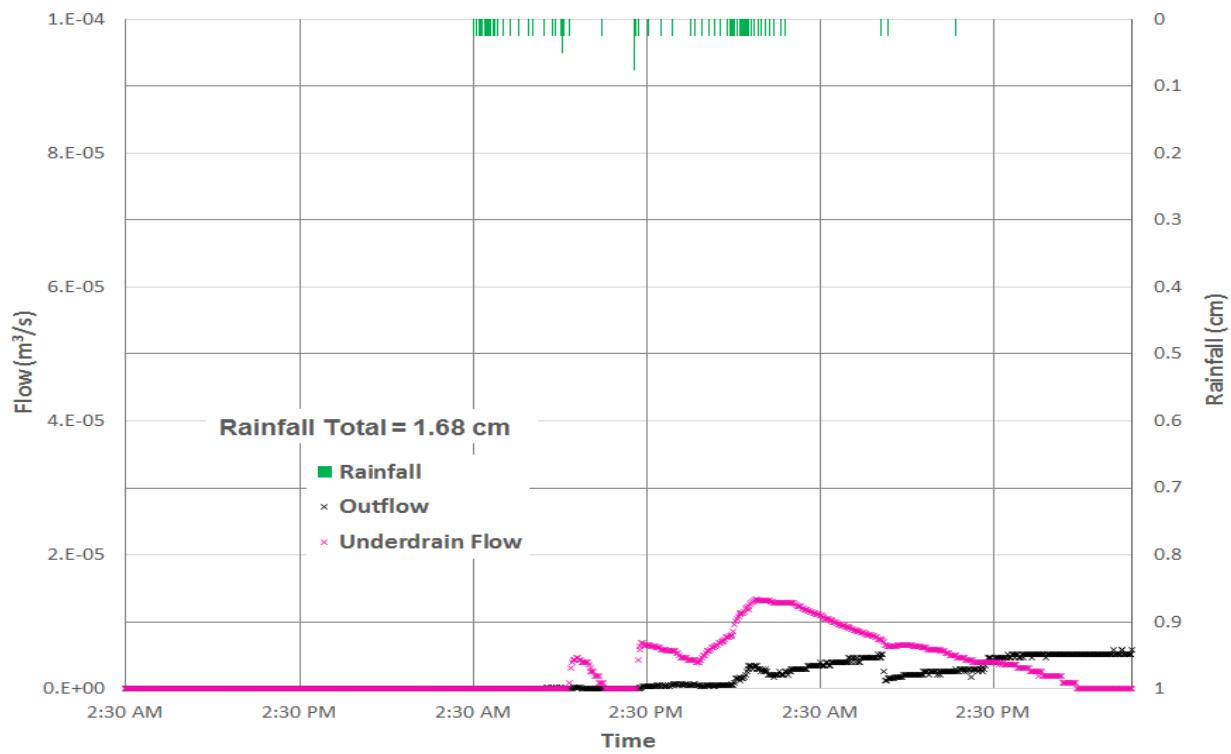
The underdrain flow and outflow at the FRGR during the 11/10/2015 storm was not similar to the flow data collected during the 9/10/2015 storm. Higher underdrain flows and outflows were observed during the 11/10/2015 than during the 9/10/2015 storm. This is likely due to higher volumetric water contents above the underdrain and liner system during the 11/10/2015 storm. During the 11/10/2015 storm, it is probable that less infiltrated water was retained as soil moisture. Some of the increases in underdrain flow are followed closely by increases in outflow. These flow data collected from the 11/10/2015 storm at FRGR are plotted in Figure 5.35. From Figure 5.36, it is suggested that the small increases in ponding do not correlate with increases in flow rates during the 11/10/2015 event.

Figure 5.35 FRGR flow data from the 10/28/2015 event

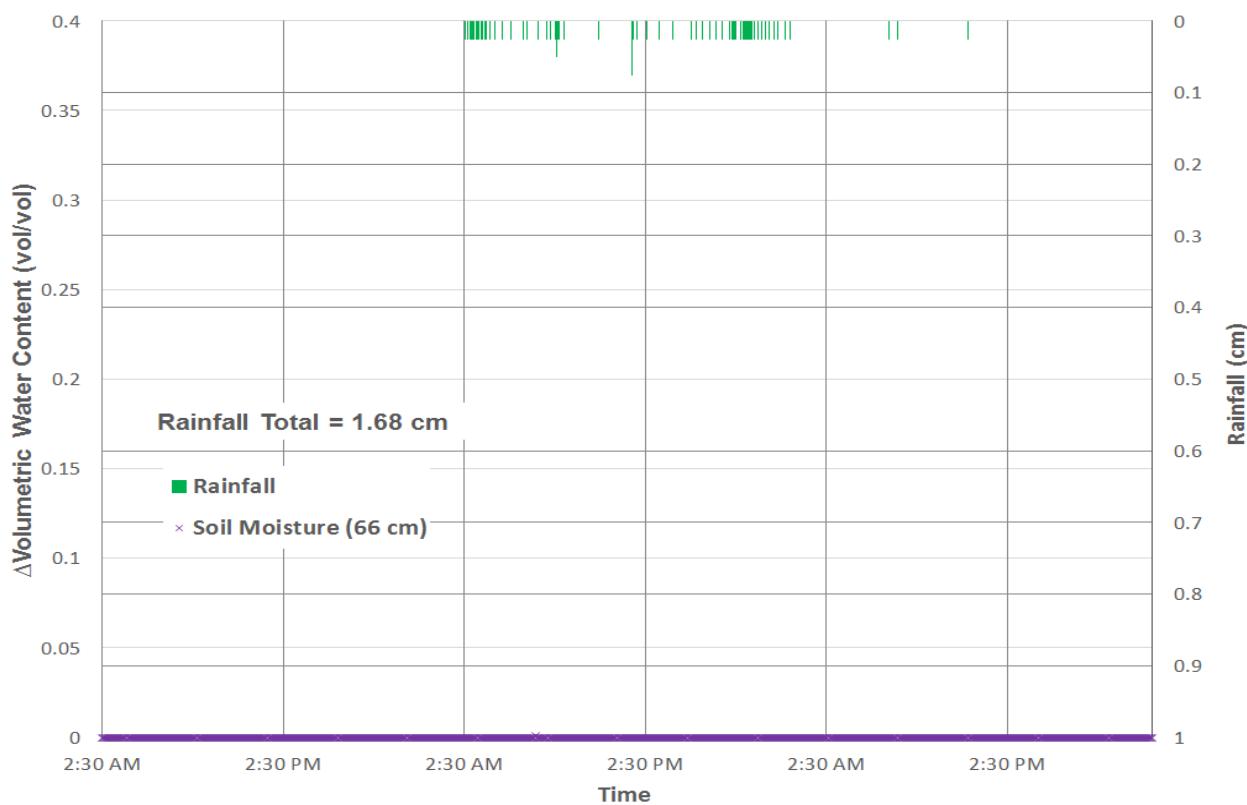
The rainfall from the 11/10/2015 storm did not cause any increase in volumetric water content at 66 cm at the FRGR. This differs from the 9/10/2015 storm, which caused an increase of 0.039 (3.9%) of volumetric water content at this depth. However, the soil moisture sensor at 66 cm deep indicated that the volumetric water content was 0.384 (38.4%) prior to the start of the 11/10/2015 storm. This is 0.034 (3.4%) higher than the volumetric water content observed at this depth prior to the 9/10/2015 event. It is likely that the soil media at this depth was at saturation or very close to saturation prior to the 11/10/2015 storm, so an increase in volumetric water content did not occur. The soil moisture data from the 11/10/2015 storm collected from the FRGR can be found in Figure 5.37.

Figure 5.37 FRGR soil moisture data from the 10/28/2015 event

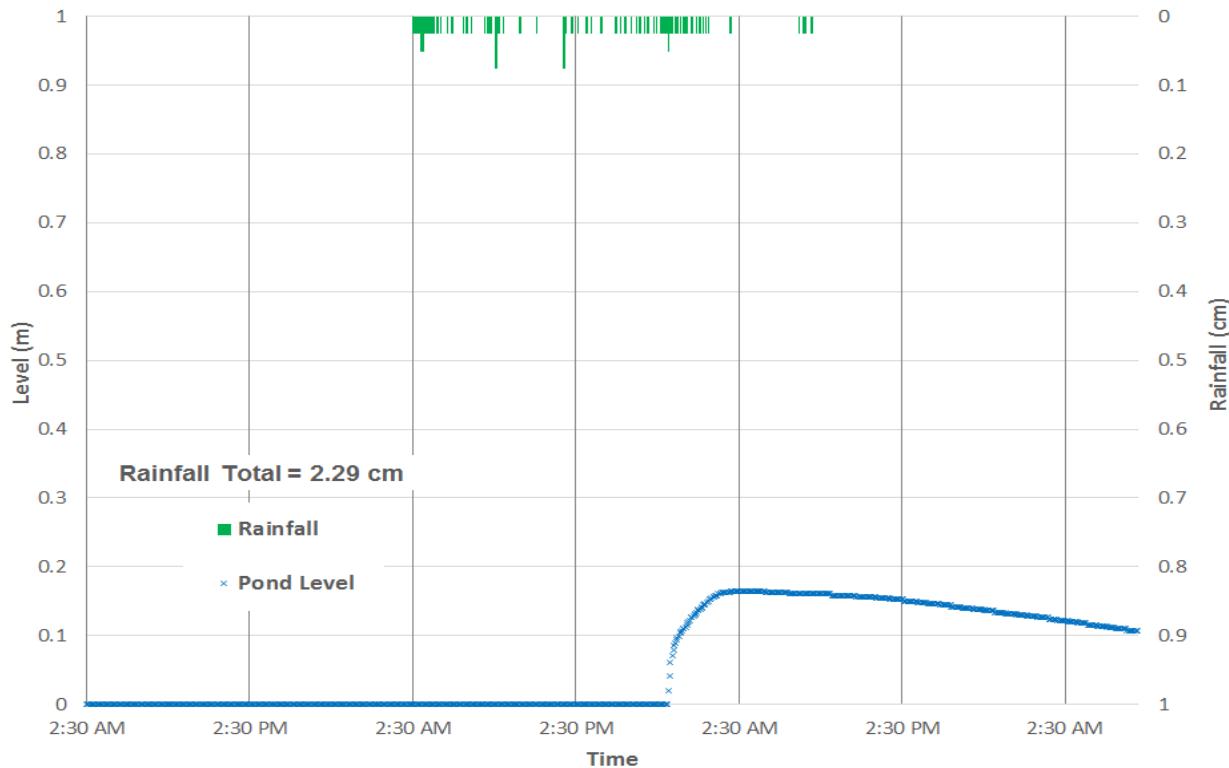
During the 11/10/2015 storm event, the PTI did experience ponding up to 0.16 m after 24 hours of rainfall. Approximately 24 hours after the rainfall event, the ponding dropped to about 0.11 m. After 72 hours had passed since rainfall had ended, the PTI pond was empty. This confirms that the PTI can adequately remove water from a typical Villanova rain event within the 72 hour constraint. This ponding scenario is different from the event that occurred during the dry period (9/10/2015), which observed no ponding during. The ponding data from the 11/10/2015 is plotted in Figure 5.38.

Figure 5.38 PTI ponding data from the 11/10/2015 event
