**EVALUATING RAIN GARDENS OF DIFFERENT  
CONFIGURATIONS AND SCM INFILTRATION TESTING  
METHODS TO DETERMINE RAIN GARDEN DESIGN AND  
SITE INVESTIGATION RECOMMENDATIONS**

Thesis

Civil Engineering

April, 2016

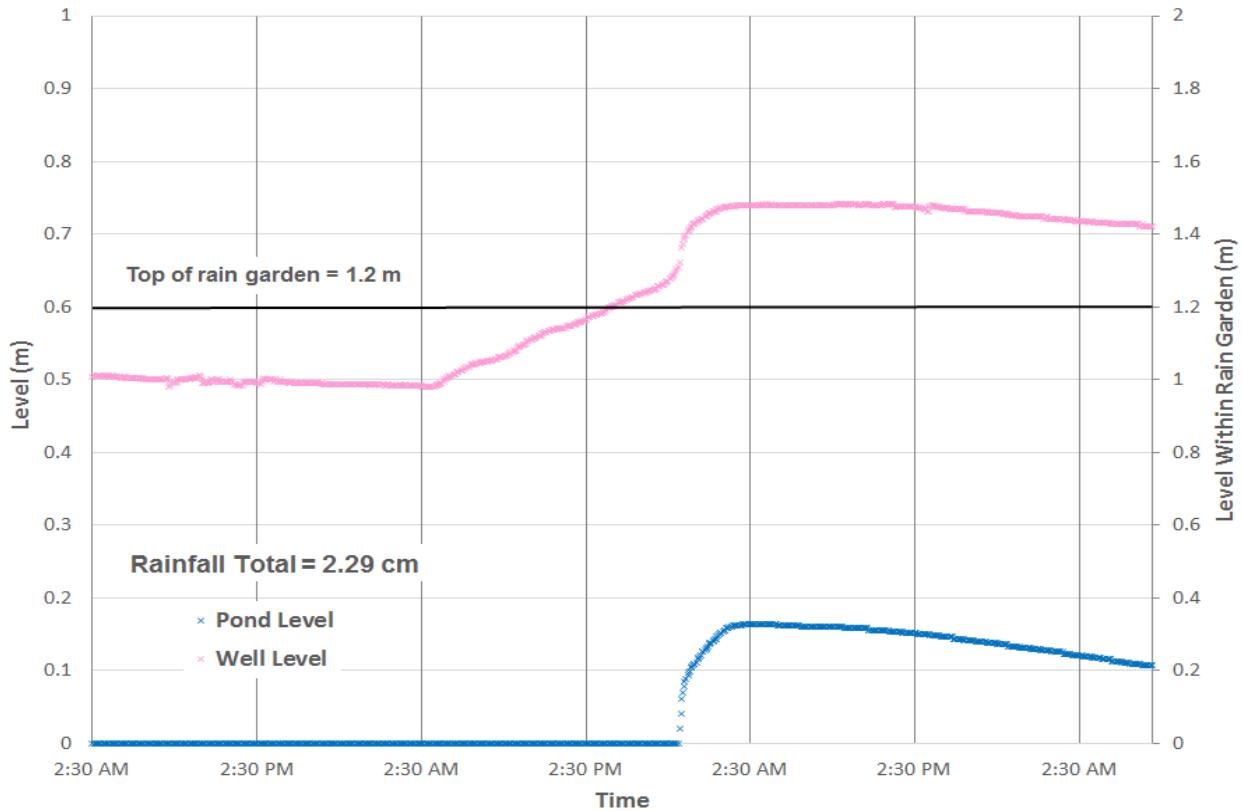
been created during the well installation. This would cause the water in the well to fill before the rest of the PTI. These data are shown in Figure 5.40.

Figure 5.40 PTI ponding data and well transducer data from the 11/10/2015 event

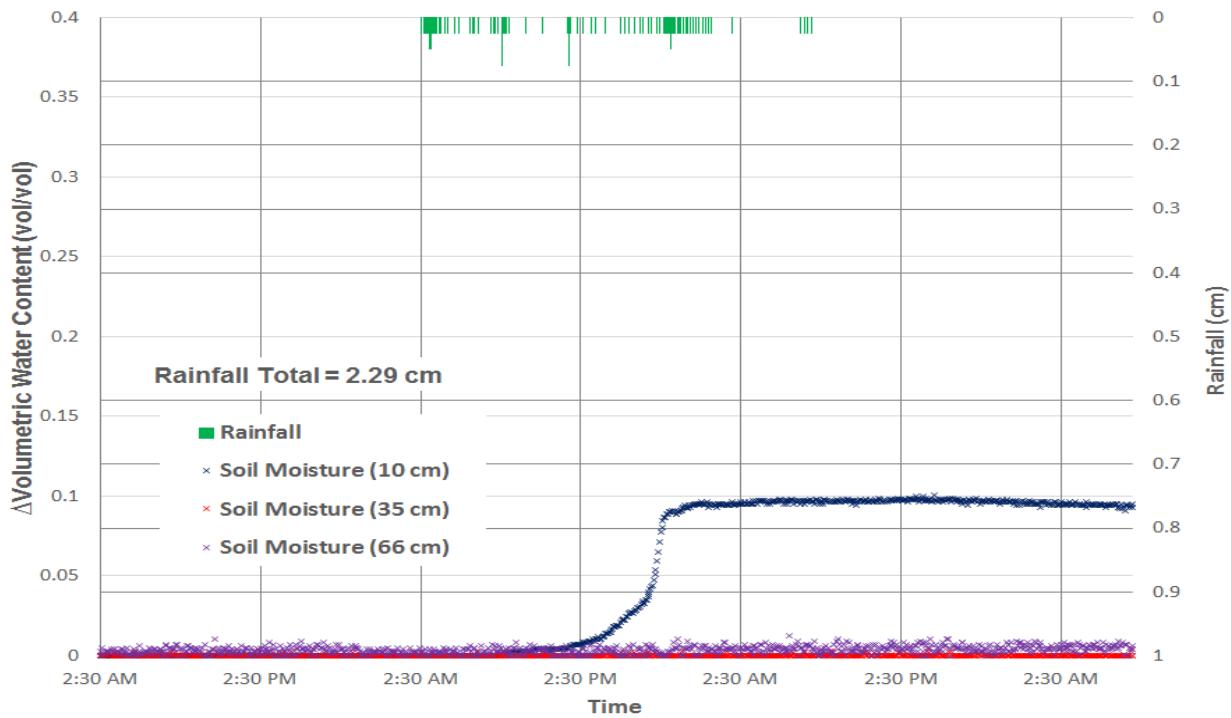
event. The shape of the increase in volumetric water content at 10 cm deep is staged and more rapid during the 9/10/2015; however, this could be due to the dryness of the soil. The soil may have been so dry during the 9/10/2015 event that the suction could have changed how the soil became wetted. The 10 cm soil moisture sensor demonstrated an expected curve during the 11/10/2015 sensor; however, it began with a water content 0.269 (26.9%) higher than during the 9/10/2015 storm, so it could have followed a different wetting pattern. During the 11/10/2015 storm, the volumetric water content at 10 cm deep stopped increasing in about 6 hours, which was much faster than the 12 hours required during the 9/10/2015 storm. This was expected due to the dryness of the media during the 9/10/2015 storm. The soil moisture data for the 11/10/2015 storm are demonstrated in Figure 5.41.

Figure 5.41 PTI soil moisture sensor data from the 11/10/2015 event

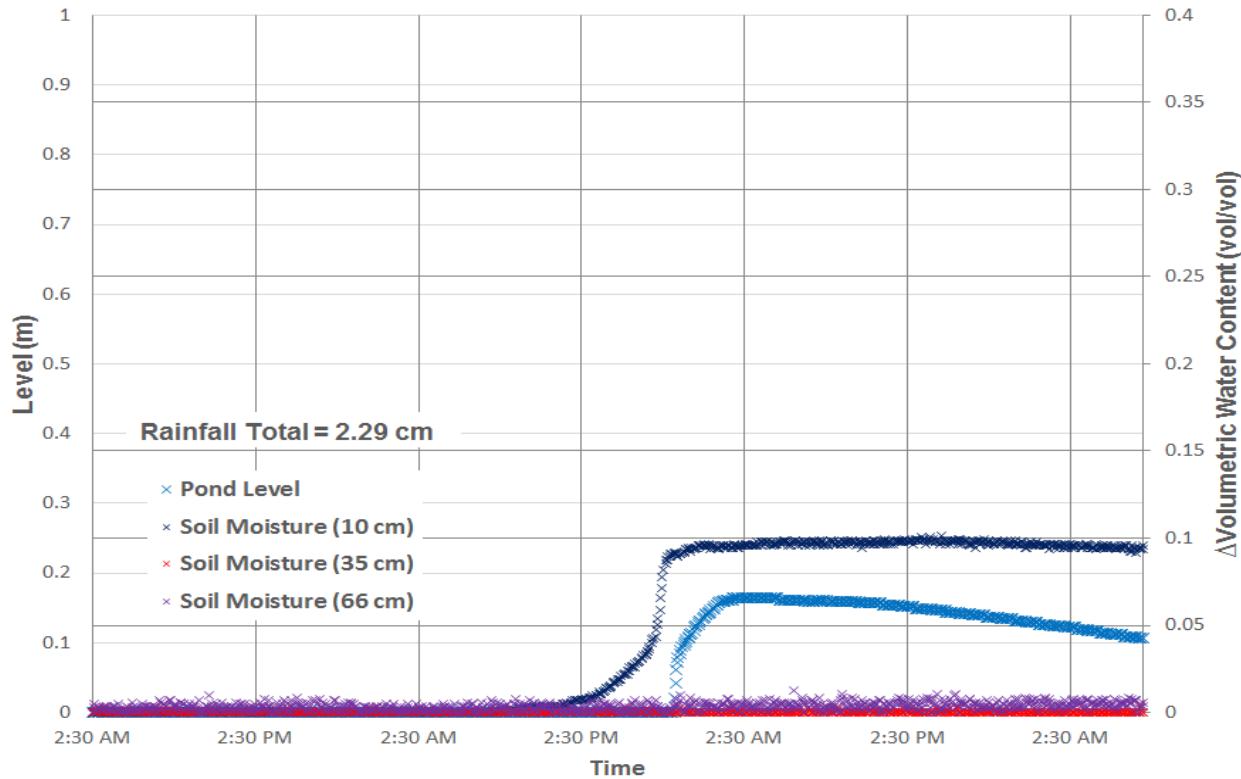
events, the volumetric water content stopped increasing before the well transducer level stopped rising. This could be due to macroporosity and quick infiltration rates of the sandy material. The well transducer data and soil moisture sensor data are shown in Figure 5.42. As expected from the high infiltration rates of the sandy material, the volumetric water content 10 cm deep began increasing before ponding occurred during the 11/10/2015 storm. These data are plotted together in Figure 5.43.

Figure 5.43 PTI soil moisture sensor data and ponding data from the 11/10/2015 event

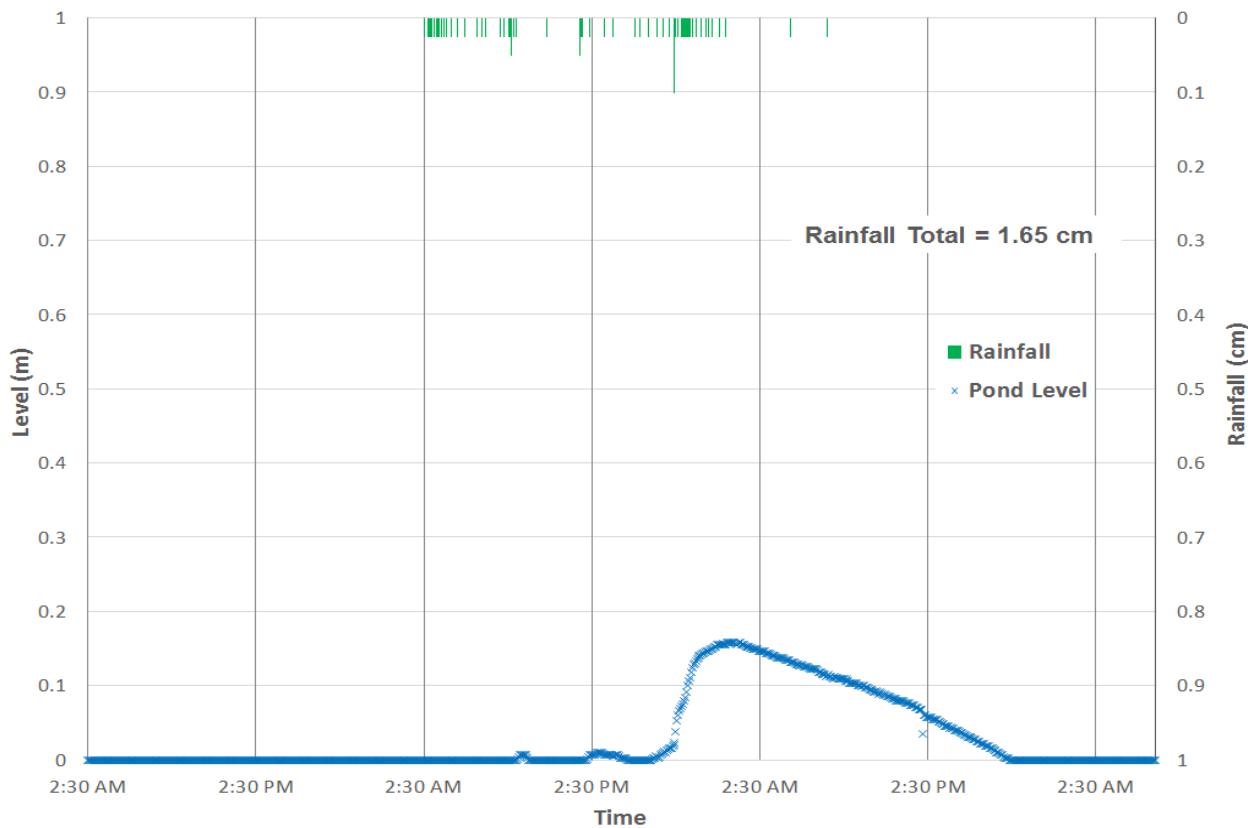
occurring during the 11/10/2015 storm event as it did during the 9/10/2015 storm event. During the 11/10/2015 event, some minor increase and decreases in ponding were observed during breaks in rain; however, these were not as significant as during the 9/10/2015 storm event. This could be due to longer breaks in rainfall dryness of the soil during the 9/10/2015 storm. The ponding data from the 11/10/2015 storm are demonstrated in Figure 5.44.

Figure 5.44 BTI pressure transducer data from the 11/10/2015 event

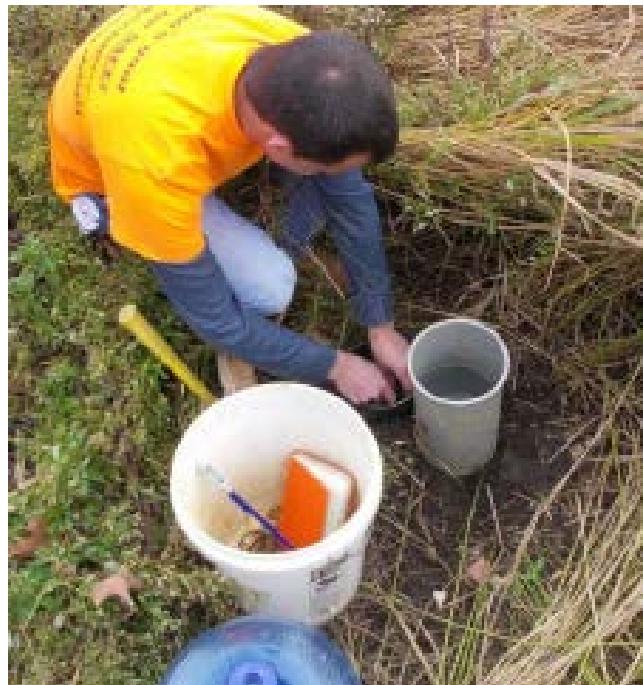
Figure 6.2 A single-ring infiltration test at the BTI (Emerson et al. 2015)

During the fall of 2014, seven single-ring infiltrometer tests were performed at the BTI in the locations provided in Figure 6.1. These tests were performed by Zukowski et al. (2016) as part of a study to compare the single-ring infiltration testing method with the long-term average recession rate of the BTI. A single-ring infiltrometer test conducted at the BTI is depicted in Figure 6.2. During the initial field investigation, the soil at the BTI was saturated from a previous storm but ponding was not present within the SCM. The water temperature, hydraulic conductivity, and depth of the organic silt loam layer were recorded for each of the seven tests.

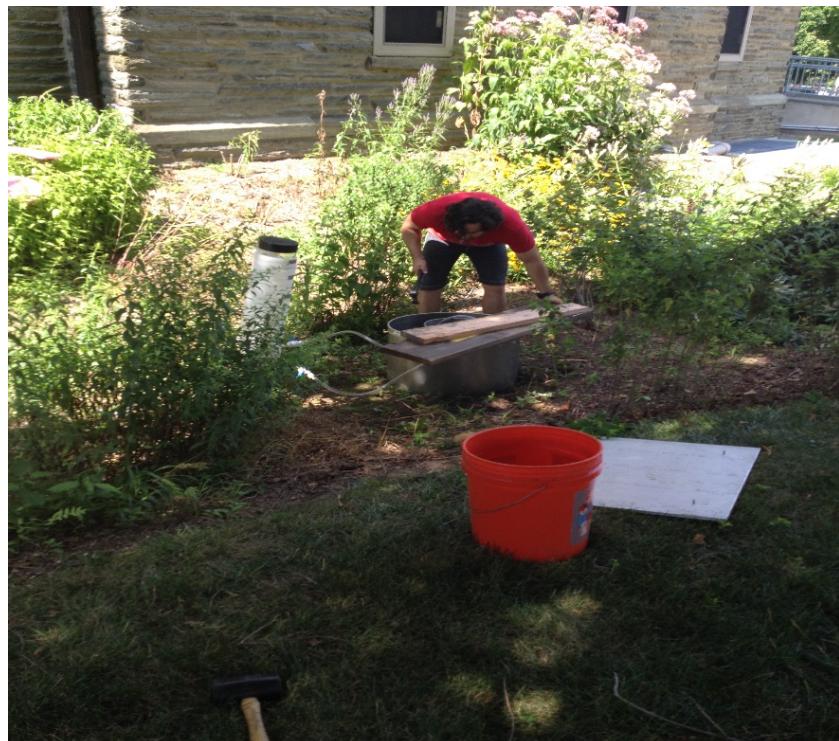
Figure 6.4 FRGI-02 being installed at the FRGI

Modified Philip-Dunne infiltrometer were normalized to 10°C using Equation 4.1. The dynamic viscosity of water at 12°C is 0.00131 kg/m-s according to calculations provided by Touloukian et al. (1975). Figure 6.4 shows a double-ring infiltrometer test being installed at the FRGI, and Figure 6.5 show a double-ring infiltrometer test being conducted at the FRGI. The locations of the tests performed are shown in Figure 6.6, and the data collected from the FRG are provided in Table 6.2.

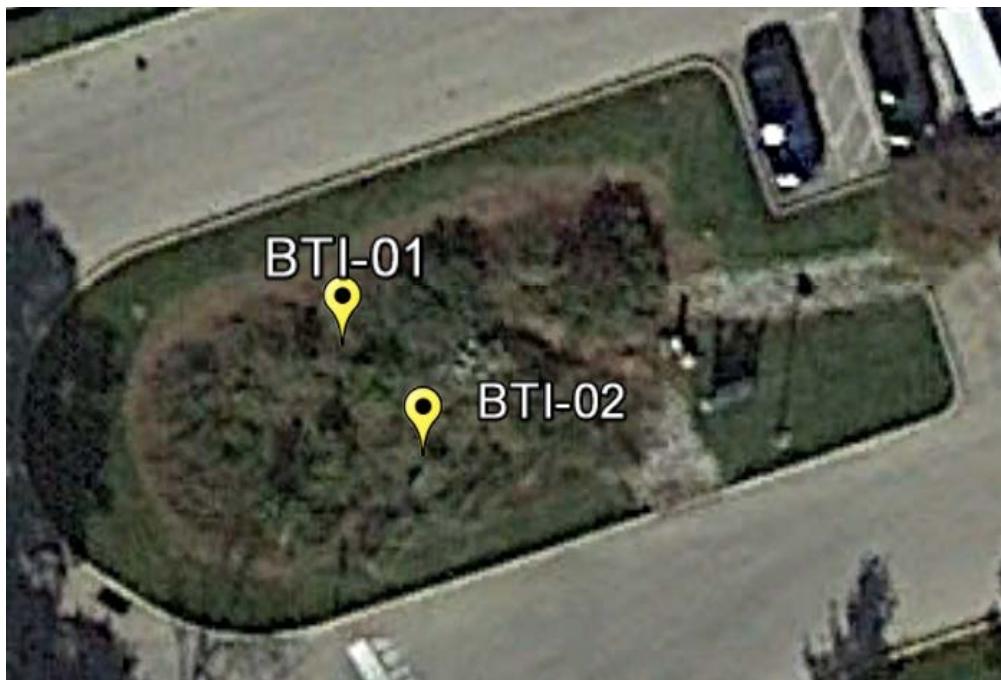
Figure 6.7 Infiltration test locations at the BTI

During the summer of 2015, two Modified Philip-Dunne infiltrometer tests were conducted at the BTI. Additionally, samples were taken at these locations for the UMS KSAT laboratory hydraulic conductivity testing method. These locations were chosen because they are in the vicinity of two of the single-ring tests performed, which were test number 1 and test number 6 from the previous section of this chapter. This provided the necessary information to compare the Modified Philip-Dunne infiltrometer test method, the KSAT test method, and single-ring infiltrometer test method. As was the case with the infiltration test data collected from the FRG, the Modified Philip-Dunne infiltrometer and single-ring infiltrometer data were normalized to 10°C for comparison with the KSAT. The locations of the tests performed are shown in Figure 6.7, and the data collected from the BTI are provided in Table 6.3. The KSAT samples taken from the BTI failed during the testing procedure, so the KSAT data are not provided.

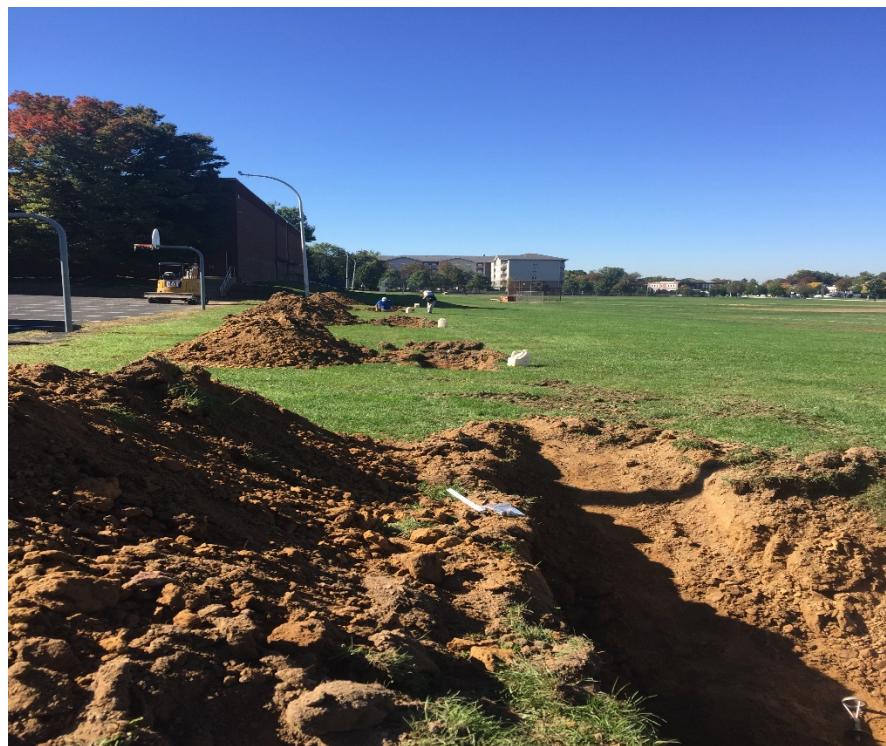
Figure 6.8 Test pits dug at the Upper Moreland site

Modified Philip-Dunne infiltrometer could be used to determine hydraulic conductivity values in test pits during site investigations for SCM design. The goal of the investigation was to determine the underlying soils at the site, as well as conduct necessary infiltration testing to determine what kind of SCM would be best suited for the site and properly design the selected SCM. A total of 15 test pits were dug with an excavator and infiltration testing was conducted within the test pits, which ranged between 1.2 and 1.5 m in depth. In each test pit, a private consultant conducted a falling-head infiltrometer test method with a PVC pipe. For this comparison study, these test results were ignored because they do not account for the head of water within the pipe and unsaturated flow beneath the PVC pipe. Two double-ring infiltrometer tests were conducted and three Modified Philip-Dunne infiltrometer tests were conducted to compare the methods in native soil. Additionally, six soil samples were taken for gradation size distribution testing using the sieve and hydrometer analysis methods (ASTM D422) and Atterberg limits testing (ASTM D4318). The sampler used also allowed for quick determination of the dry unit weight of the soil samples. The goal was to classify the soil at the Upper Moreland site and determine if Atterberg limits parameters correlated to hydraulic conductivity values found. Six samples were also taken for KSAT laboratory analysis for the comparison study. Figure 6.8 depicts the test pits dug at the Upper Moreland site, and Figure 6.9 and Figure 6.10 show all of the infiltrometer tests being conducted in test pits.

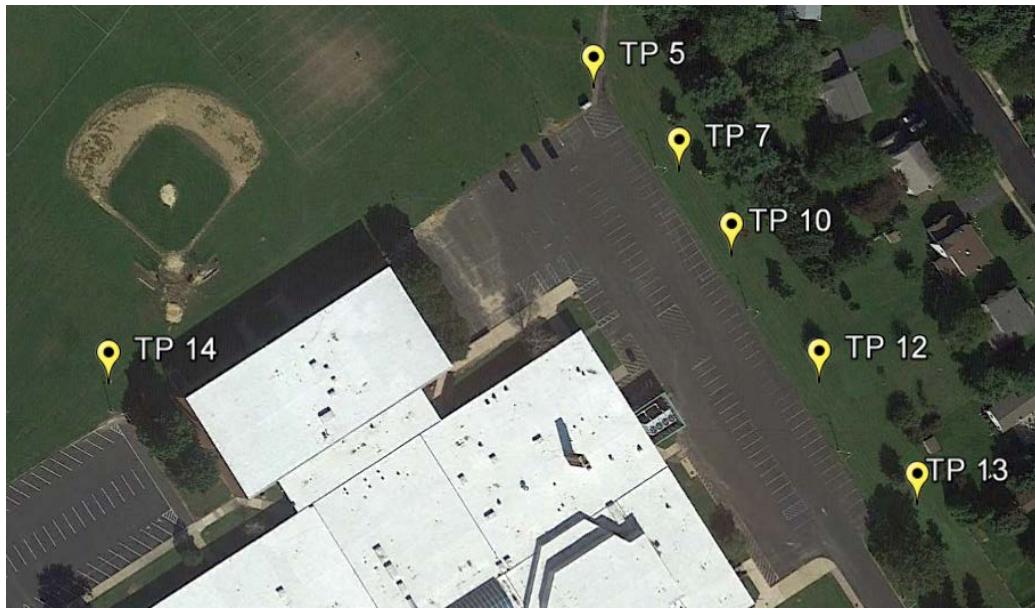
Figure 6.11 Test pit locations and infiltration tests conducted at the Upper Moreland site

The goal of this study was to compare data from the double-ring infiltrometer test method, the Modified Philip-Dunne infiltrometer test method, the UMS KSAT laboratory hydraulic conductivity test method, and the plasticity index determined by the Atterberg limits testing. The double-ring infiltrometer tests, which were conducted at TP 14 and TP 5, did not indicate any change in water level during the test, which validated infiltration was too slow to measure at these locations. As was the case with the infiltration test data collected from the FRG and BTI, the Modified Philip-Dunne infiltrometer data were normalized to 10°C for comparison with the KSAT. The locations of the tests performed are shown in Figure 6.11, and the data collected from the Upper Moreland site are provided in Table 6.4. In Table 6.4, the term BDL was used to indicate that the hydraulic conductivity could not be determined because the value was “below the detection limit”.

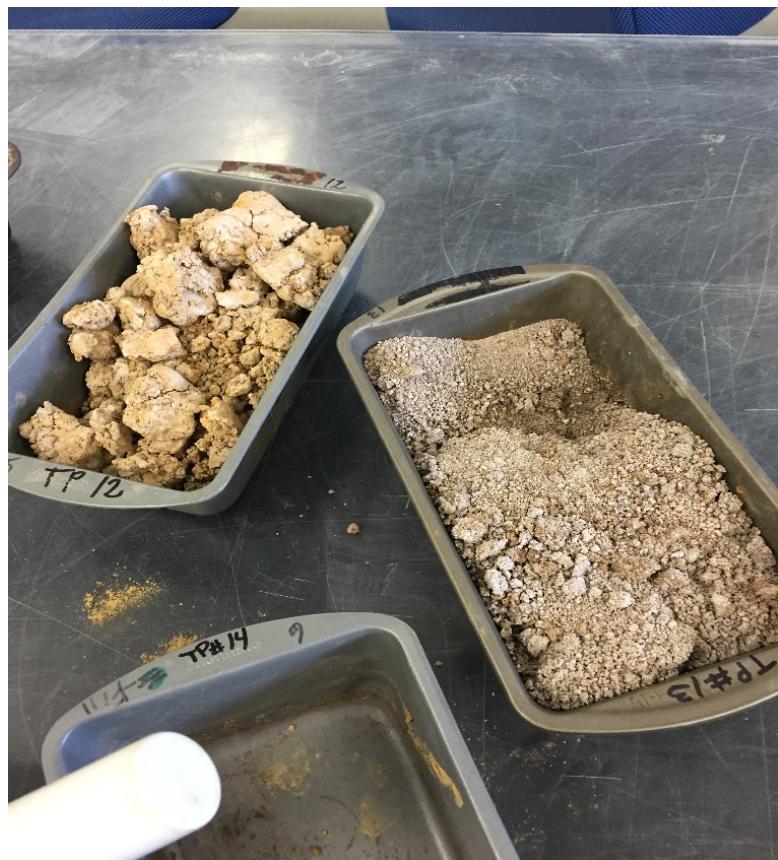
Figure 6.12 Samples TP 12 and TP 13 being prepared for laboratory testing

Figure 6.12 shows soil laboratory samples being prepared for sieve, hydrometer, and Atterberg limits testing. These data and the dry unit weight data are provided in Appendix A. From the laboratory testing, it was determined that all soil samples except TP 13 were classified as USCS silt and USDA silt loam. TP 13 was classified as a USCS sand and a USDA sand. **Figure 6.13** depicts where the soil samples plotted on the USDA soil triangle. These classifications are represented in Table 6.5.

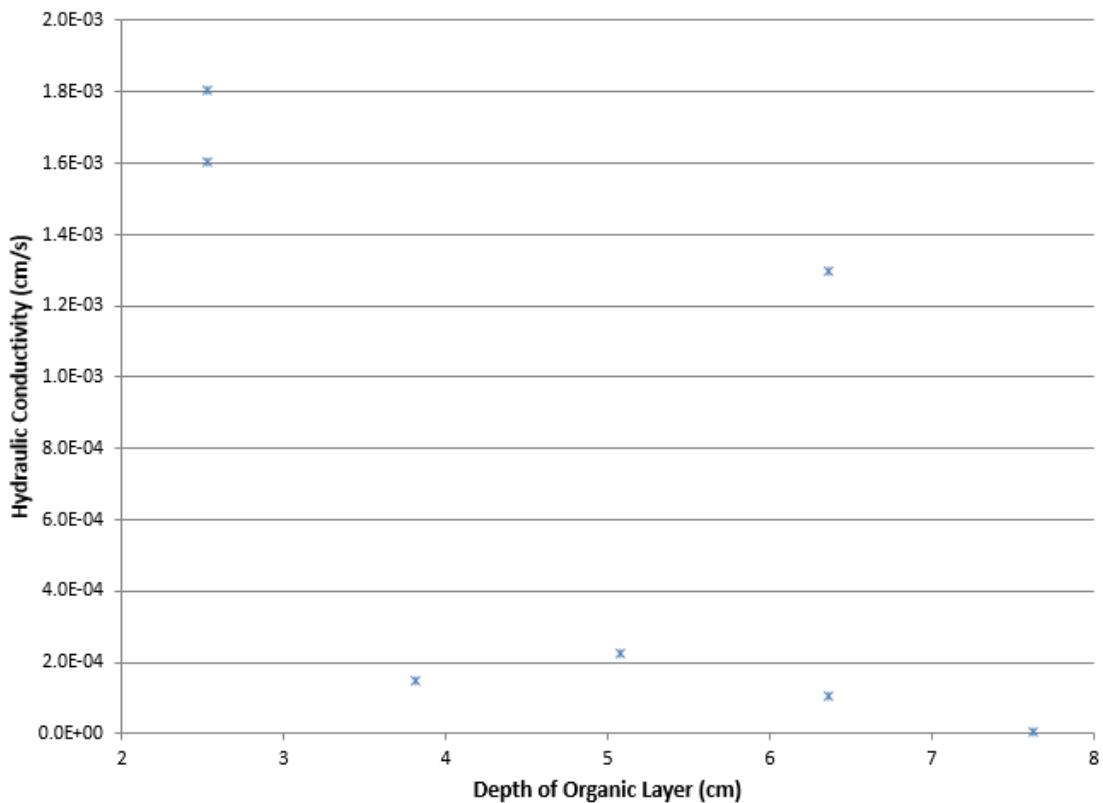
Figure 7.1 Hydraulic conductivity values obtained and the depth of the organic silt loam layer for each test

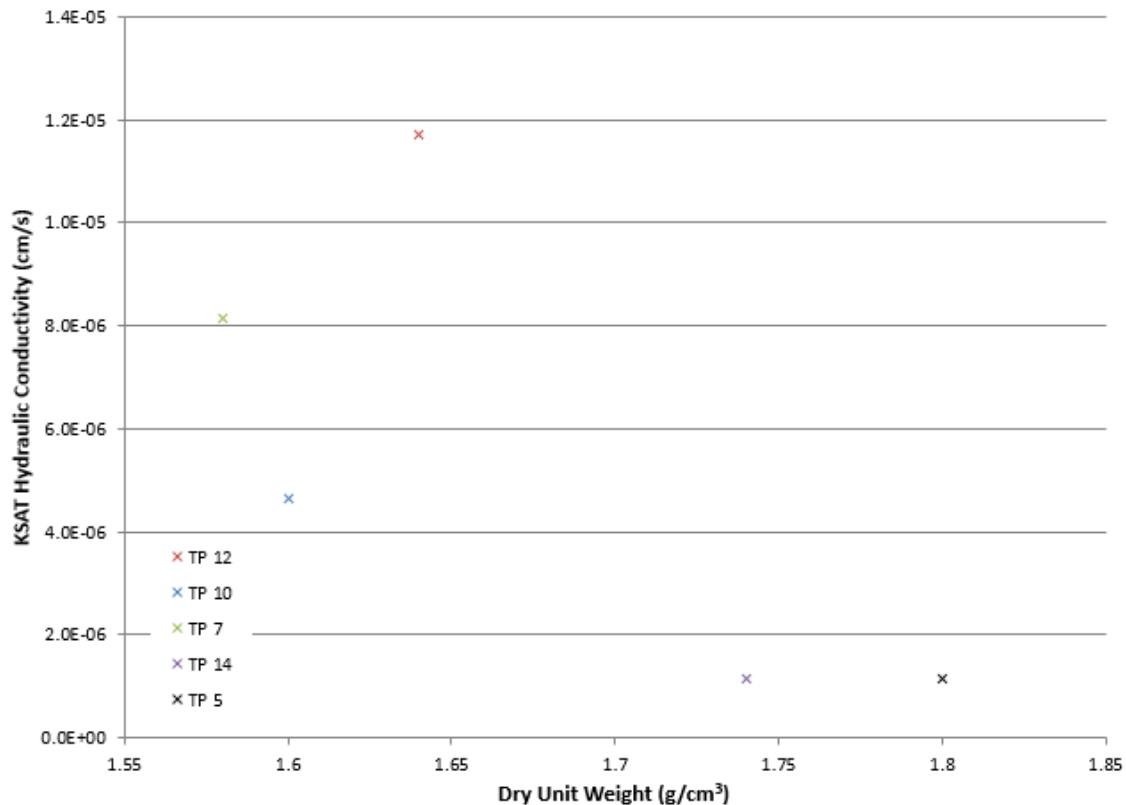
Figure 7.4 Dry unit weight and KSAT hydraulic conductivity data from the Upper Moreland site

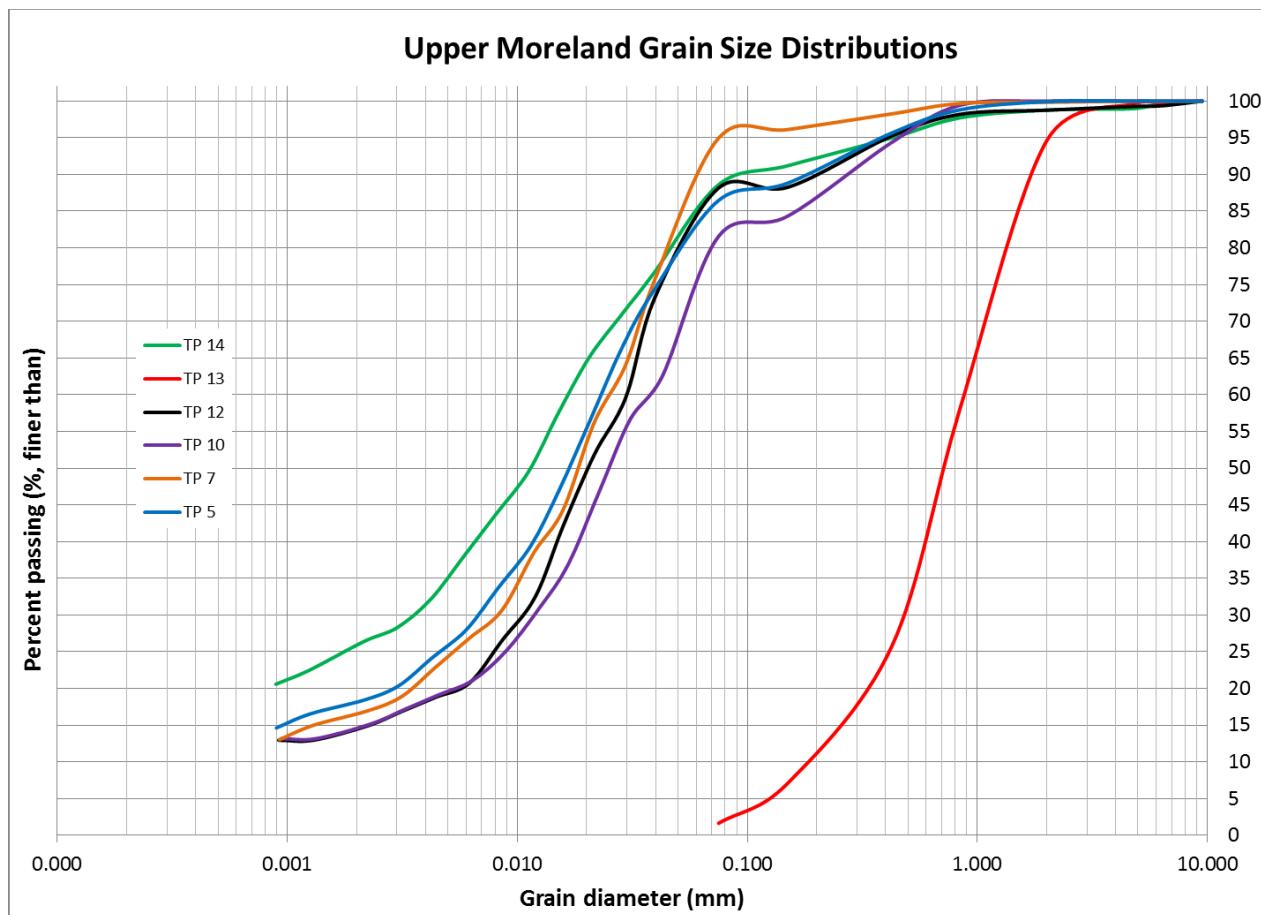
**Figure A.7** Upper Moreland grain size distributions
