# Green Stormwater Infrastructure at Wissinoming Park, Part 2: Construction Considerations and Lessons Learned

# Lessons Learned: Stormwater BMP Construction Challenges & Issues

# Opportunities for Improvement when Severe Weather Complicates Construction

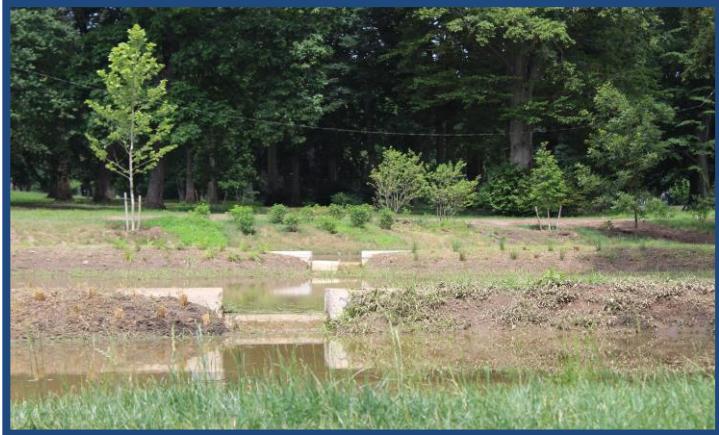
**Figure 1.** Substantially Complete Sloping Wetland System following 4-inches of rainfall in less than 4 hours on July 12, 2021 (~100-year storm).

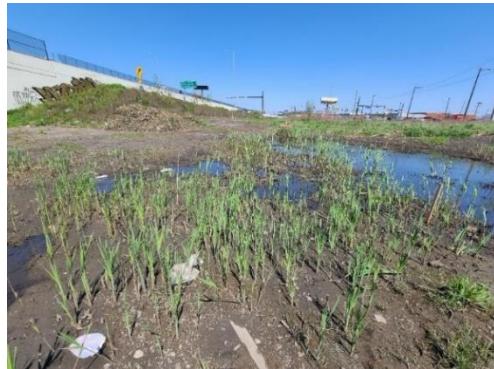
Figure 1 shows an existing site where a higher-than-expected groundwater table was encountered. The challenge in this case was to minimize changes to the basin design because construction around the perimeter had already begun, while still complying with all local and state requirements.

Figure 1. Site of a stormwater basin which encountered a high groundwater table prior to construction.
